Gazos Creek Post-fire Stream Habitat Assessment in July and September 2022 (revised from August 2022; text changes are in *italics bold*)

Jerry J. Smith

29 October 2022

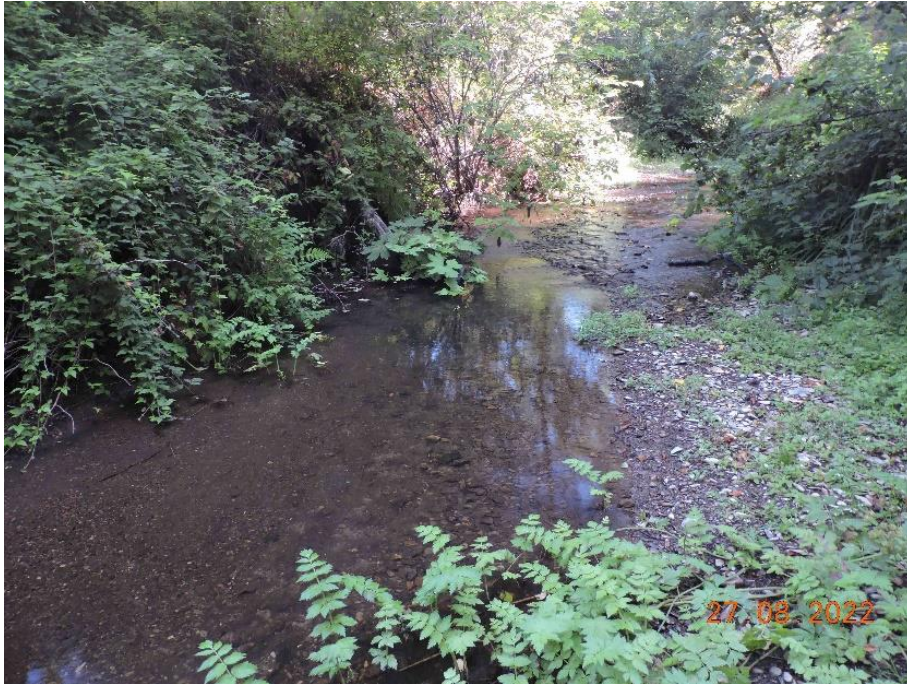
Photo 3. Mile 1.8, looking upstream. Pool widened and shallower, with loss of undercut right bank. Fines and small gravel.

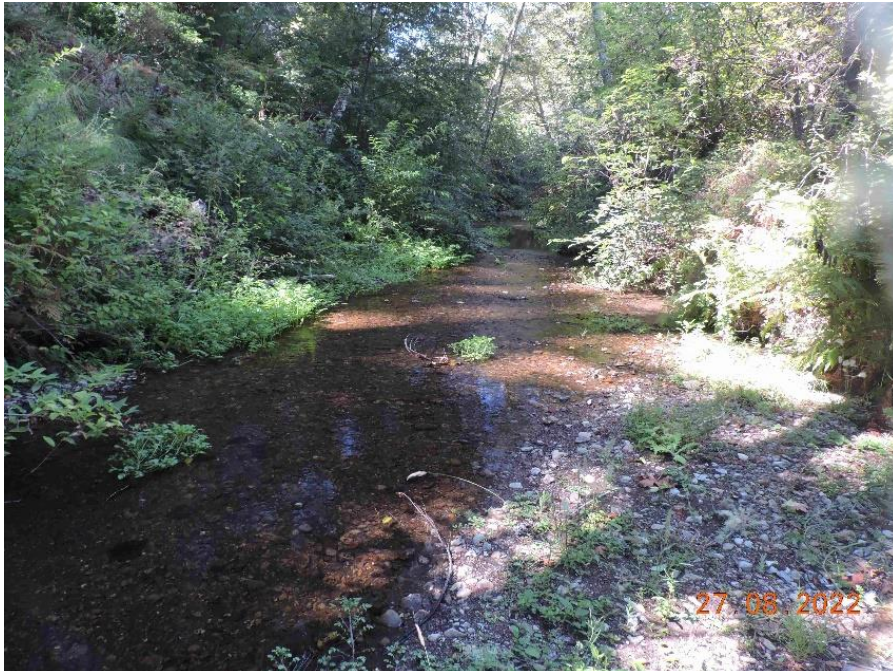
Photo 4. Mile 1.8, looking downstream. Downstream of pool 4 the channel is shallow and has been widened and flattened.

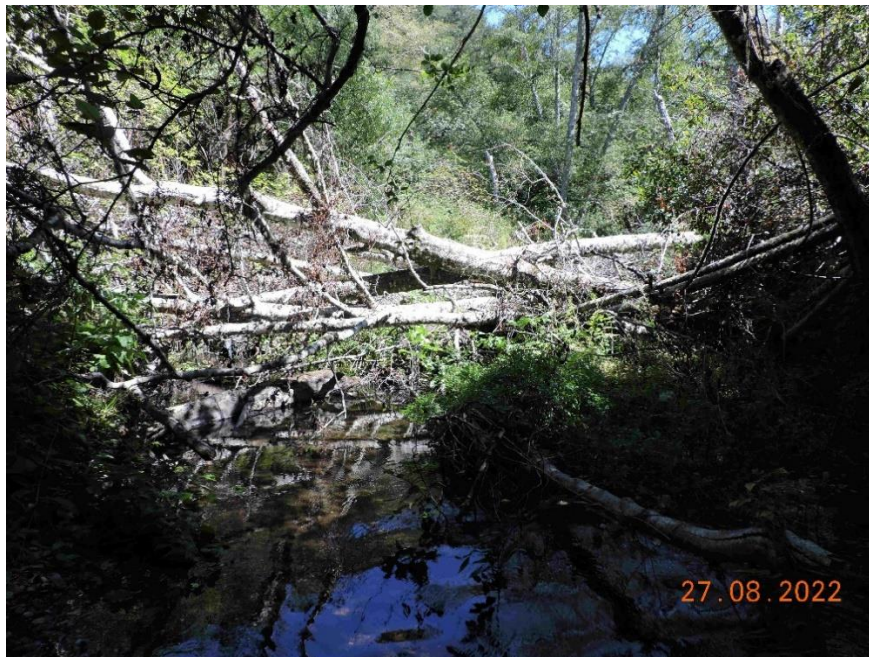
Photo 6. 1.8+ mile, looking upstream. Just upstream of the fish sampling site, a large partially open log jam of fallen alders is now present near the former site of an old jam anchored by a large multi-trunk maple. The jam was open enough to allow coarse and fine sediment to pass downstream to the sample site and presently not a fish passage barrier.

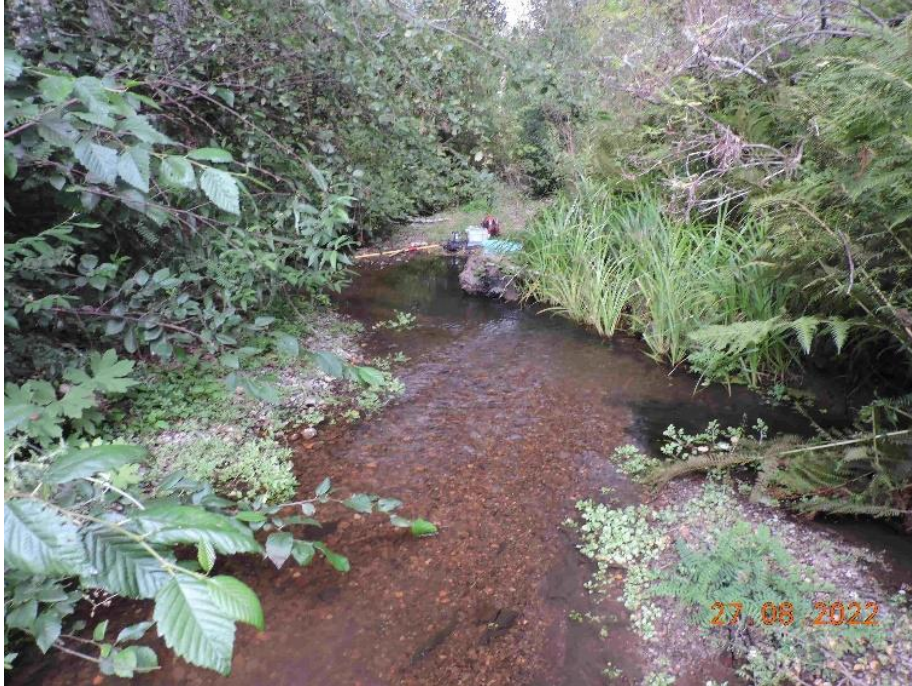
Photo 7. Mile 2.1, looking downstream. The lowermost fish-sampling pool upstream of Old Woman's Creek Bridge had filled in 2021, but was re-scoured and similar in 2022 to conditions before the fire. All other sample sites had substantial pool filling in 2022.

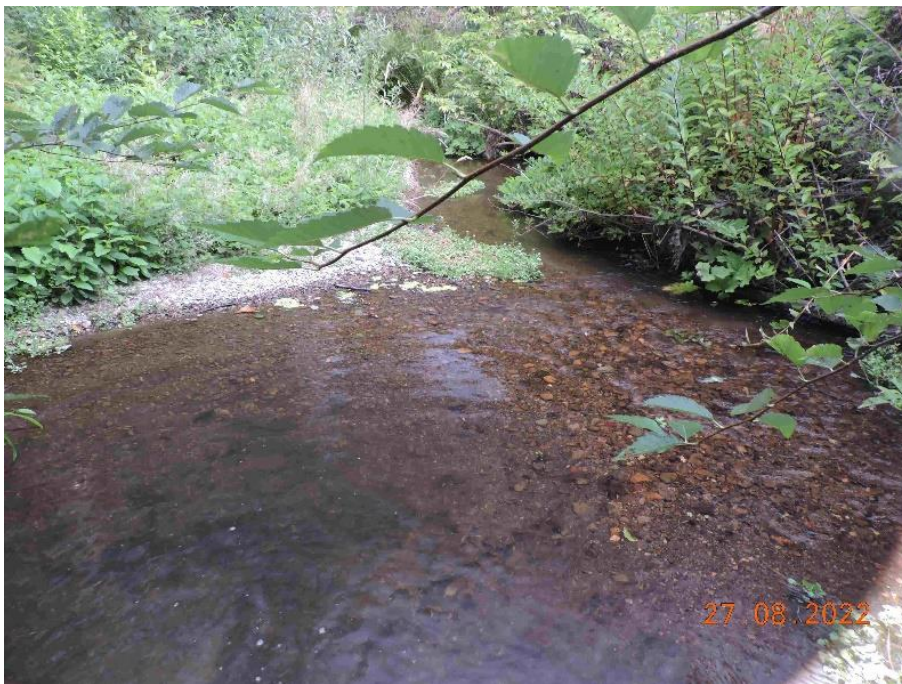
Photo 8. Mile 2.L, looking downstream (tail of pool 2). Pool 2, a corner pool, was recut to similar to pre-fire and gravels deposited at tail crest. The pool was substantially filled in 2021 with fines.

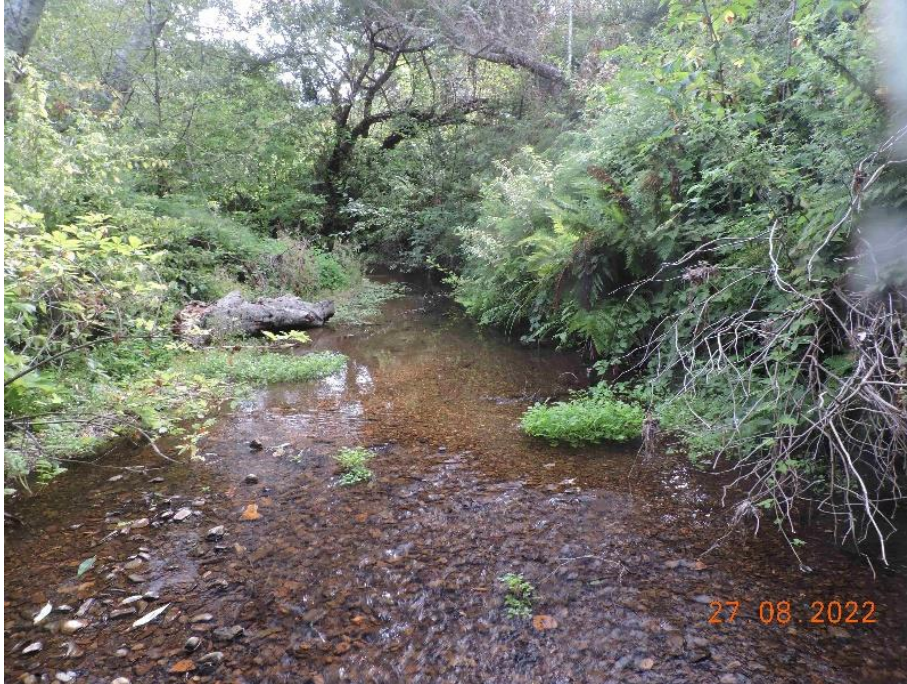
Photo 9. Mile 2.1, looking upstream. Pool and glide was substantially filled with fines in 2021, but was recut and cleaned and was similar to pre-fire conditions in 2022.

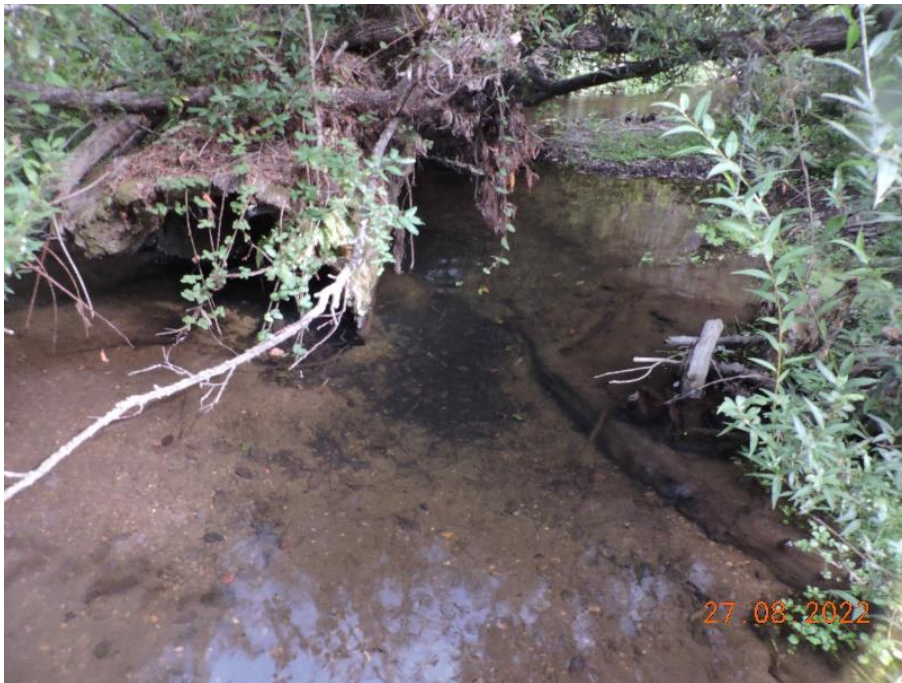
Photo 10. Mile 2.1, looking upstream. Deep pool and large wood had lost much of its depth and surface area upstream due to deposition of fines.

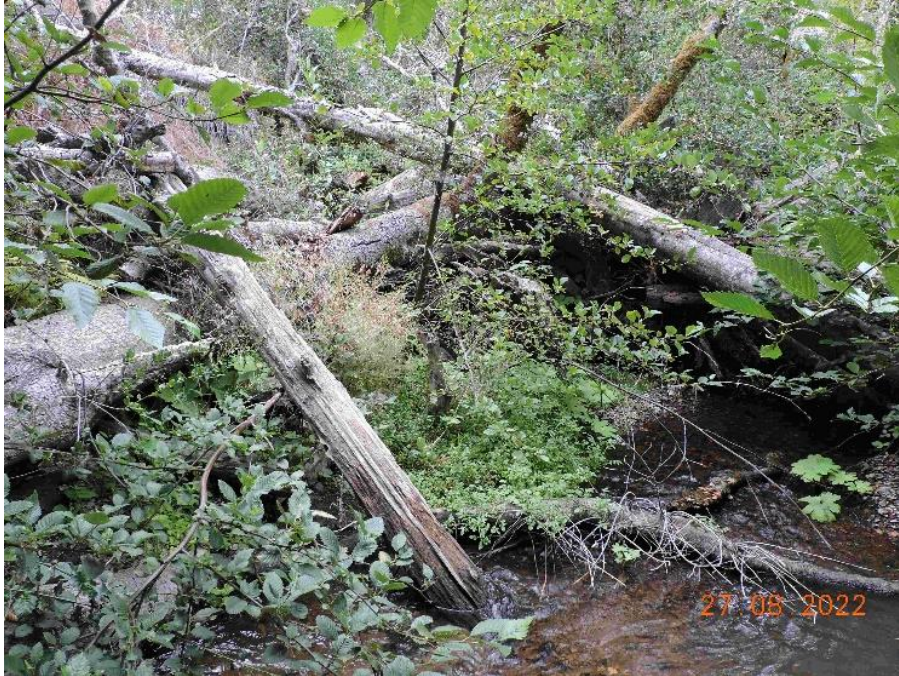
Photo 11. Mile 2.1, looking upstream. Downstream edge of large jam above sampling site anchored by fallen alders.

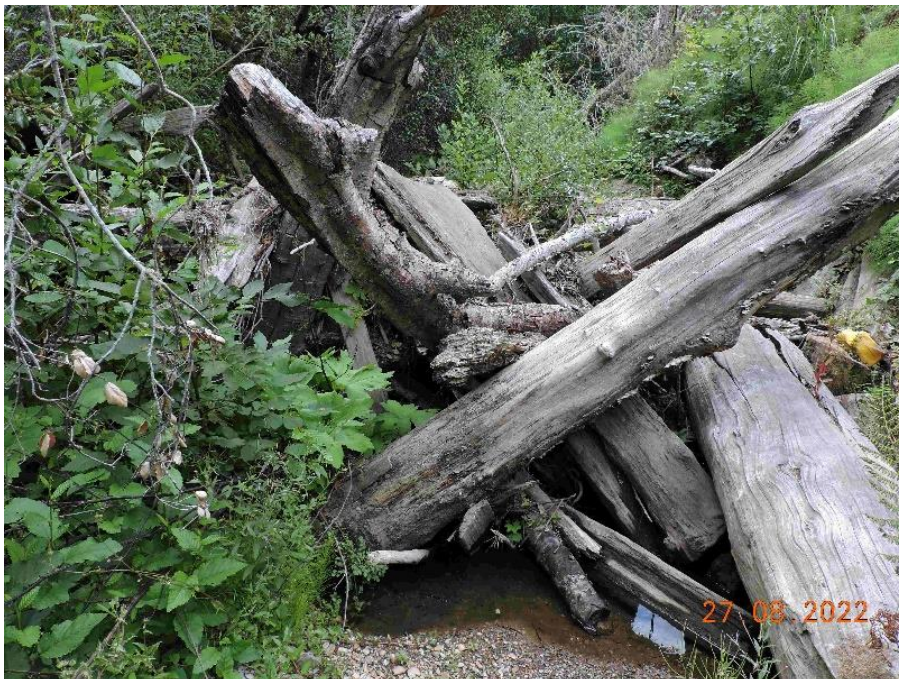
Photo 12. Mile 2.1, looking upstream. Bulk of jam is interlocking old transported wood, and is a fish passage problem. The tight jam apparently trapped transported coarse gravel and sand in winter 2021-2022, solidifying the jam, but also minimizing pool filling at the downstream sample site. That allowed the high flows to scour sediment present in 2021 from the sample site and recut the original pools.

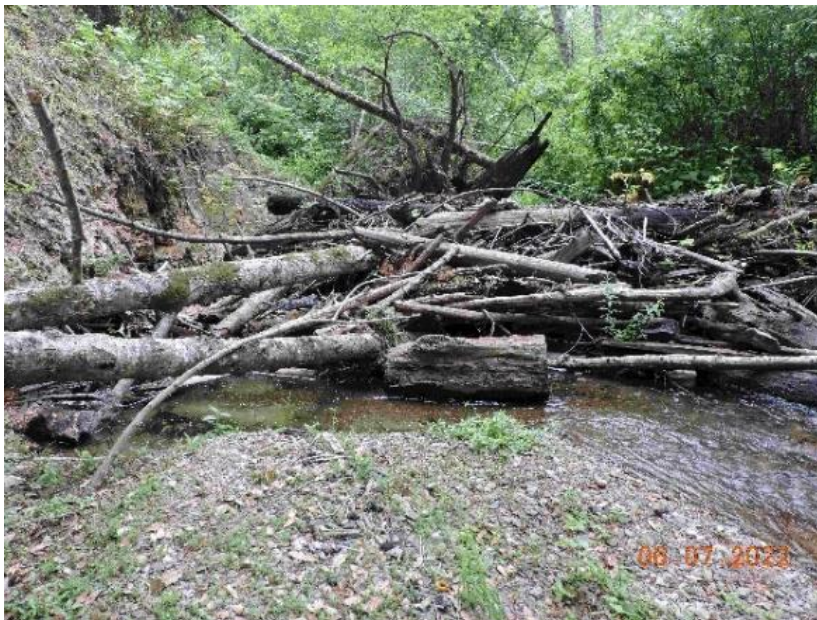
Photo 14. Mile 2.8, looking downstream. Preexisting logjam partially burned in 2020, but with added wood since. Possible fish passage underneath near left bank, but a potential fish passage problem; should be monitored and modified if needed. Backwater at the jam resulted in filling the upstream pool with sediment.

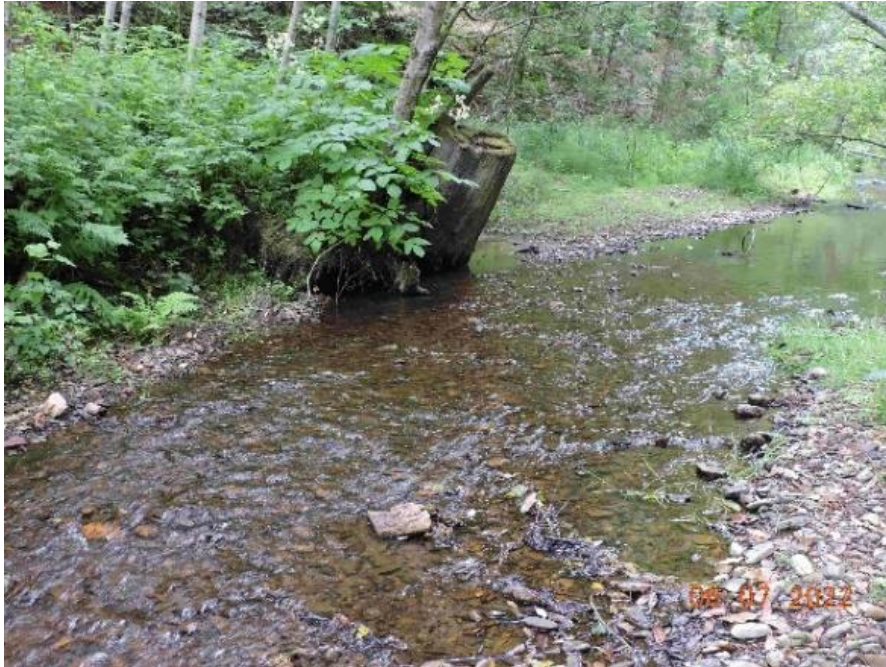
Photo 15. Mile 2.8, looking upstream. Former fish sampling pool and backwater (right bank above stump) filled by fines and mudstone gravel.

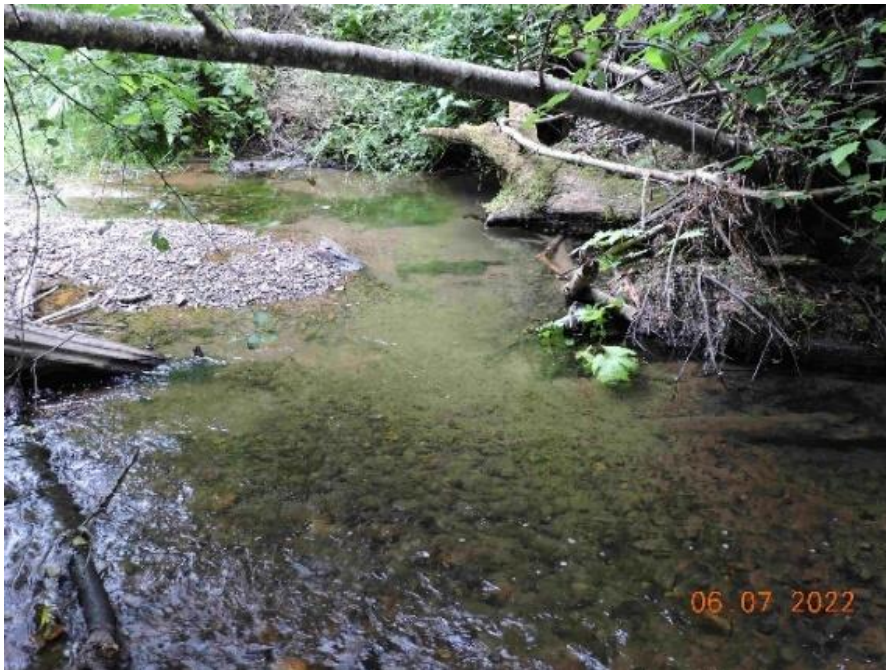
Photo 16. Mile 2.8, looking upstream. Former fish sampling pool, with downstream (near) portion filled and upstream portion at wood substantially shallower.

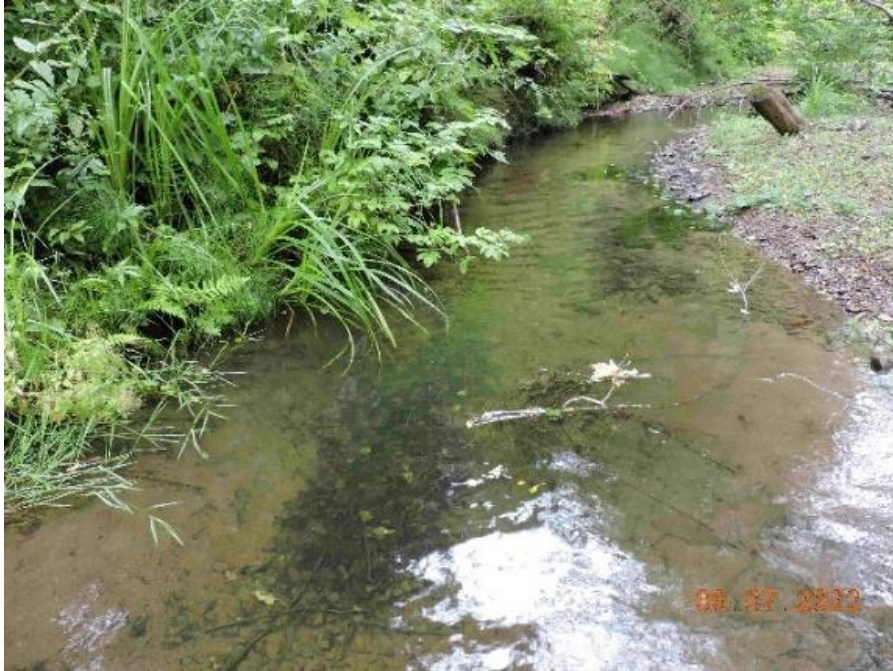
Photo 17. Mile 2.8, looking upstream. Former fish sampling glide and pool filled about 50% with fines and fine gravel, including reduction in undercut banks.

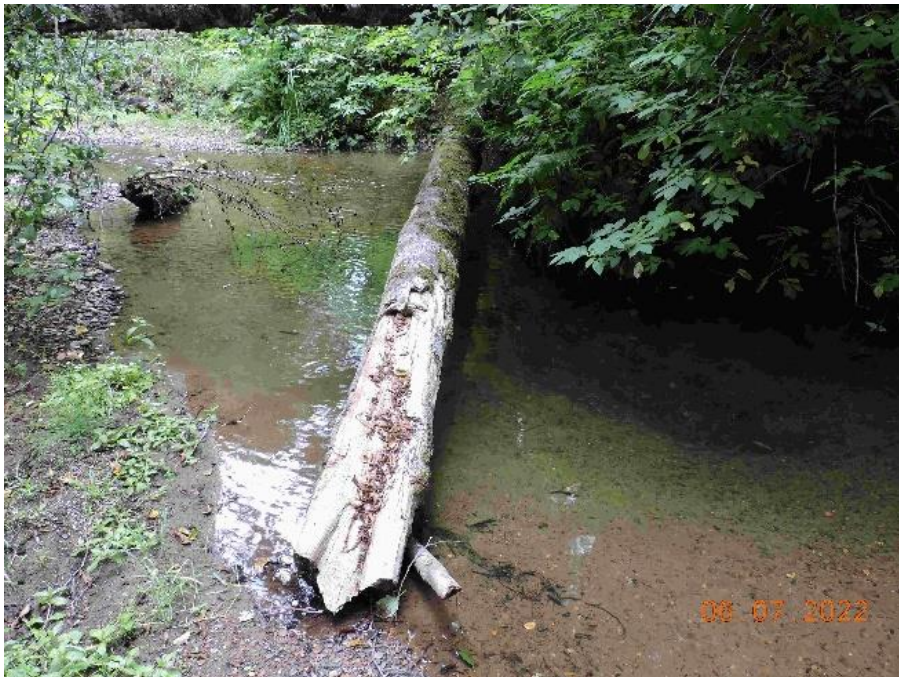
Photo 18. Mile 2.8, looking upstream. Fish sampling pool located at 1999 rootwad installation. The configuration was changed (with addition of log), but habitat overall was about the same.

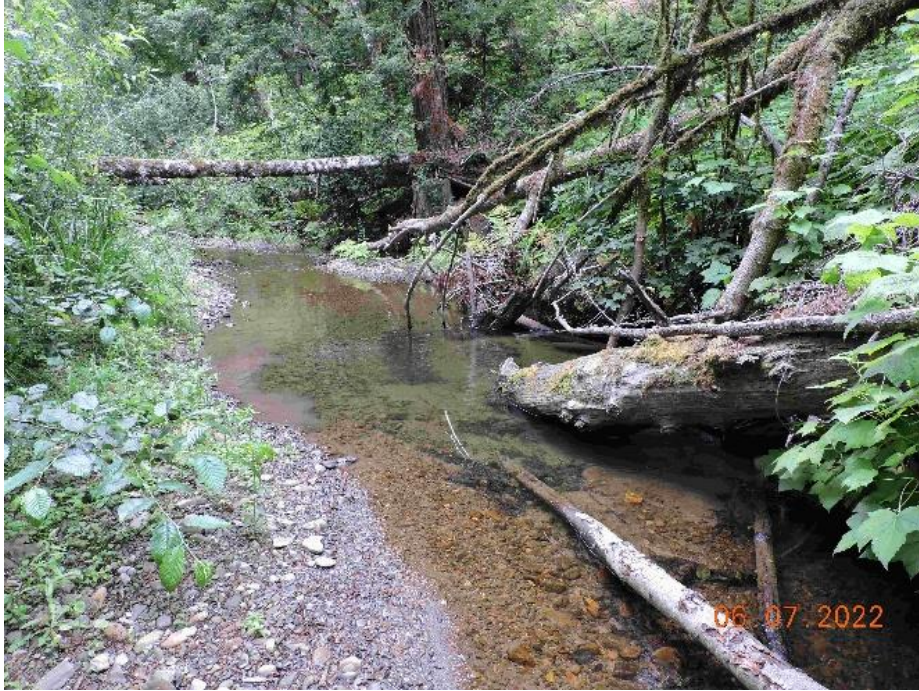
Photo 19. Mile 2.8, looking downstream. Fish sampling pool and right bank backwater, one of three fish sampling habitats with significant filling in both 2021 and 2022, especially downstream portion and backwater.

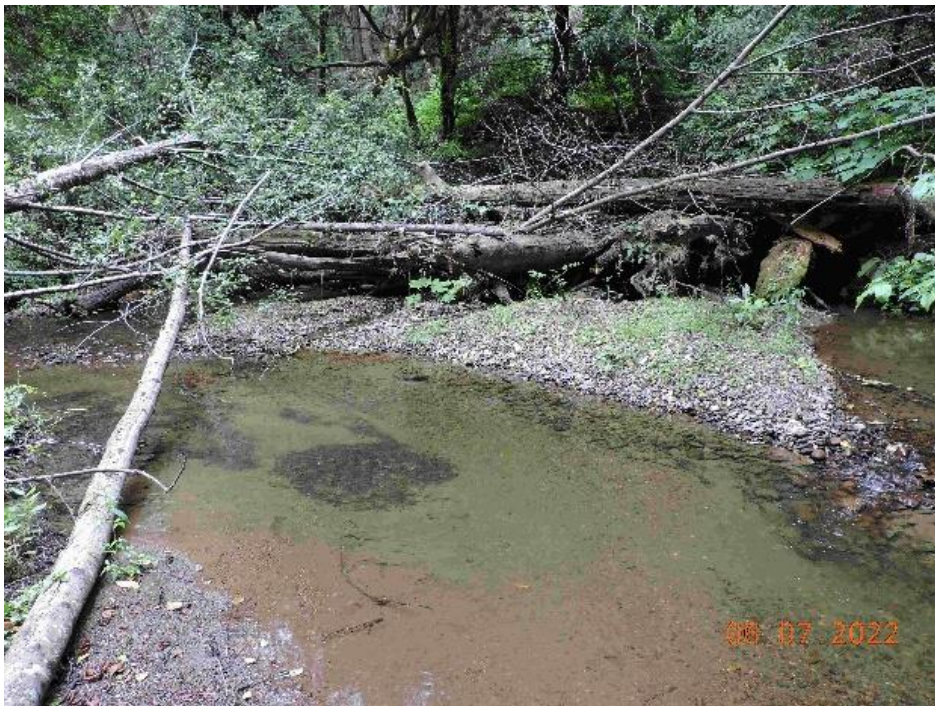
Photo 20. Mile 2.8, looking upstream. Deep and complex corner pool with wood was nearly filled by sediment.

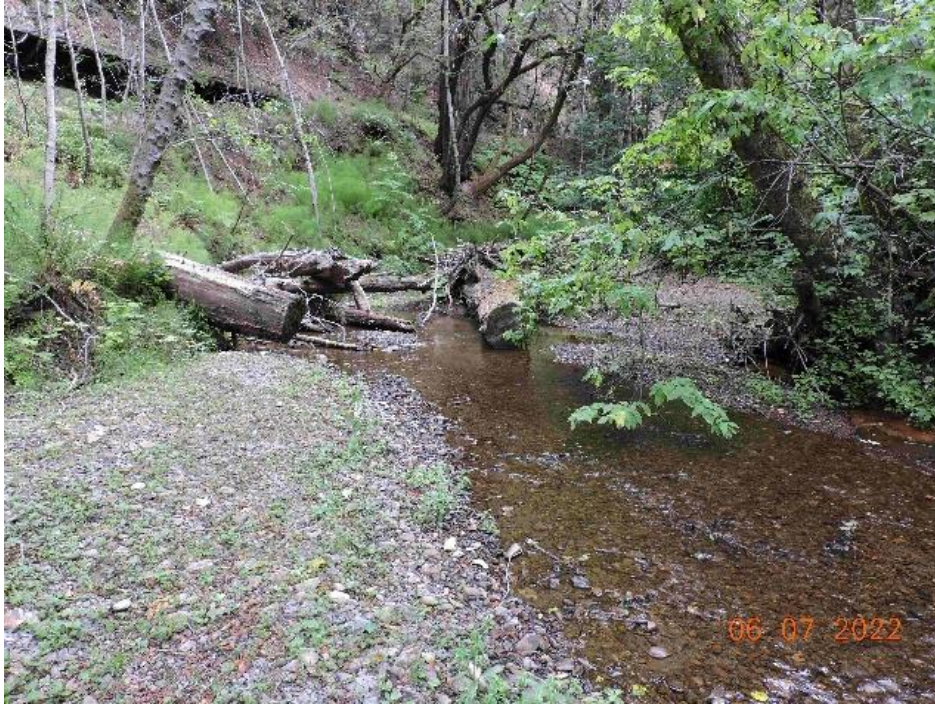
Photo 21. Mile 2.8, looking upstream above sample site pullout. Channel aggraded, flat, and shallow, with little depth associated with transported wood.

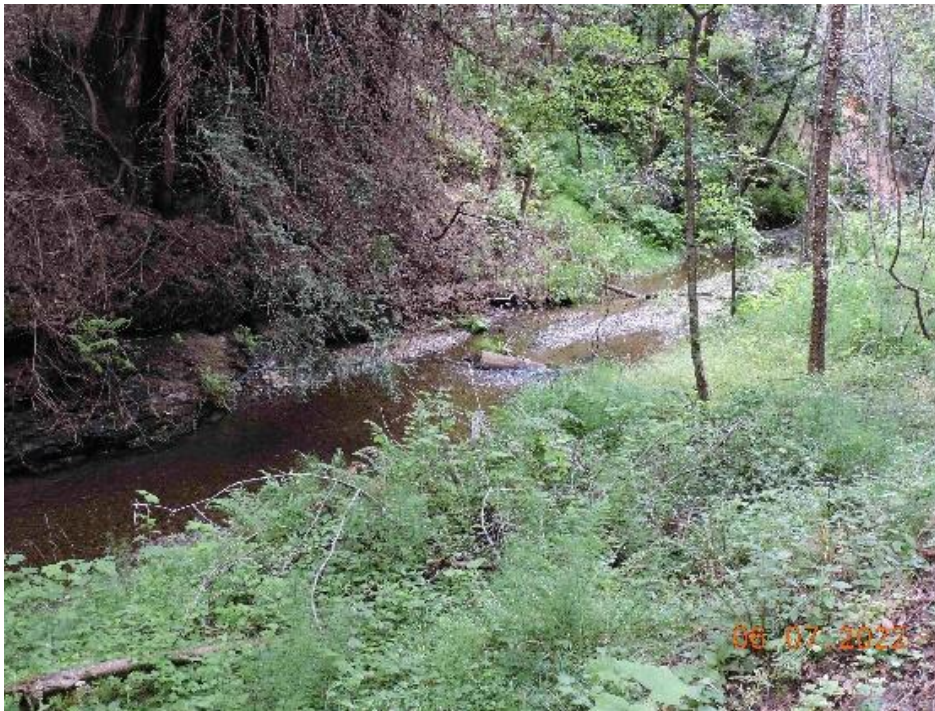
Photo 22. Mile 3.1, looking downstream. Pool and wood far downstream in photo has been eliminated by filling and wood loss. Upstream in photo, the shallow pool and glide is unchanged.

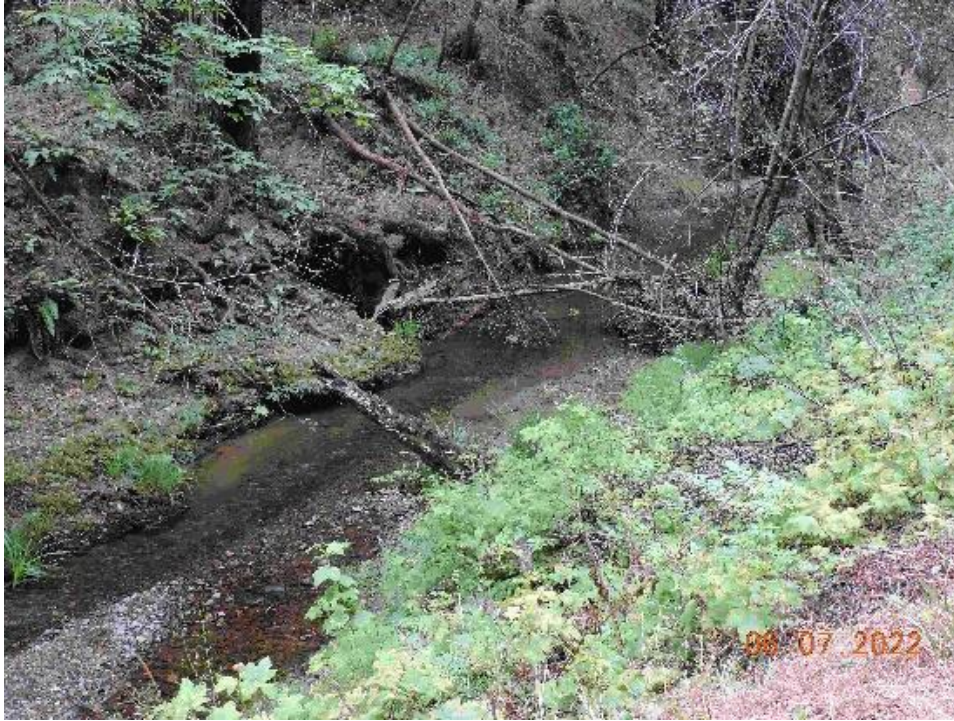
Photo 23. Mile 3.1. Complex pool with old redwood logs at small tributary has been filled and the logs buried or lost downstream.

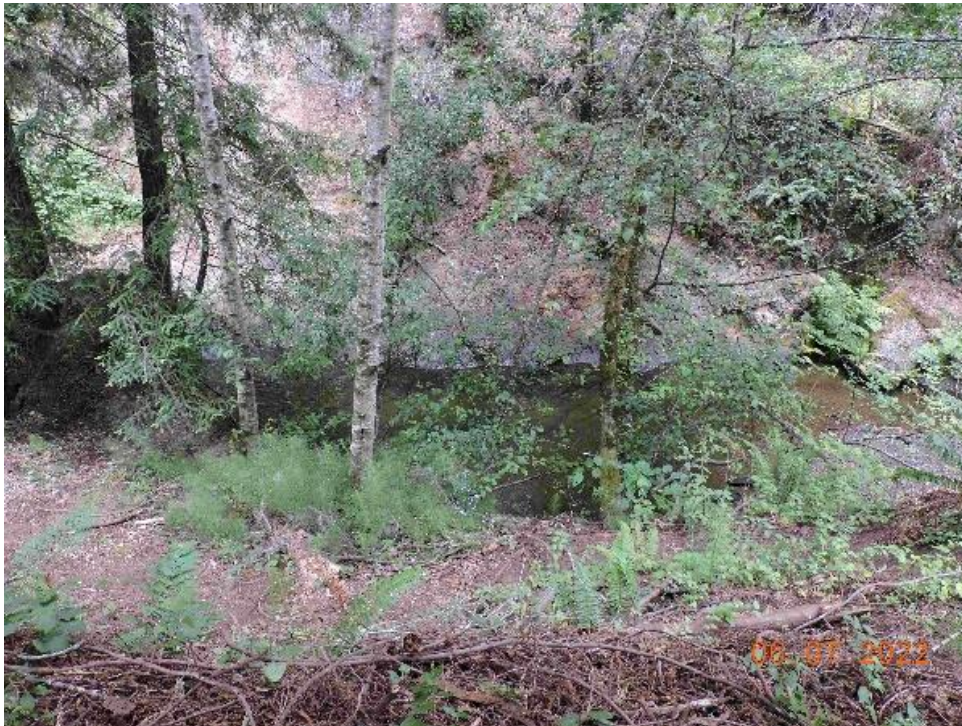
Photo 24. Mile 3.1, viewed from pullout. Bedrock pool half-filled with gravel, with tail of pool very shallow.

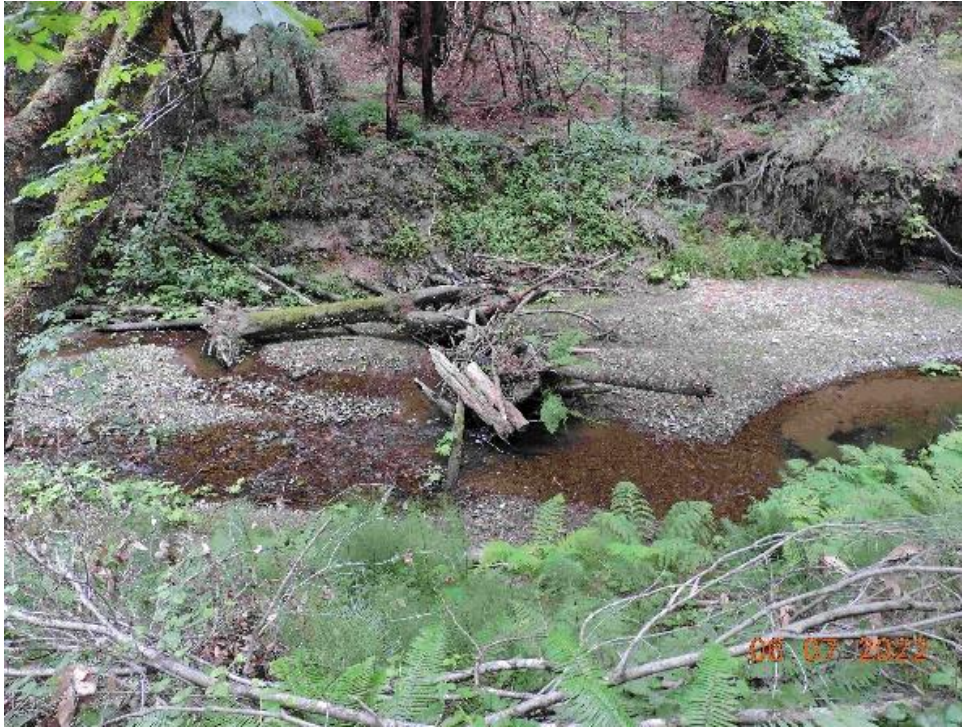
Photo 27. Mile 3.1+. Scoured and filled channel with newly deposited wood (from open jam at mile 3.2?).

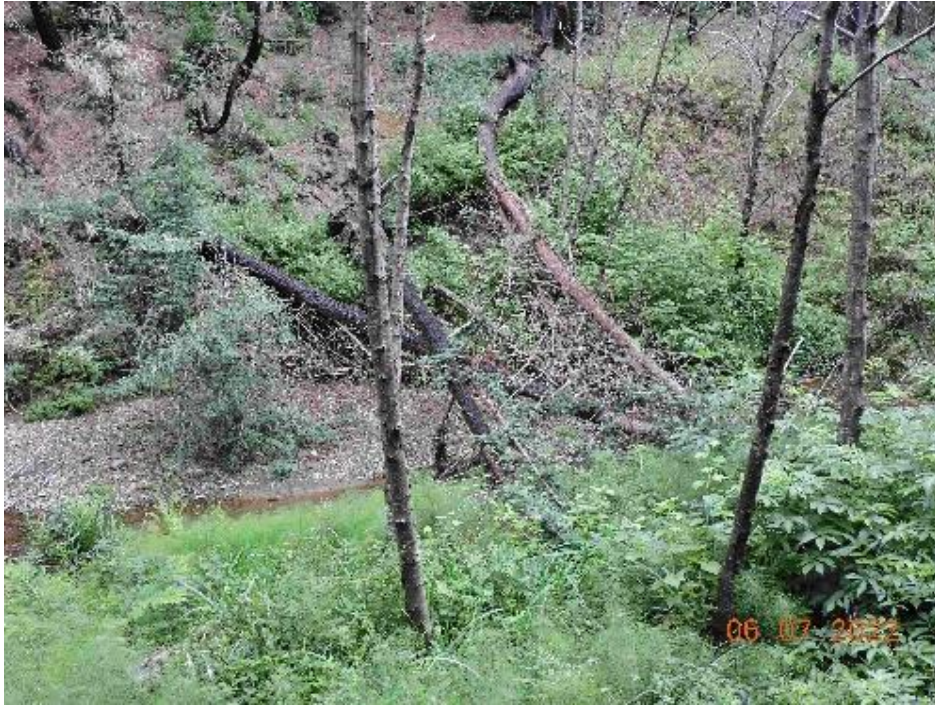
Photo 29. Mile 3.3., at one lane road against vertical cliff. South slope trees fallen and spanning the constricted channel.

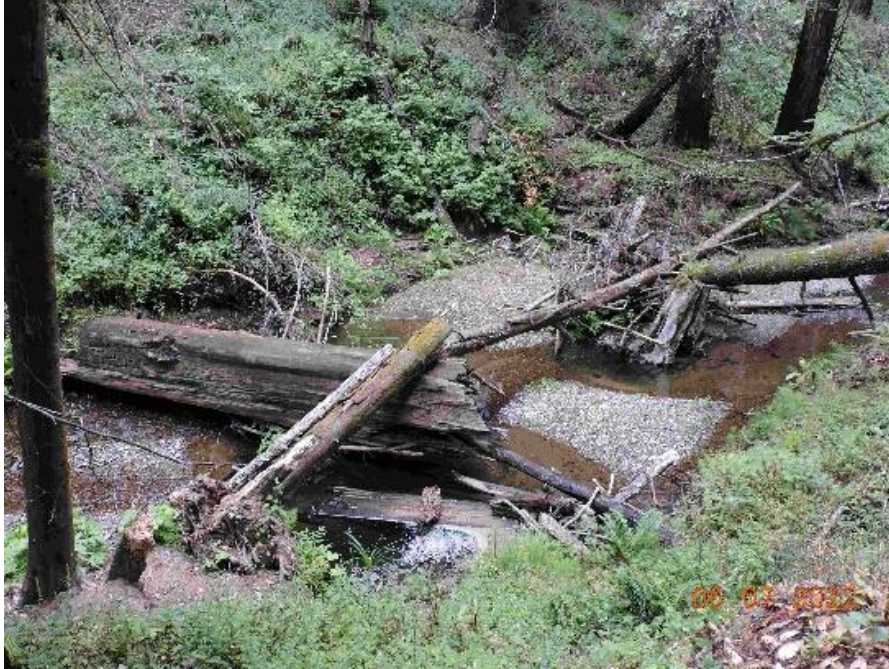
Photo 33. Mile 3.5. Cluster of new large wood producing shallow pool and escape cover in an otherwise simple, scoured channel.

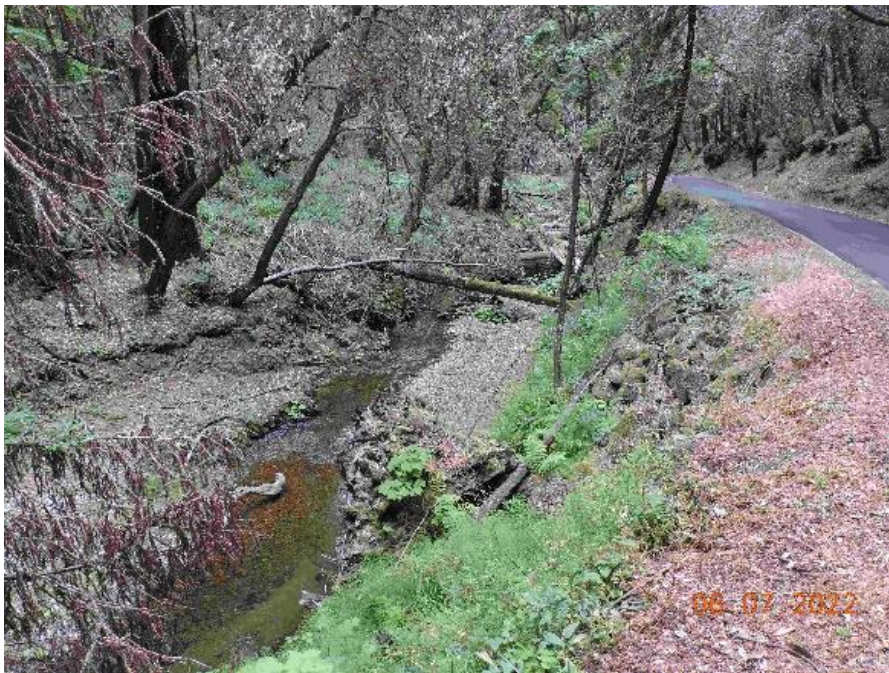
Photo 34. Mile 3.5. Shallow entrenched roadside channel, showing high flow scour line on left bank and San Mateo County stacked boulder bank protection on right bank. Level channel, despite some added wood.

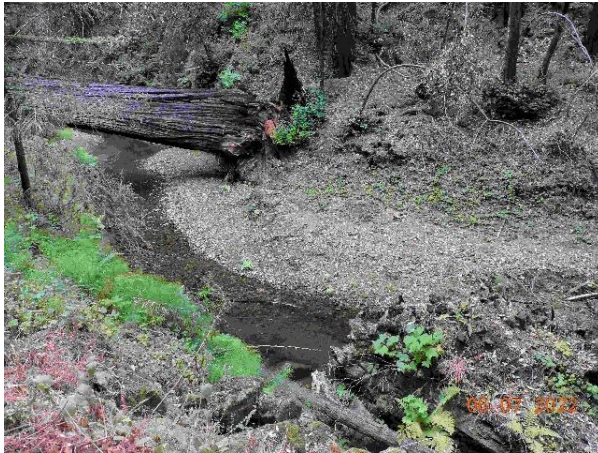
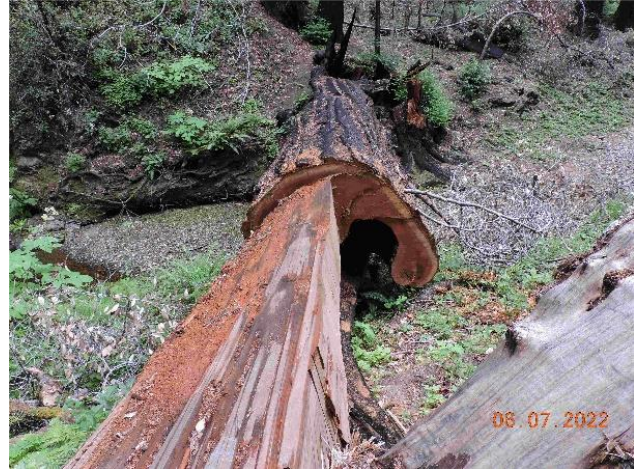
Photos 35 and 36. Mile 3.5. Large spanning 5+ ft diameter redwood that burned near the base for months and later fell across the stream and the road. The spanning trunk and the wood jam to the near right in the left picture sit in a simple channel without pools or structural escape cover.

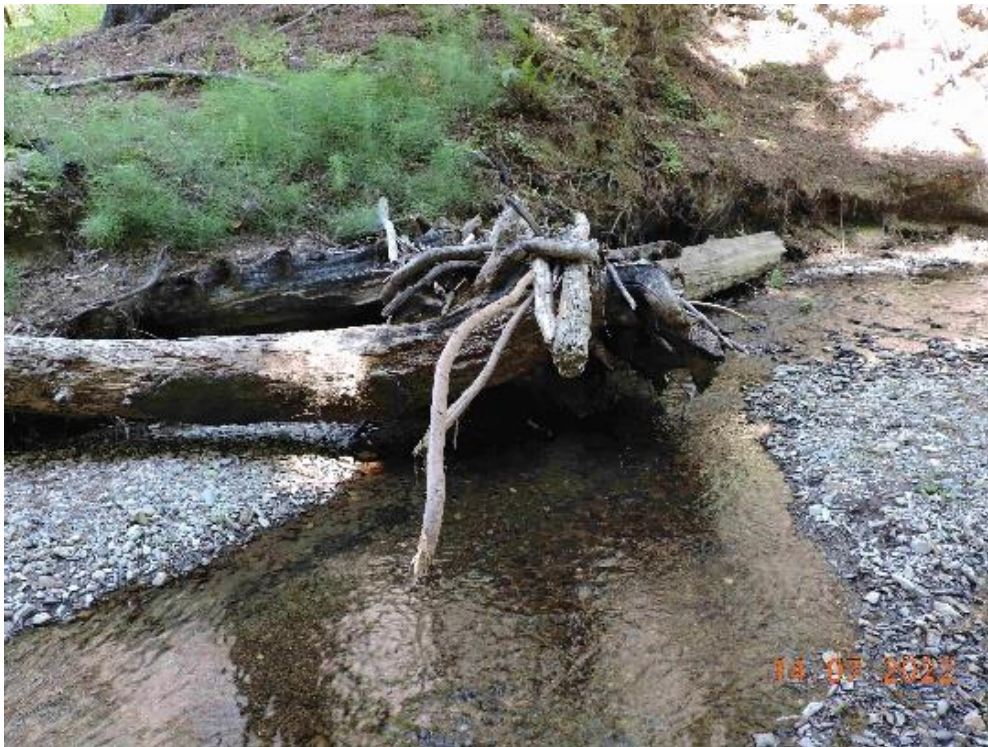
Photo 37. Mile 3.5. Just upstream of the spanning redwood a large added tree and other wood sits in a wide flat channel, not presently providing significant summer fish habitat in the low flow channel. However, it may provide some winter high flow refuge.

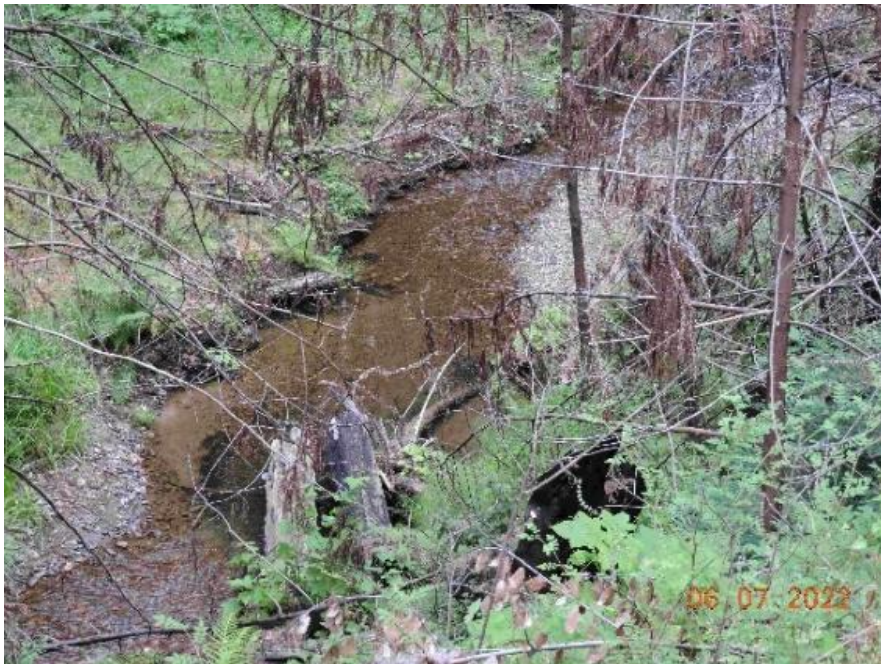
Photo 39. Mile 3.9, looking downstream. Long fish sampling pool formerly with depth and wood escape cover along right bank. Largely filled with gravel and shifted to opposite bank away from woody structures that provided depth and escape cover

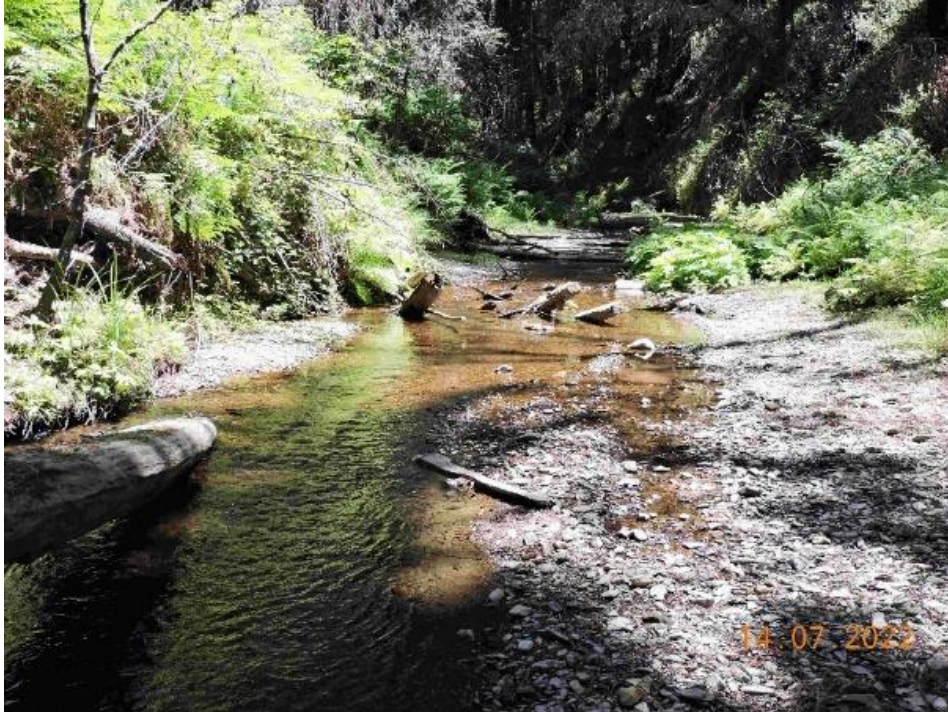
Photo 40. Mile 3.9, looking upstream. Series of 4 small pools associated with channel wood has been filled and is now mostly run habitat.

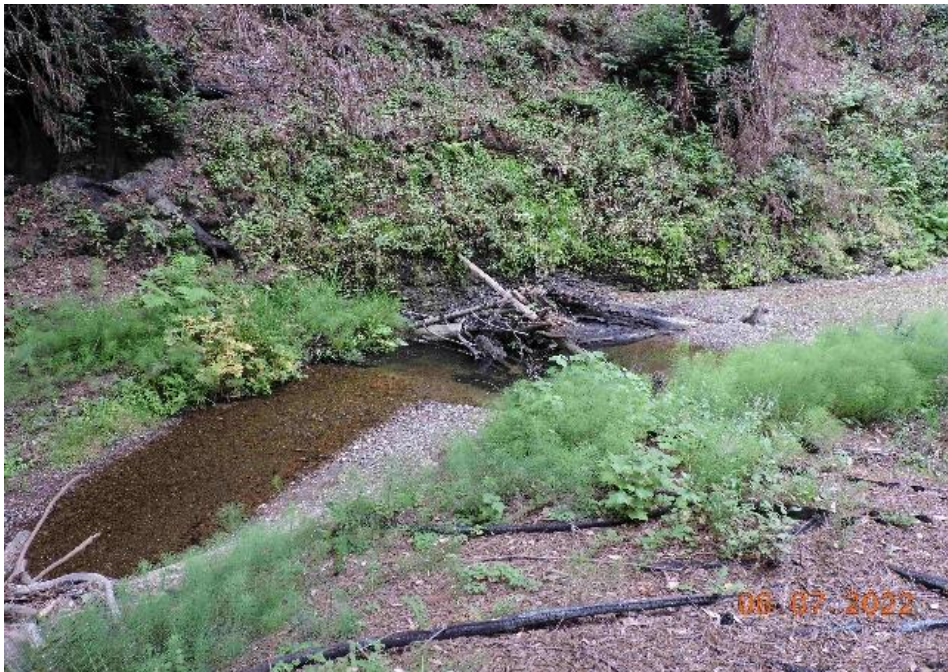
Photo 41. Mile 3.9. Leveled gravel channel, with filling of long, deep pool, except around the old large rootwad/log in center of pool (annual fish sampling pool). Entrenched channel with 10 ft high near-vertical right bank.

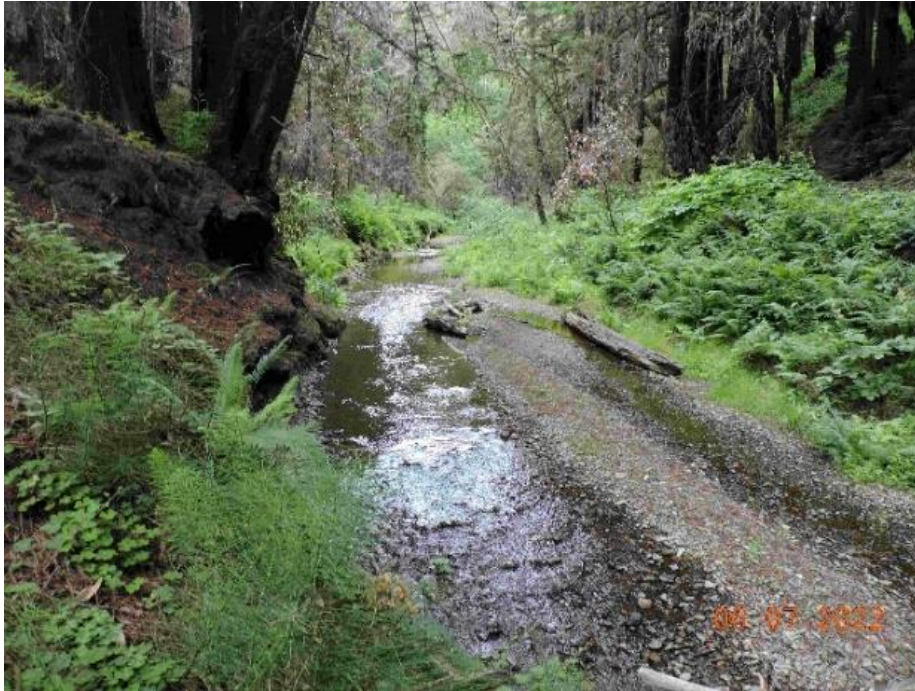
Photo 42. Mile 3.9, looking upstream from uppermost fish sampling pool. Leveled channel and filling of pools, including at bottom of photo.

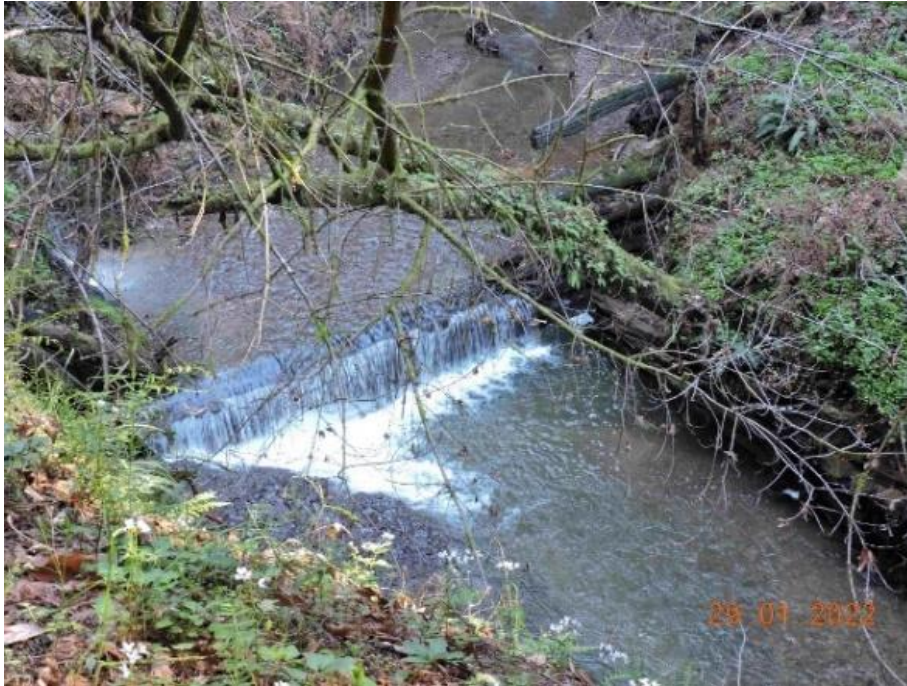
January Photo 44. About mile 4.0. Log weir with level gravel channel upstream. Three foot jump required from the partially filled pool.

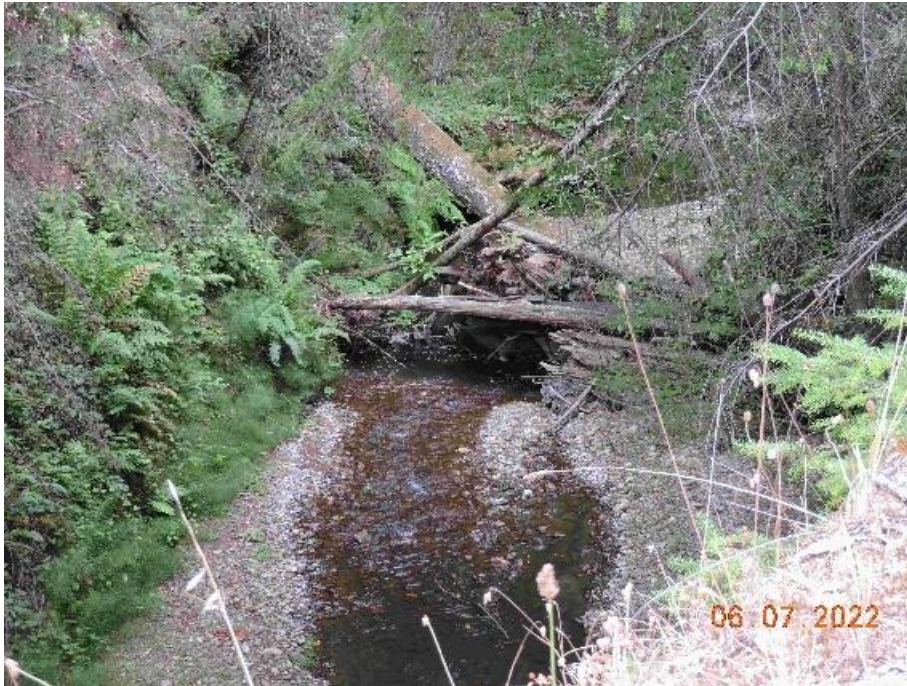
Photo 45. Mile 4.05. New partial log jam (open at bottom) formed at fallen upslope wood with transported wood (possibly from wood transported downstream from the old jam at mile 4.2). In entrenched, flat aggraded channel. Little summer habitat, but potential winter flow refuge.

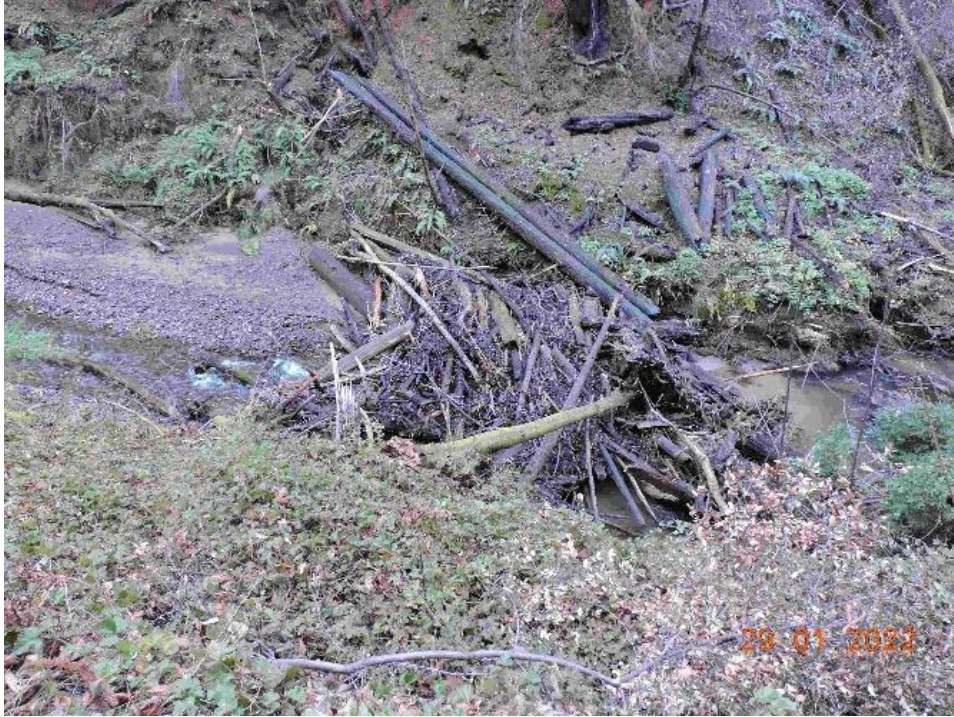
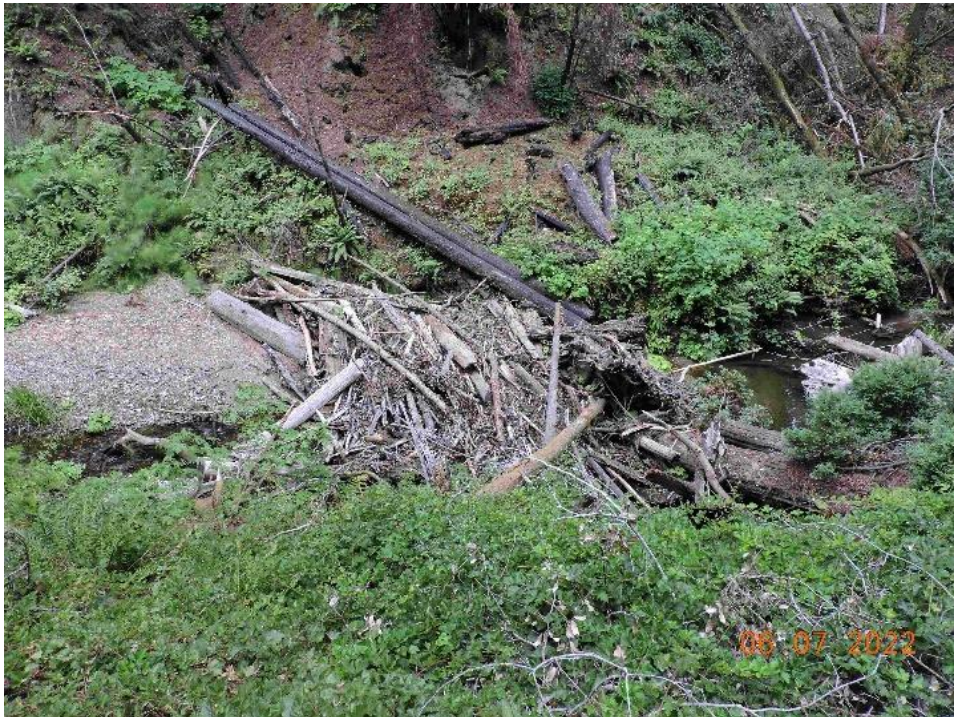
Photos 49 and 50. Mile 4.1+. (top January) Major new jam on flat gravel channel. (bottom July) Restoration of extensive ground cover by July. Jam is anchored by fallen upslope trees. Much of debris is probably from substantially blown out multi-decade jam at mile 4.2.
