Gazos Creek Post-fire Stream Habitat Assessment in July and September 2022 (revised from August 2022; text changes are in *italics bold*)

Jerry J. Smith

29 October 2022

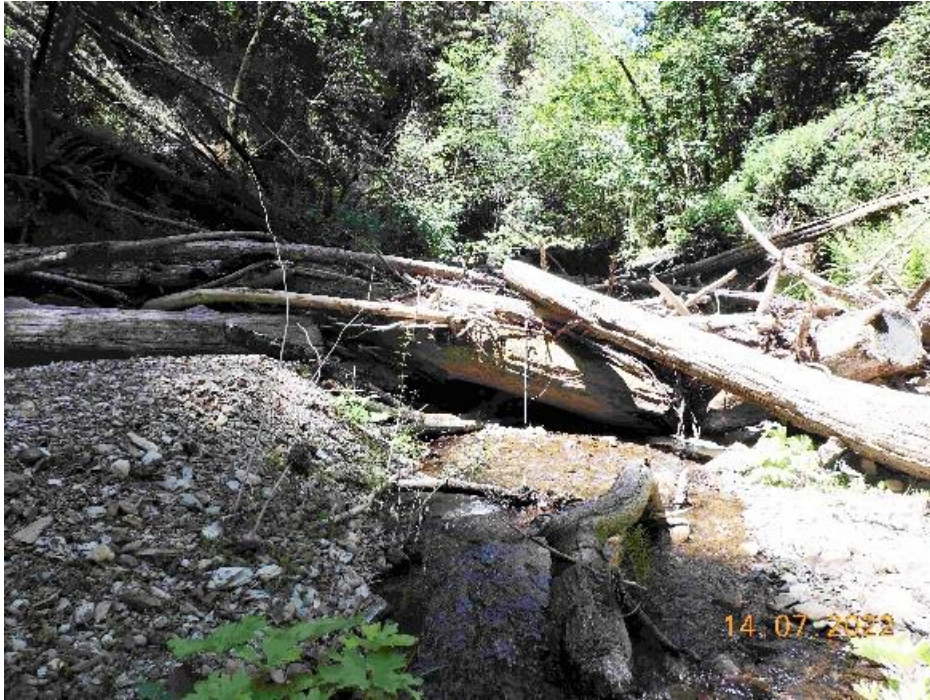
Photo 51. Mile 4.1+. View of jam from upstream. Jam is 5 ft high, 35 ft wide, and 35 ft long. Possible fish passage under the jam along the right bank. The well-anchored jam is a potential serious fish passage barrier that should be modified.

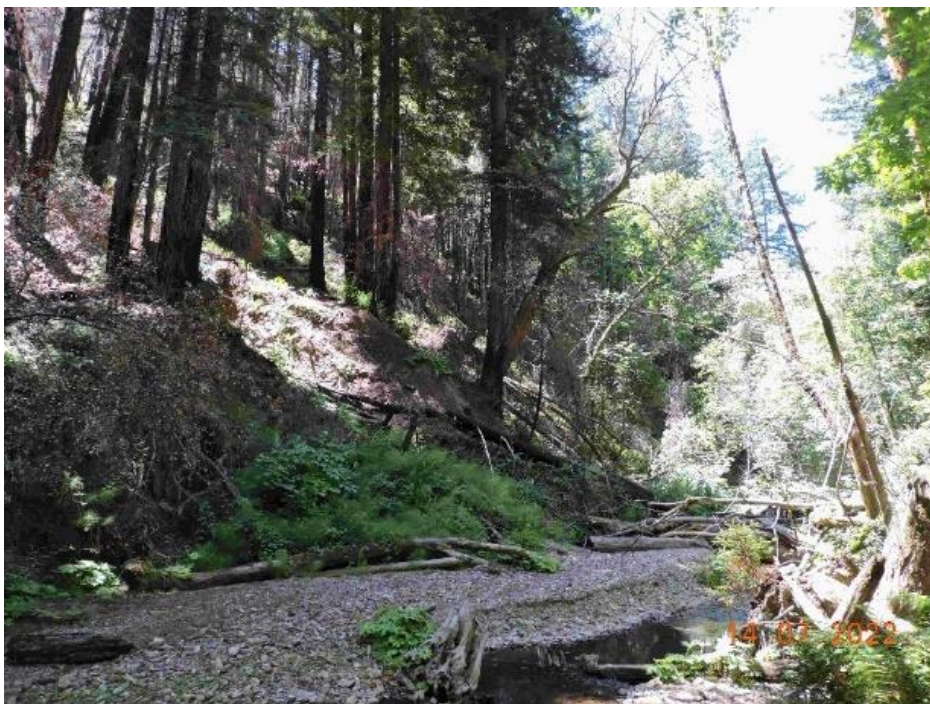
Photo 52. Mile 4.1+. View of channel and south slope at the jam. The jam backed deep "lake deposits," and later cut down through them along the right bank (bank in lower middle).

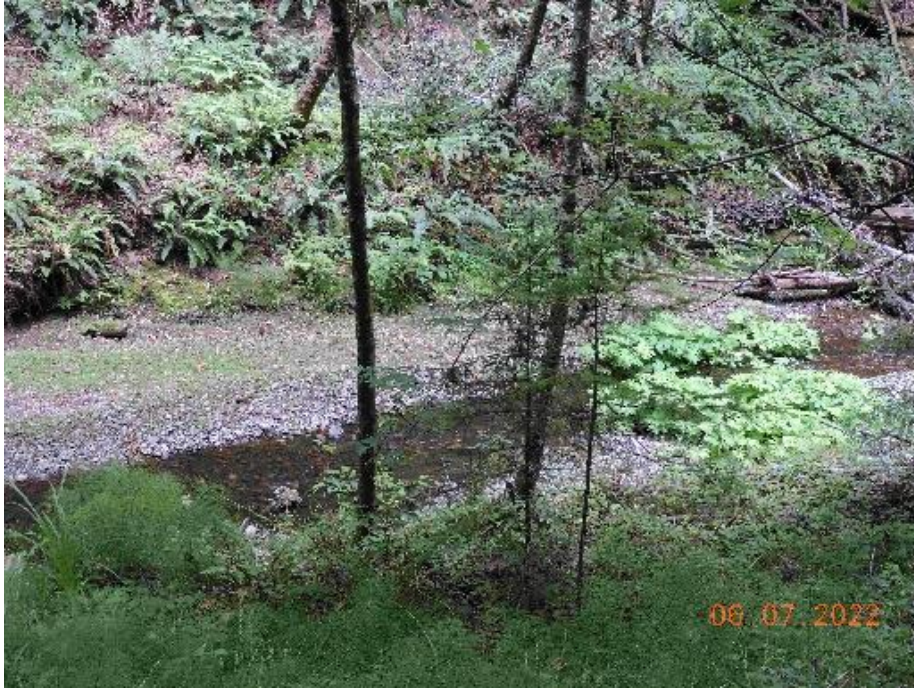
Photo 57. Mile 4.4. Several small 1.5 ft deep fish sampling pools and glides were eliminated by leveled and widened gravel streambed.

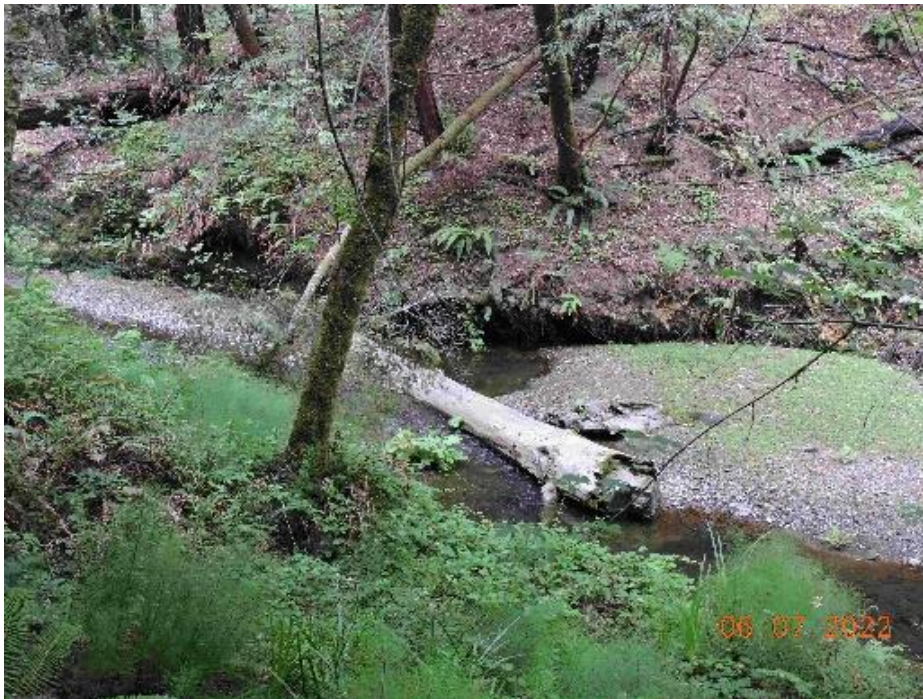
Photo 58. Mile 4.4. Deep fish sampling pool and channel above and below the old redwood log was filled and leveled by gravel in October and December 2021.

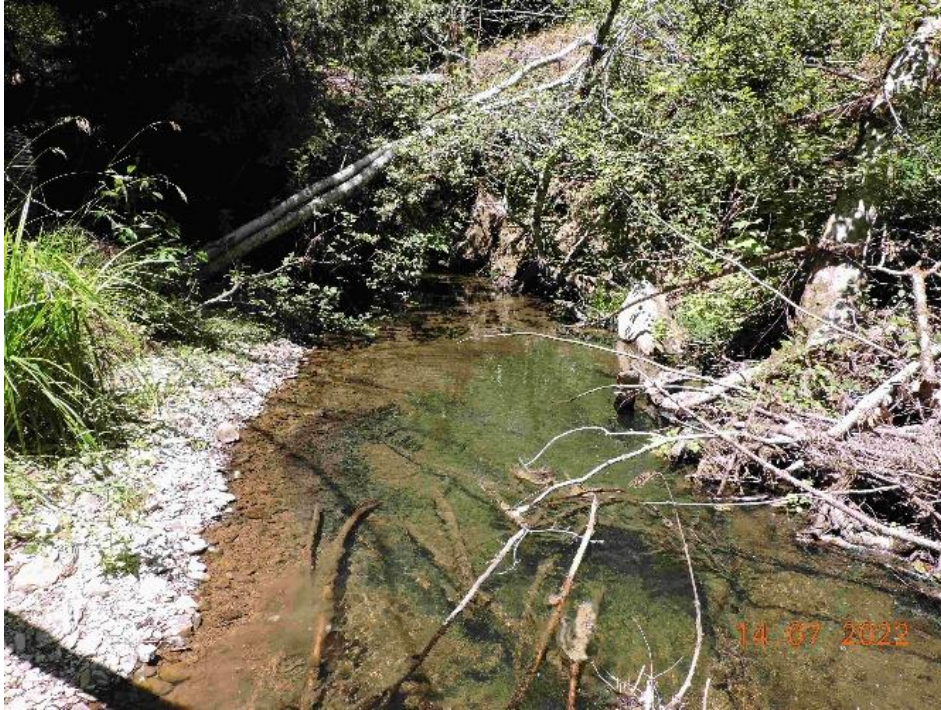
Photo 59. Mile 4.4, looking downstream. Upper-most fish sampling pool changed little upstream of bend (near portion), but deep, complex pool in bend and under fallen multi-trunked redwood was half filled in 2022.

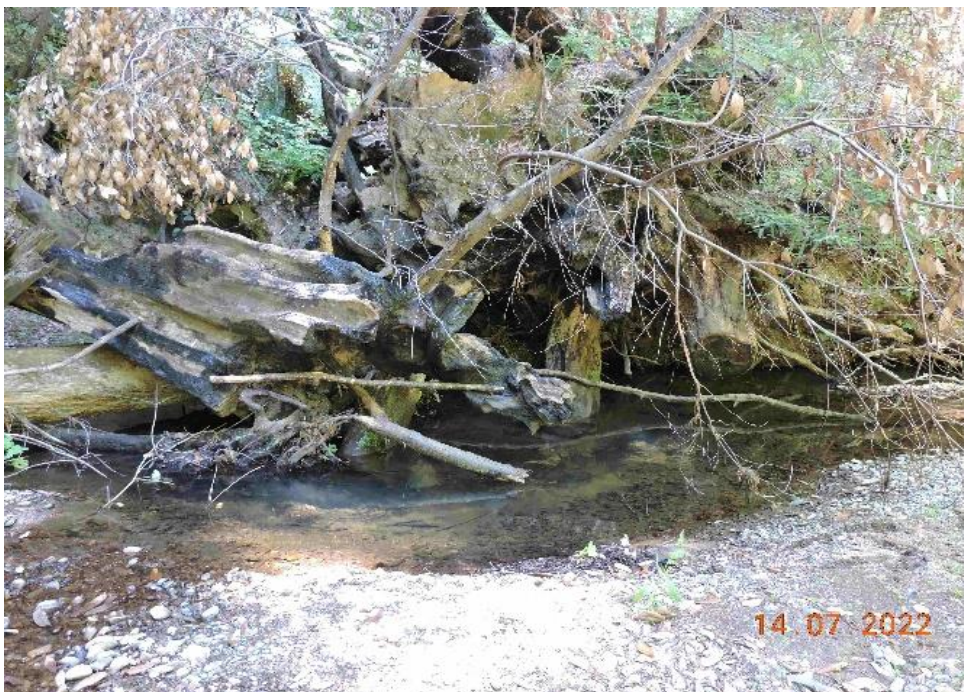
Photo 60. Mile 4.5. Pool associated with 1998 fallen and cut multi-trunked redwood is mostly now filled by gravel, except immediately around the wood.

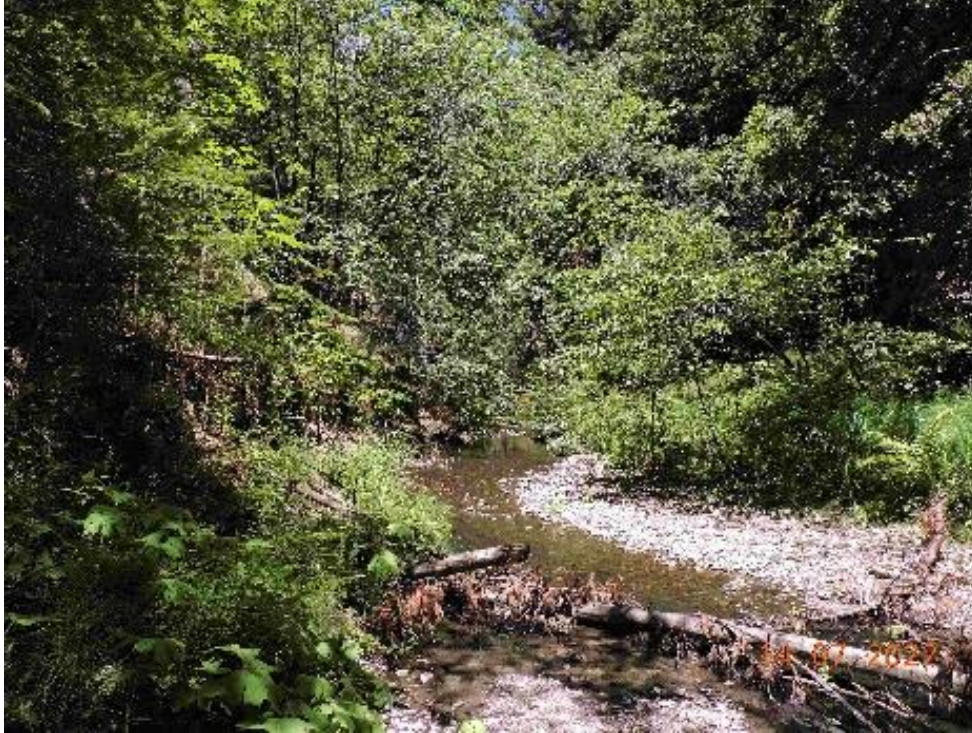
Photo 61. Mile 4.5. Looking upstream of bend pool at flat aggraded channel.

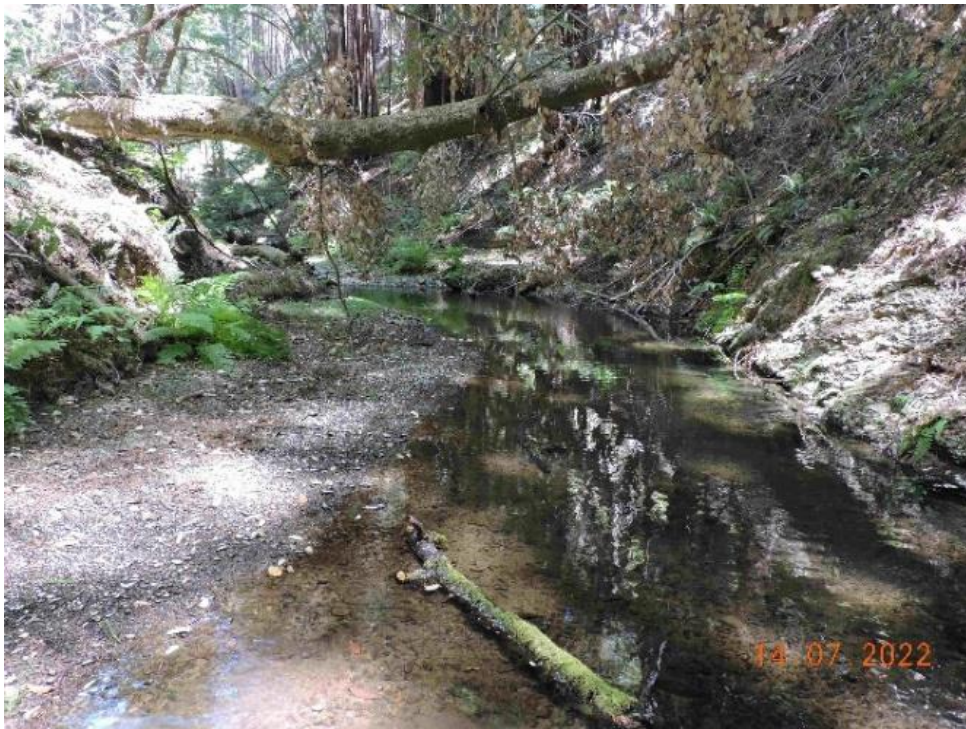
Photo 62. Mile 4.9, looking upstream. Downstream two-thirds of fish sampling pool was more than half filled by fines and gravels.

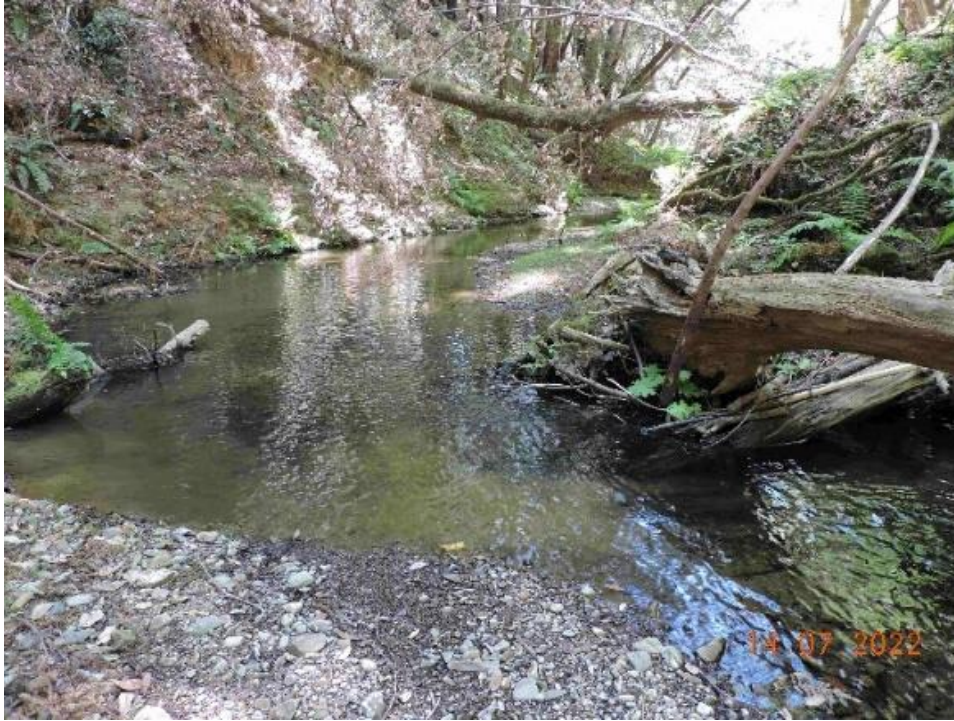
Photo 63. Mile 4.9, looking downstream. The much deeper upstream third of the pool was about 70% filled, except at the bank and wood structure at the head of the pool.

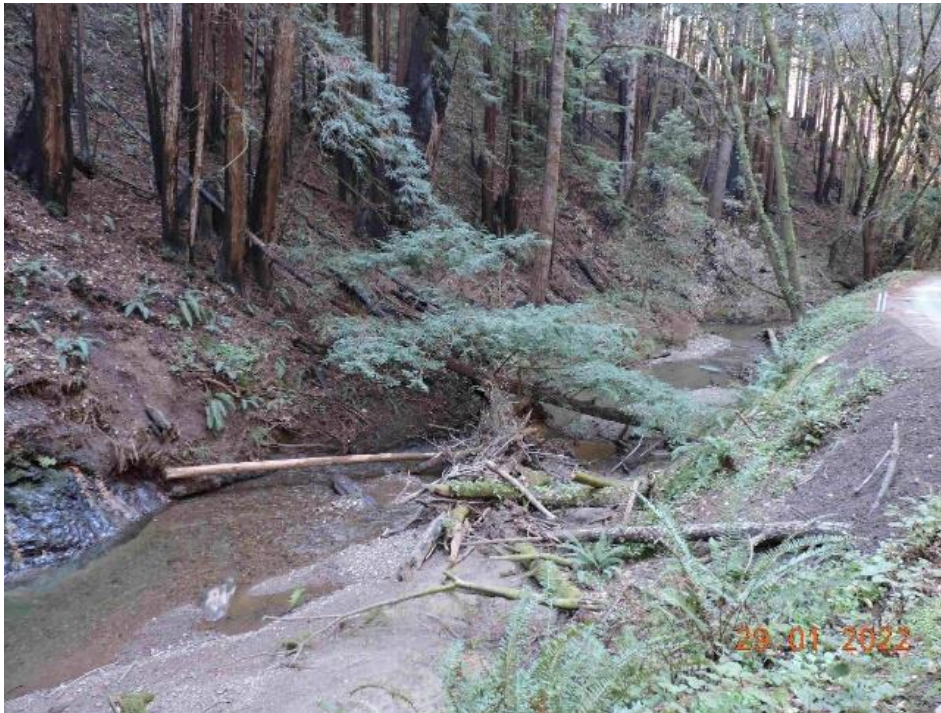
January Photo 64. Mile 4.9, looking downstream. Fish sampling pool at and downstream of preexisting partial wood jam was half filled with fines and gravel in October and December 2021.

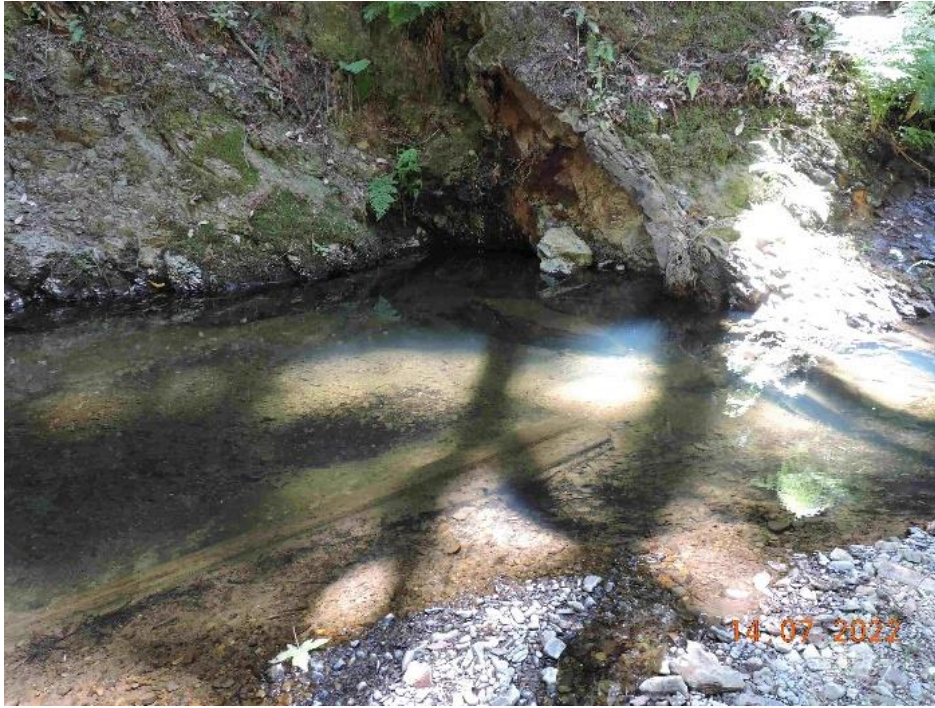
Photo 65. Mile 4.9. Fish sampling pool with alcove at bedrock outcrop has been about half filled with fines and gravel, and part of the alcove has collapsed eliminating the deepest habitat.

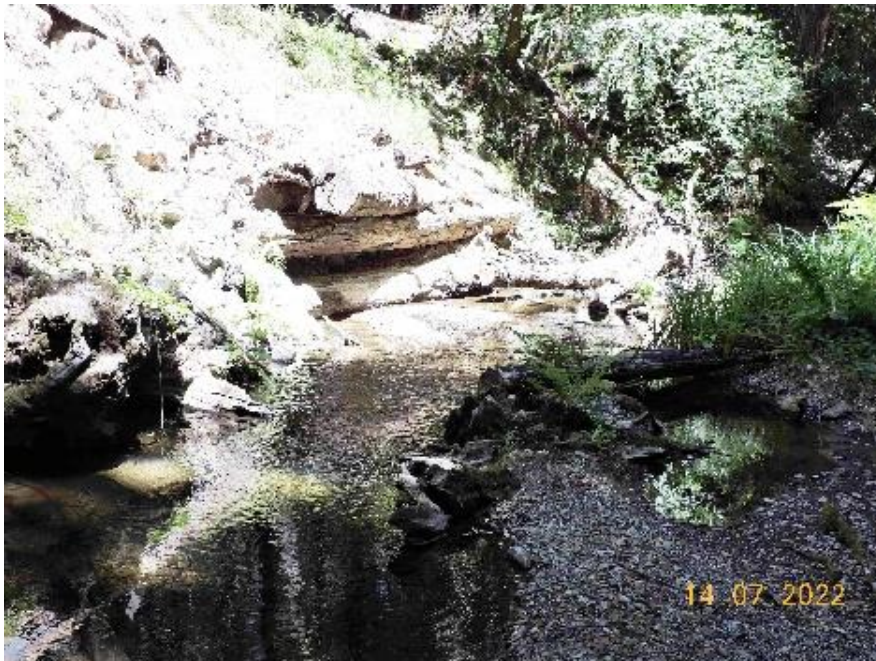
Photo 68. Mile 4.9. Upper fish sampling pool with San Mateo County stacked log bank protection upstream and stacked boulders and root wad bank protection downstream. The pool, one of three fish sampling habitats with significant filling in both 2021 and 2022, is now mostly filled, with undercut banks eliminated.

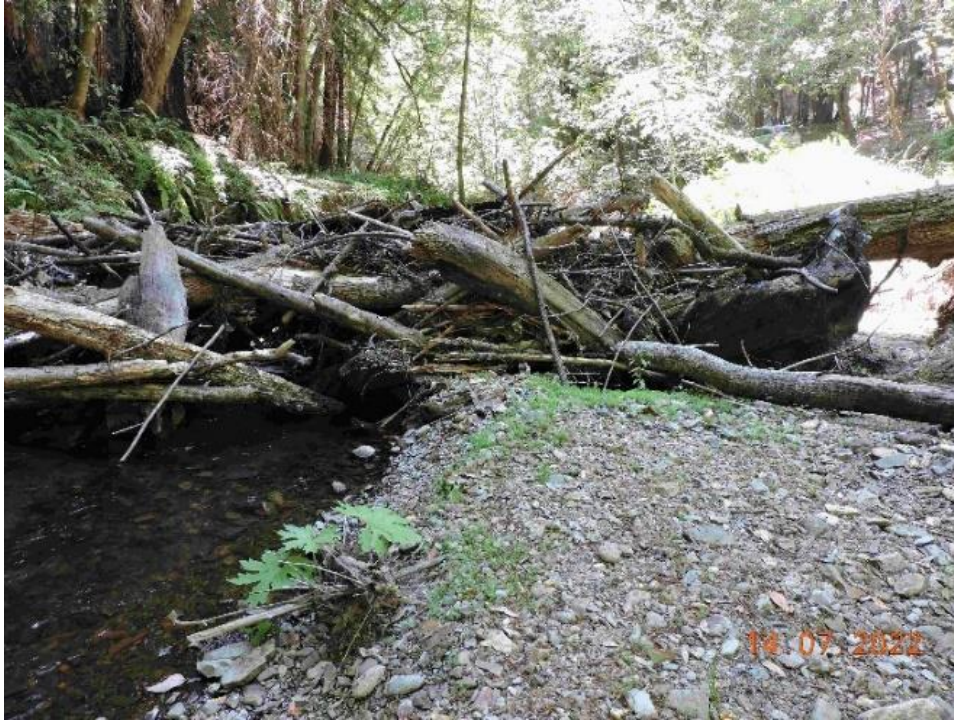
Photo 69. Mile 5.0, just upstream of Slate Creek, viewed from upstream. Large (5 ft high by 30 ft wide) partial wood jam. Presently passable underneath and, at high flows, around the jam on right bank.

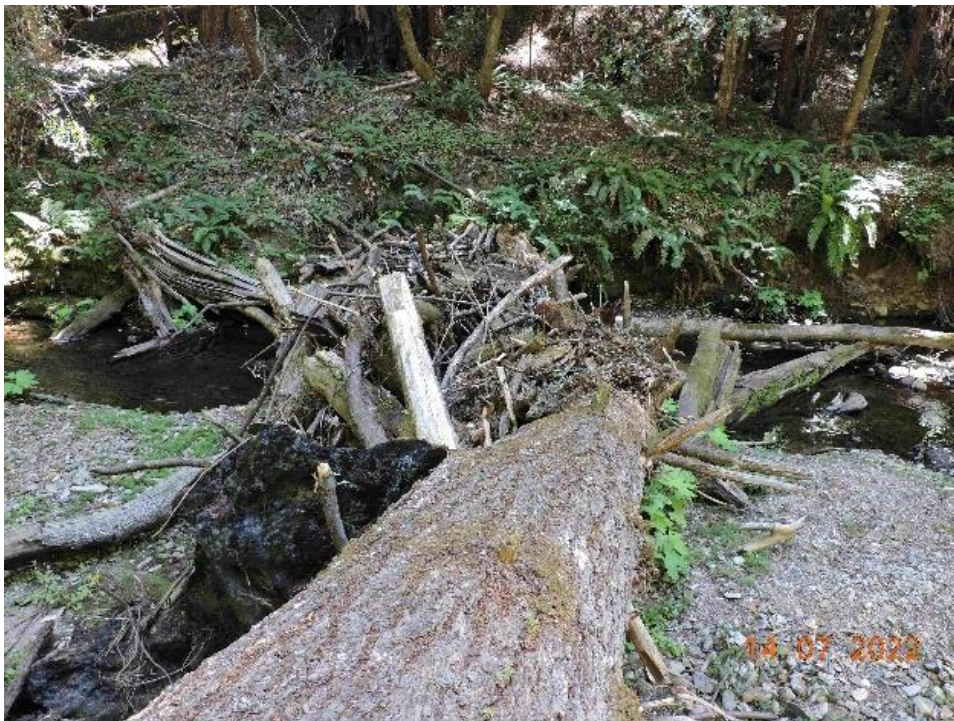
Photo 70. Mile 5.0. Large fallen Douglas fir trunk anchors the downstream jam above Slate Creek. The jam is likely to solidify and should be modified to ensure fish passage.

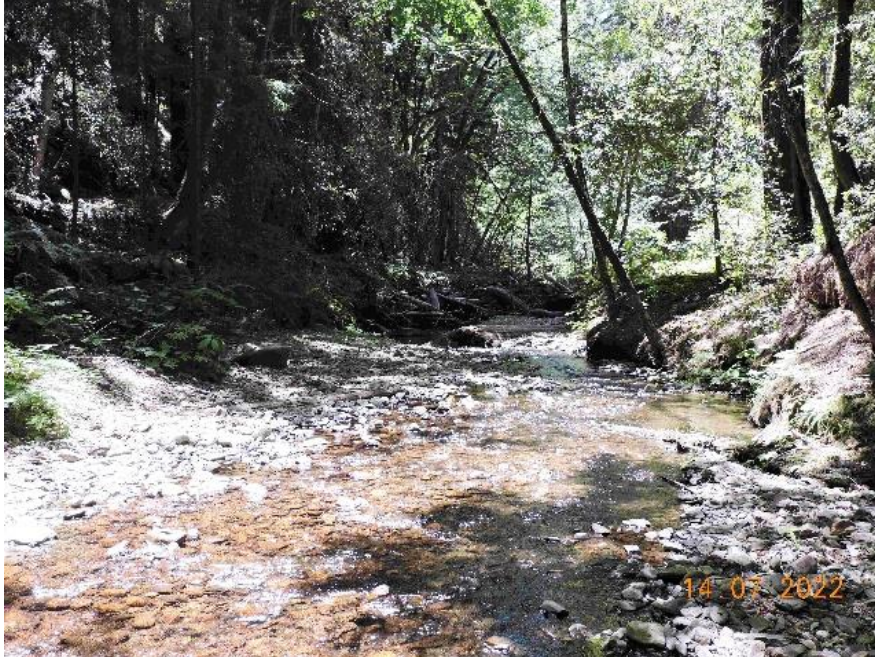
Photo 71. Mile 5.0, looking downstream toward the lower Slate Creek jam (in shade). The deeply entrenched channels on Gazos Creek upstream of mile 2 confine and anchor wood jams. They then tend to persist and grow, potentially becoming barriers to fish passage. They should be monitored and modified as necessary.

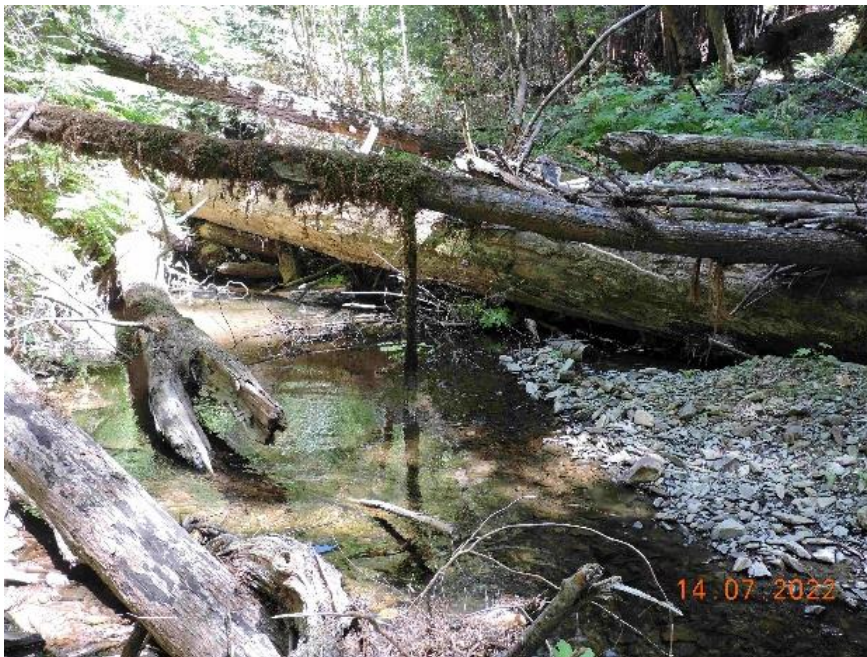
Photo 72. Mile 5.0+, just upstream of the lower jam. The large upstream jam is 6 ft high and well-anchored by fallen trees from the fire. Like the lower wood jam, it is partially open and not presently a barrier to fish passage. However, it is likely to grow into a barrier to fish passage.

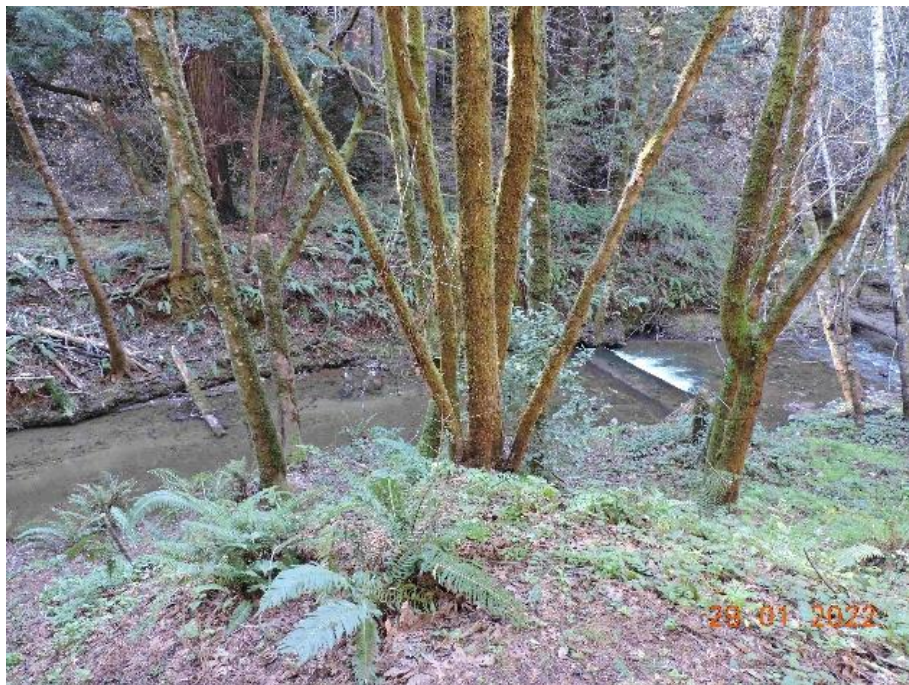
January Photo75. Mile 5.25. Tail of long pool above Humboldt Crossing and short, deep pool below crossing are fish sampling habitats. The habitat below the drop is unchanged, but the habitat upstream suffered substantial filling.

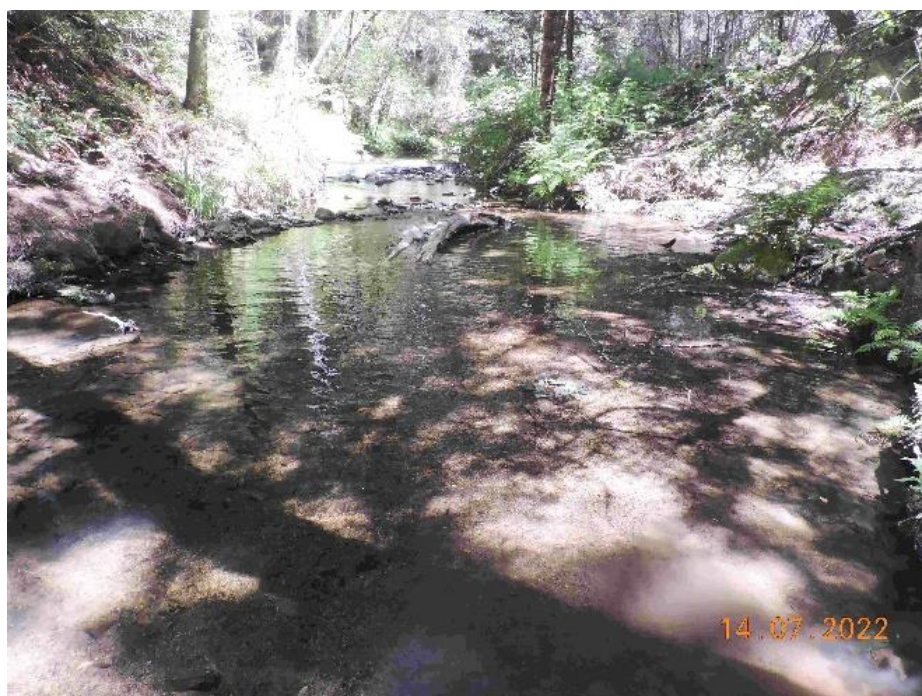
Photo 76. Mile 5.25, looking upstream. Fish sampling pool upstream of Humboldt crossing is now two-thirds filled with fines and gravel, eliminating undercuts on left bank.

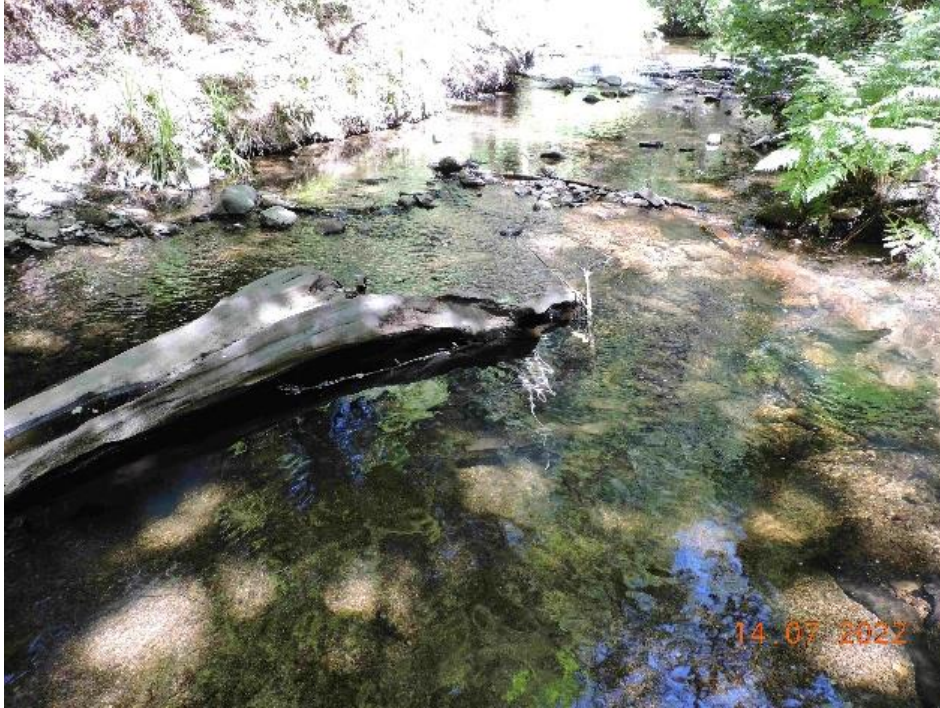
Photo 77. Mile 5.25. Remnant scour around buried log, but half of depth and extent of scour has been lost. Complex head of pool habitat upstream is still good feeding habitat.

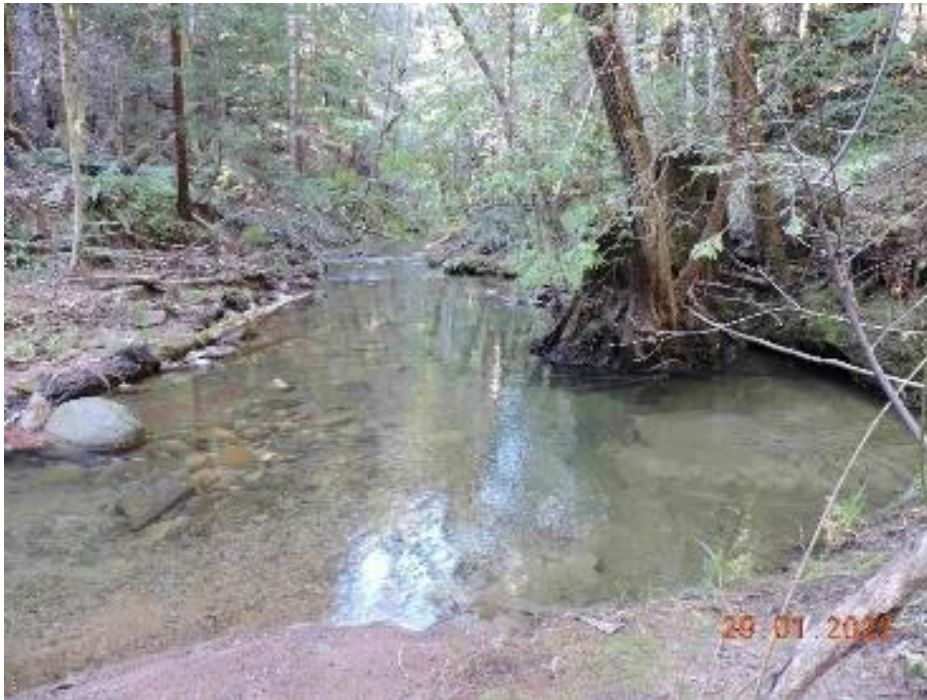
January Photo 78. Mile 5.25, looking downstream. Fish sampling pool and backwater alcove to the right have been about half filled by fines and gravel. The short riffle separating it from the pool upstream is gone.

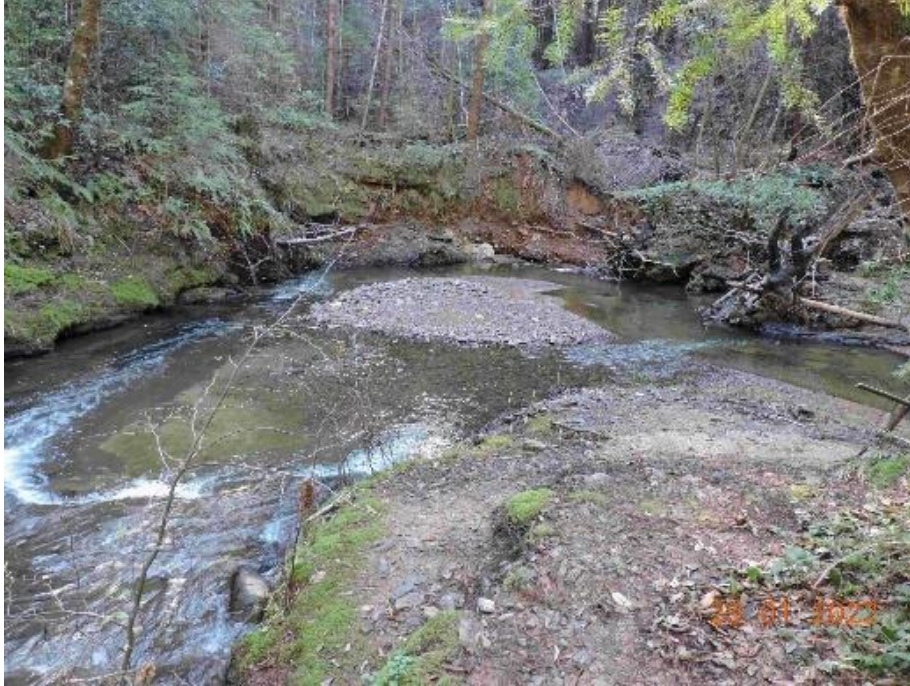
January Photo 79. Mile 5.25, downstream of bridge. Large deep and complex corner pool was more than two-thirds filled with fines and gravel by both 2021 and 2022, reducing escape cover and high flow refuge.

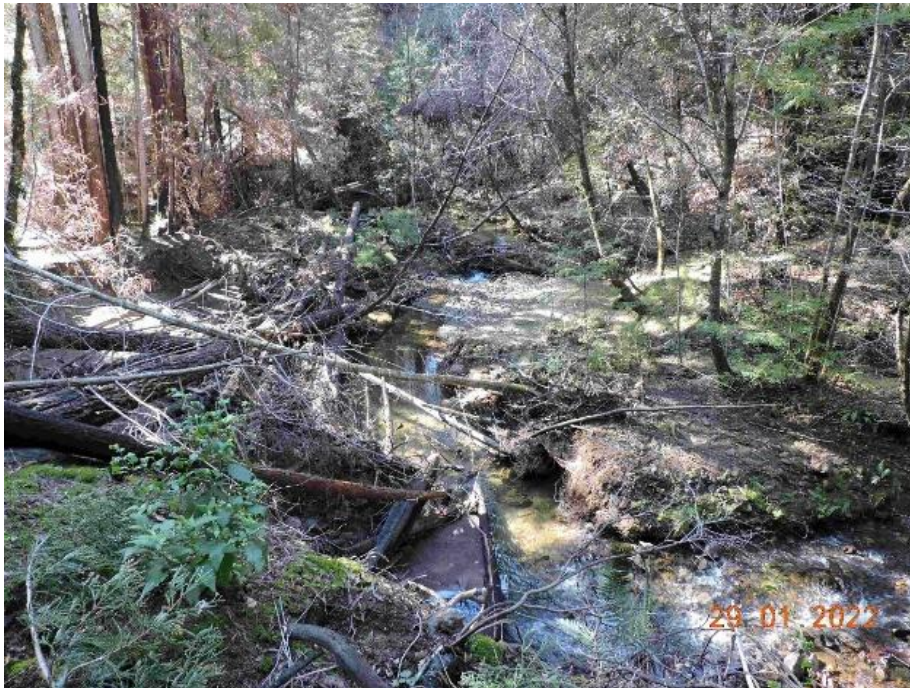
January Photo 80. Mile 5.35, looking downstream. Abundant log debris caught in bend now a potential fish passage barrier, but also a high flow refuge.
