2022 Channel and Habitat Changes at Six Long-term Index Sites on Scott Creek from the CZU Fire.

Jerry J. Smith

31 October 2022

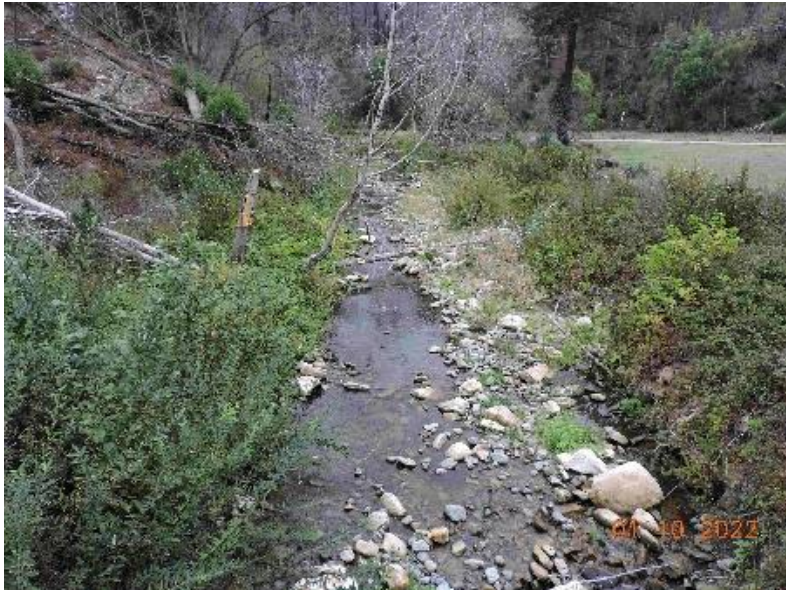
Photo 1. Looking upstream of Swanton Road (1 Oct 2022). Open canopy due to fallen and cut alders (to prevent bridge blockage). Pool above bridge and pocket water along the banks was lost by high flows and bedload movement. Channel composed of runs and short riffles, and channel armored with cobbles and small boulders, with little change from 2021.

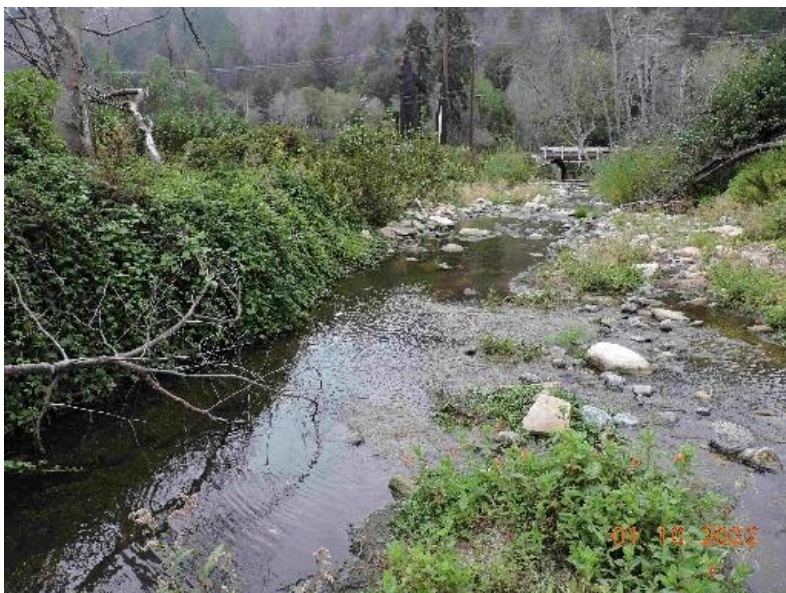
Photo 2. Looking downstream towards Swanton Road. Pool with undercut bank along left bank present in both 2021 and 2022.

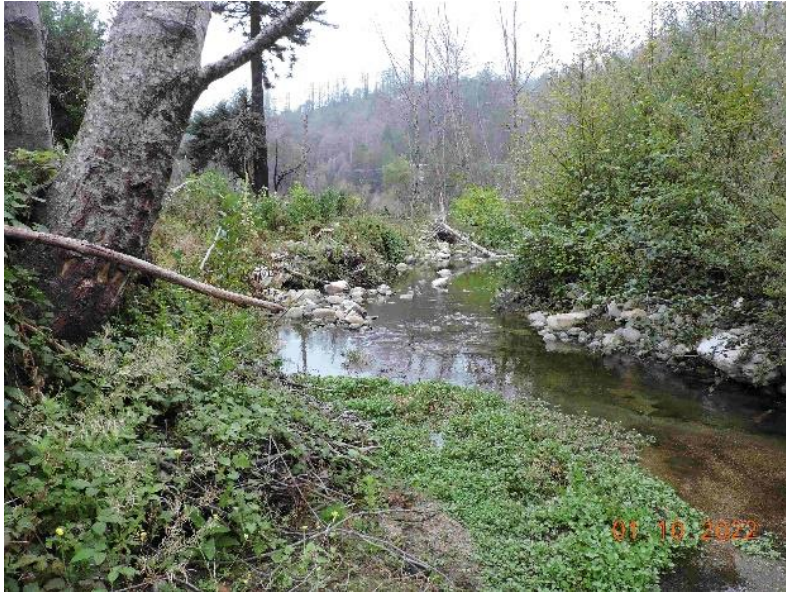
Photo 3. Looking downstream. Narrow, shallow pool and run has replaced a deeper pool (about 50% filled).

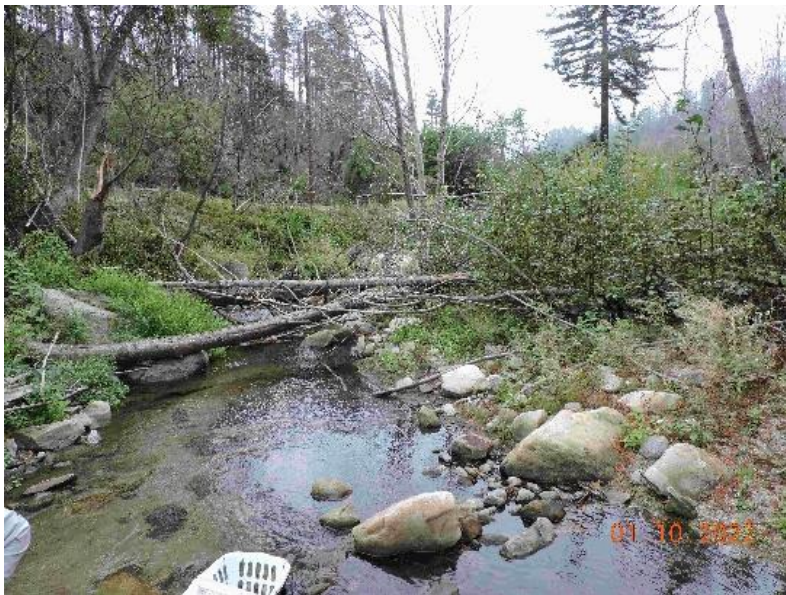
Photo 4. Looking downstream at tail of pool below V-weir. Short moderately deep pool mostly filled. Alders down and canopy opened.

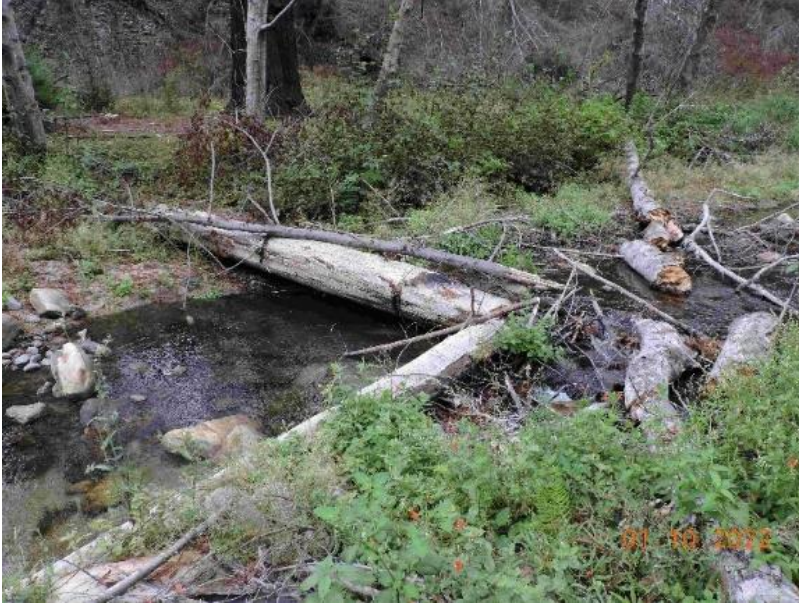
Photo 5. Decades old V-weir was substantially rinsed under the cap logs, mostly eliminating the protected undercut that provided high flow velocity refuge and escape cover. The average depth of the pool below the weir has been reduced by at least half. Streamside alder canopy is mostly gone.

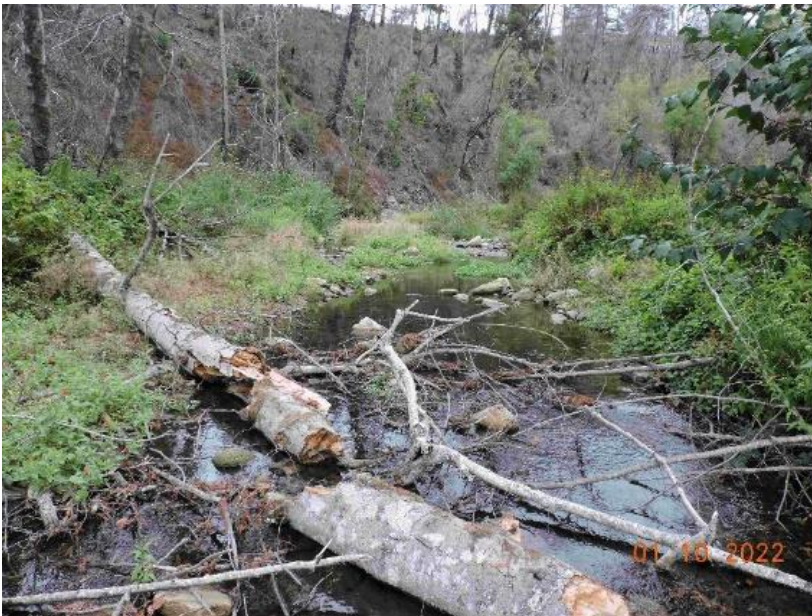
Photo 6. Looking upstream from V-weir. Shallow pools with undercut right bank substantial filled. Most of the streamside alder canopy is gone.

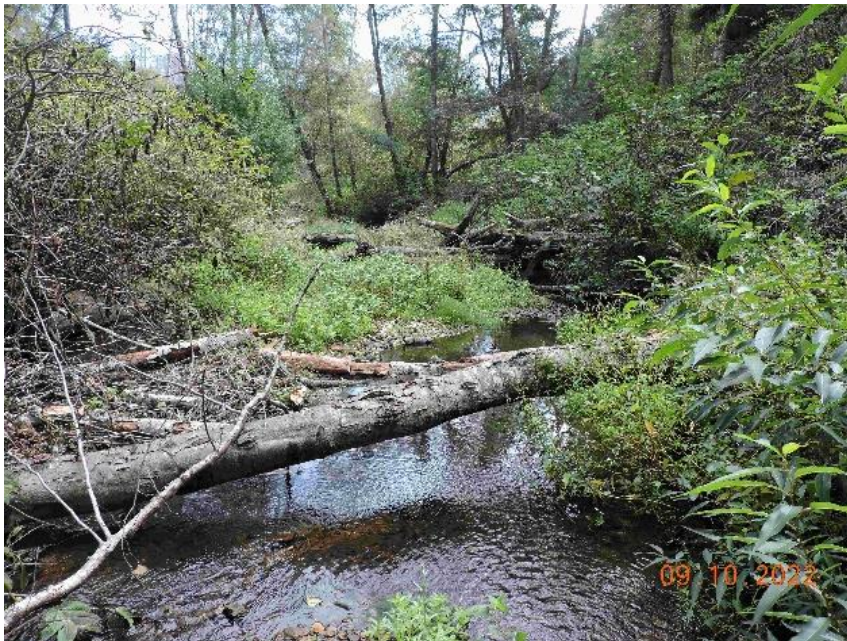
Photo 7. Looking downstream. Canopy partially opened by loss of alders. Shallow pools and runs with scattered logs in channel.

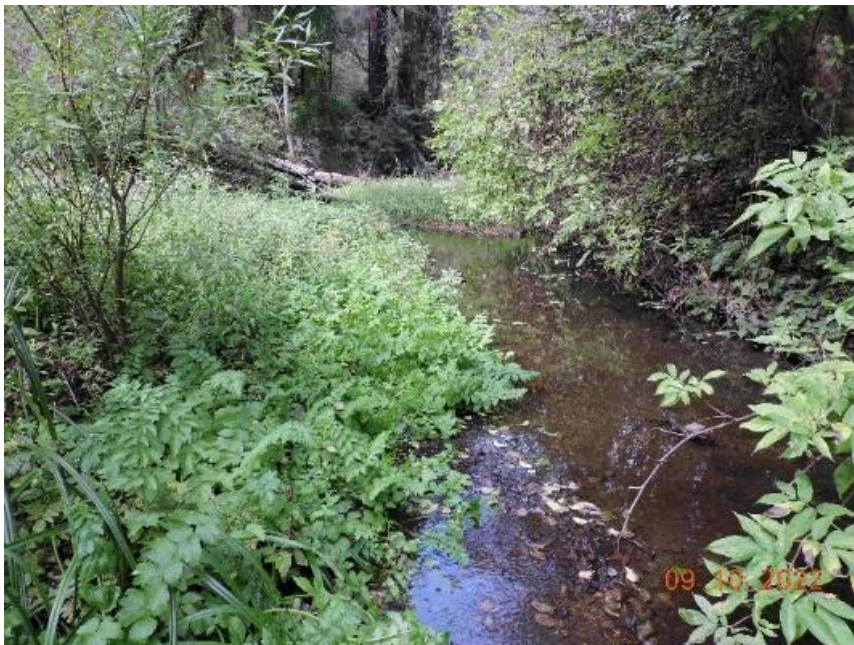
Photo 8. Looking upstream. Lowermost sampling habitat is a shallow pool and glide. Undercut banks have been reduced and depths formerly associated with wood in the channel have been reduced. Stream bed with a layer of fine silt.

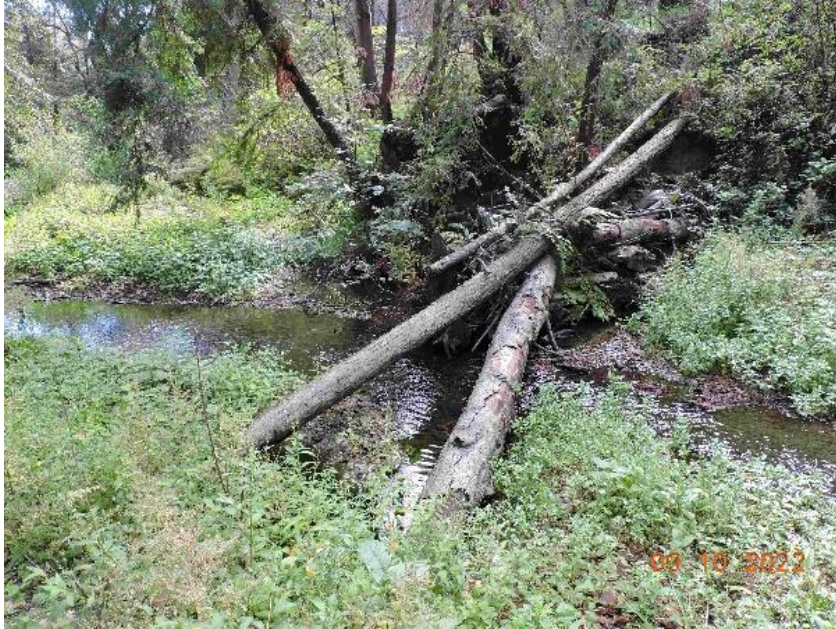
Photo 9. Partial log jam present in 2021 has been reduced, but the stream channel upstream (to the right) has been rearranged from the far bank to the near bank (foreground). The formerly deep pool (now under the logs) at the large redwood stump on the far bank is now half filled with sediment and is now largely isolated from the main current and stagnant; this has eliminated the fast-water feeding habitat and few fish were present. The stump pool does provide high flow over-wintering habitat.

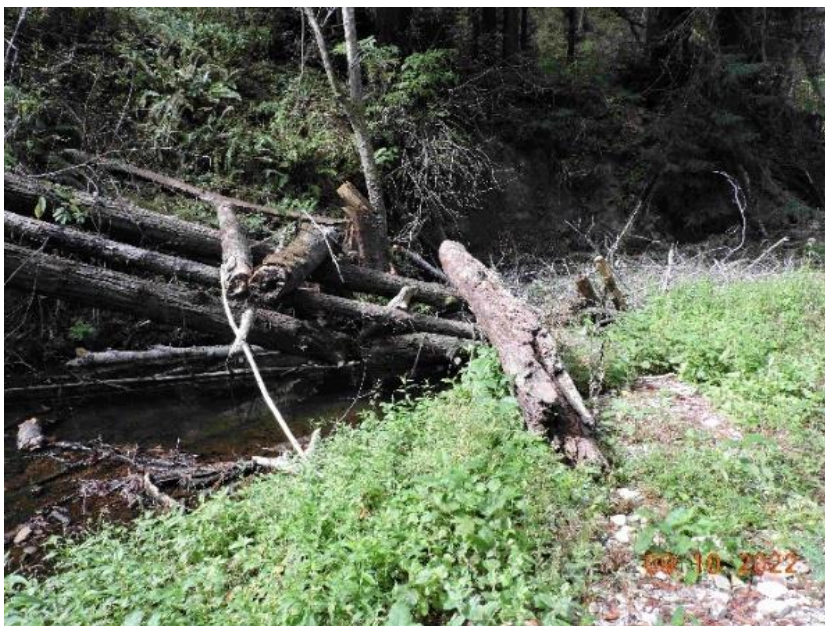
Photo 10. Looking upstream. The deep tail of the pool upstream of that shown in Photo 9 is partially filled with sediment and organic matter. Limited sampling in the stagnant habitat caught no fish. The larger portion of the moderately deep pool upstream to the bend was still present in 2021, but was completely filled by 2022, eliminating two-thirds of the pool habitat (Photo 11).

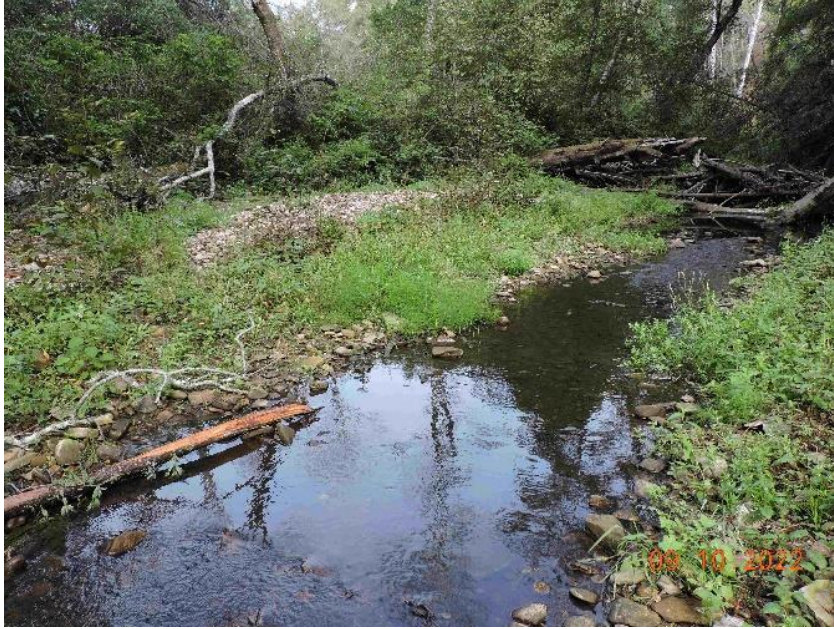
Photo 11. Looking upstream. The head of the former bend pool was along the right bank (left in the photo) in 2021, but was lost to sediment deposition in 2022. The habitat is now bypassed by a shallow riffle and run.

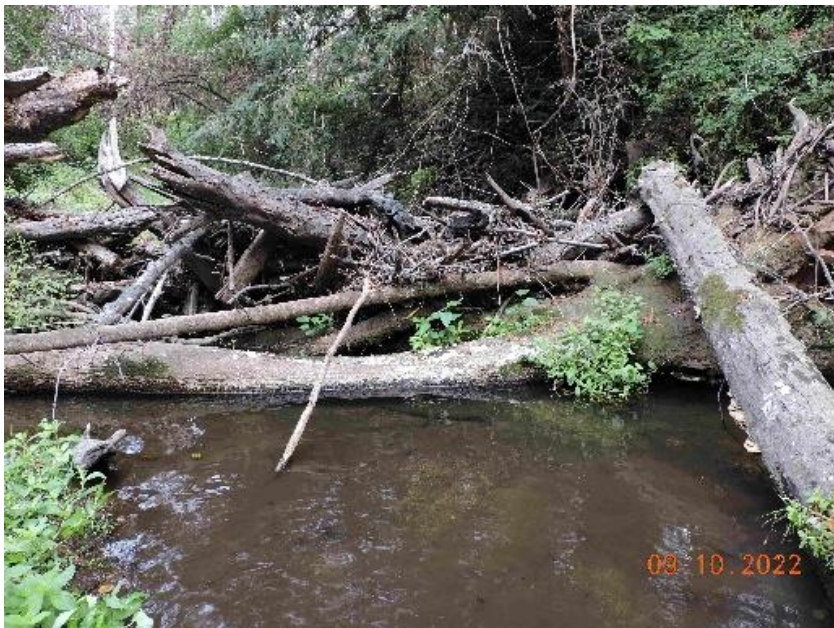
Photo 12. Looking upstream. The partial logjam from 2017 and 2019 was associated with a long pool at and upstream of the jam. The wood in the partial jam was tripled in 2022, and much of the pool upstream has been filled.

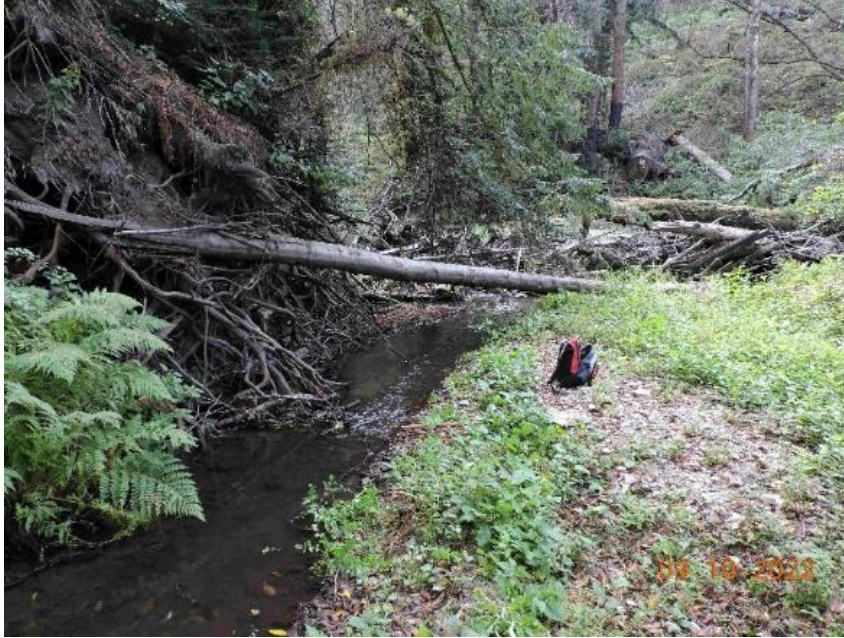
Photo 13. Looking downstream. The backwater effect of the jam in the distance (and in photo 12) has resulted in filling much of the pool and glide upstream.

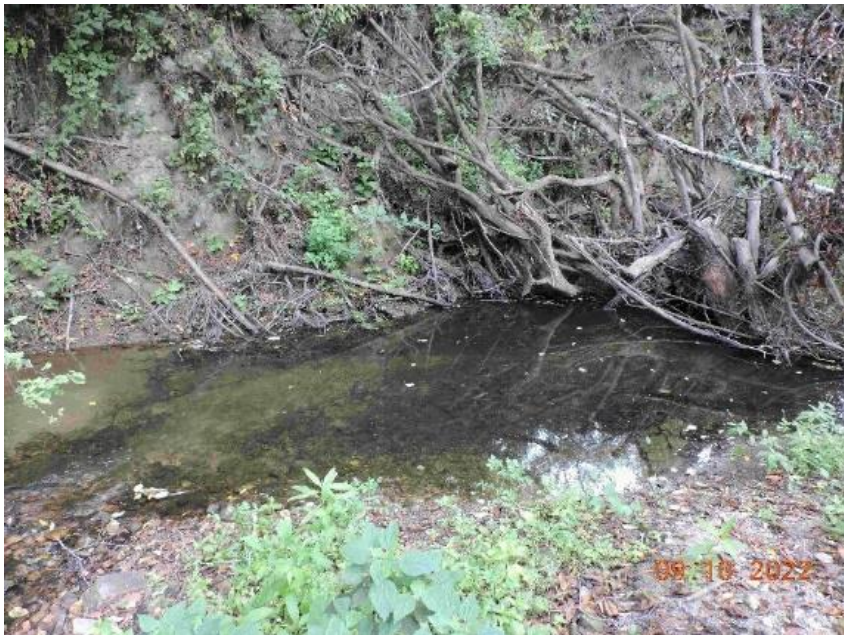
Photo 14. Scour at the bend upstream has produced a short 2 ft deep pool with a small partial jam at its tail and a fast-water feeding “head of pool” habitat upstream.

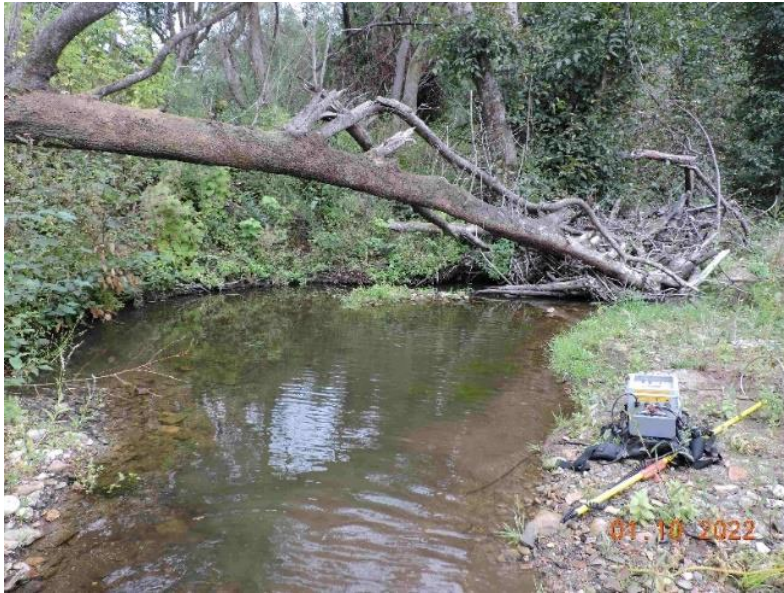
Photo 15. Looking downstream. The lower bend pool (>2 ft deep) downstream of, and parallel to, Swanton Road has modified little since 1992, mostly with the amount of accumulated large wood. Shading of the pool was reduced by the burning of several large bay trees at and upstream of the pool.

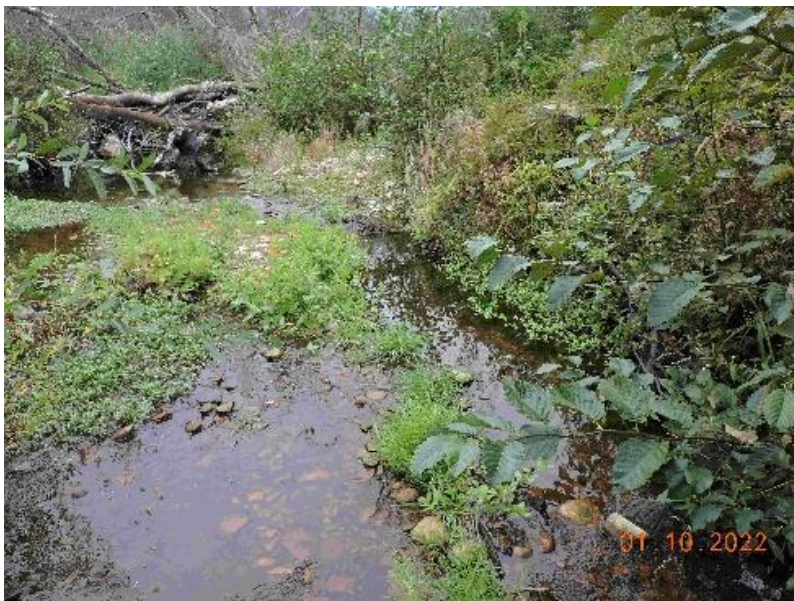
Photo 16. Looking upstream. A guide and shallow pool associated an in-channel trunk (now gone) was converted to run and riffle habitat in 2021. The section was recut in by 2022, with a narrow, shallow (< 1 ft) pool within the run. The Lockheed Reservoir upstream on Mill probably substantially attenuated the brief period of high flows in December 2021.

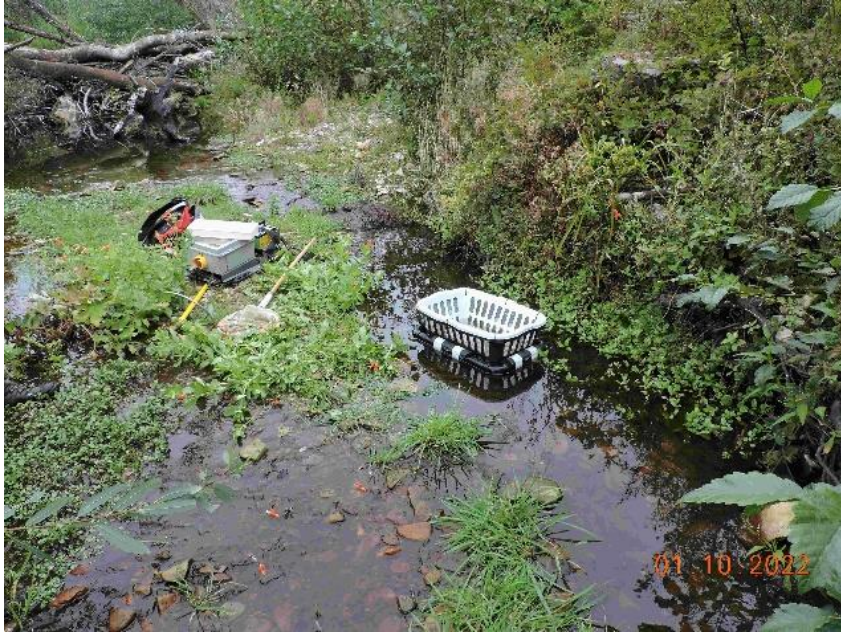
Photo 17. A narrow pool and deeply undercut bank had been present since the 1990's. It received some filling in 2021, but was narrowed and substantially filled in 2022. Half of the undercut bank survived and still provided habitat for steelhead YOY and yearlings in 2022.

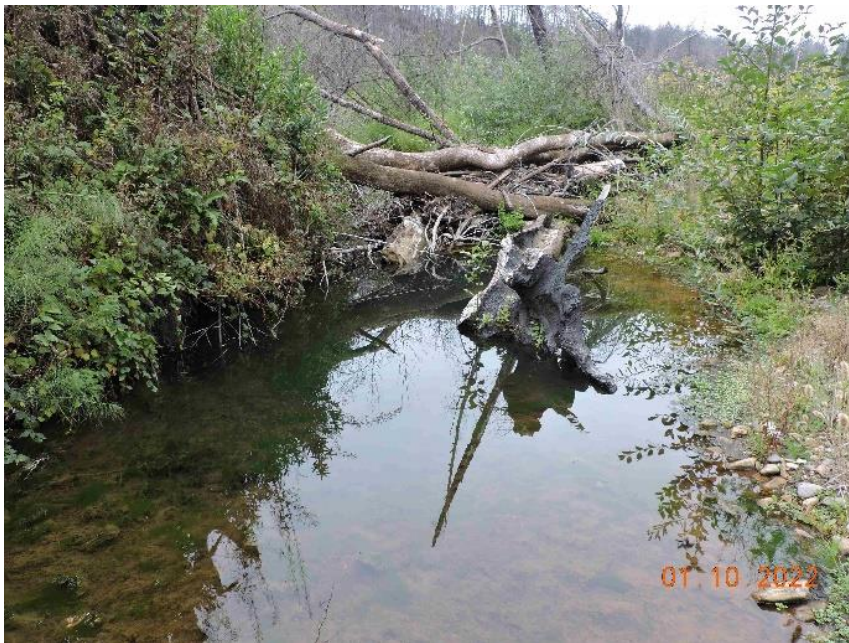
Photo 18. Accumulated large wood created a deep, complex pool in 2021 at the bottom of the horseshoe bend downstream of Swanton Road. It was unchanged in 2022.

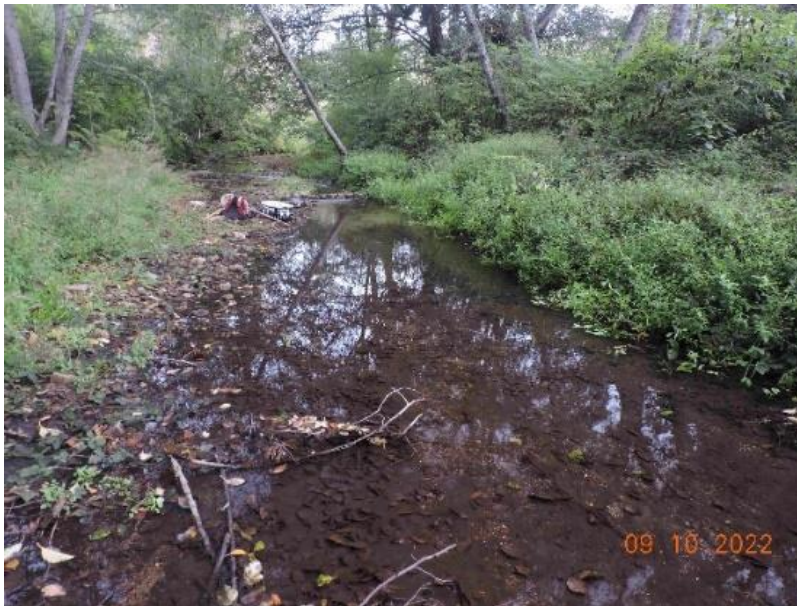
Photo 19. Looking upstream. The site of a logjam and deep pool and glide in 2017-2019, the channel up and downstream was scoured of wood and filled with sediment. This habitat immediately upstream of the PIT antenna is now shallow pool/glide and run habitat.

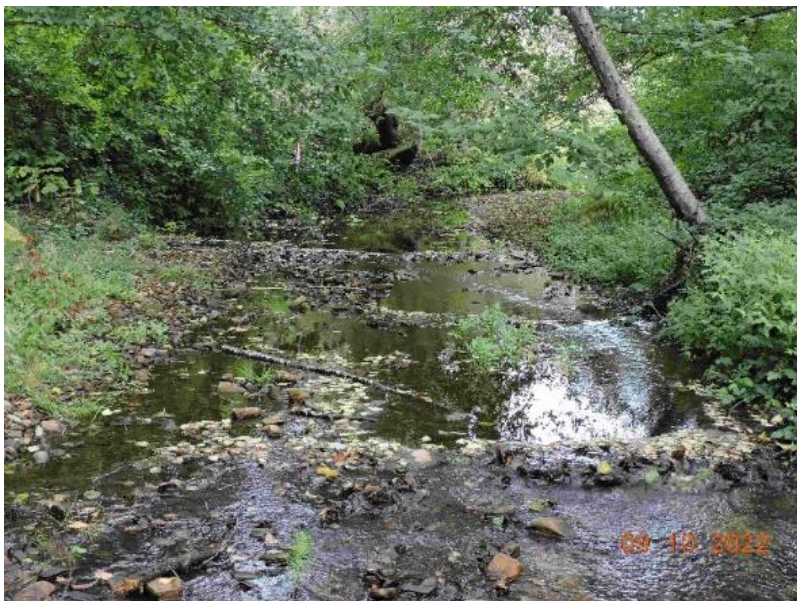
Photo 20. Looking upstream. Run and glide habitat, with canopy intact.

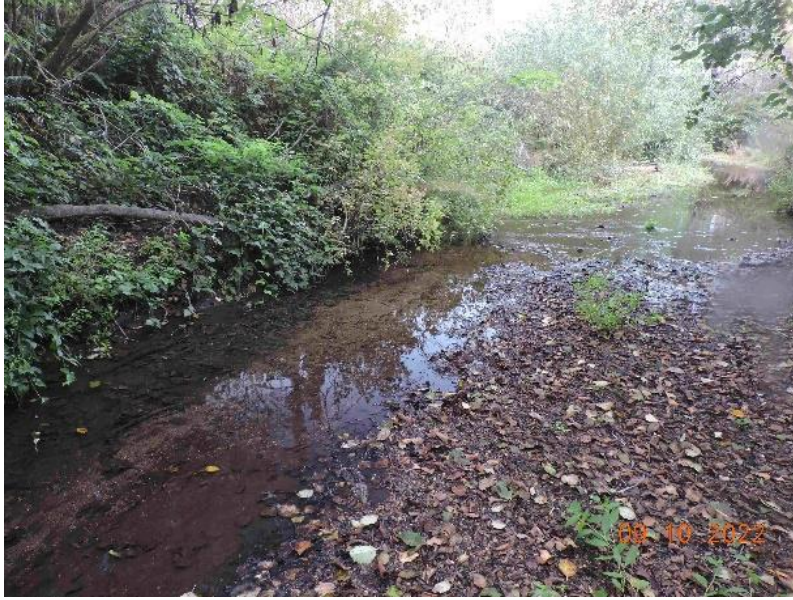
Photo 21. Looking upstream. Glide and shallow (1-2' ft) pool habitat is shallower and has lost bank undercuts and much of the overhanging vegetation. The low flow channel is primarily sand and silt, although the flood plain is gravel. The head of the pool upstream provides fast-water feeding habitat.

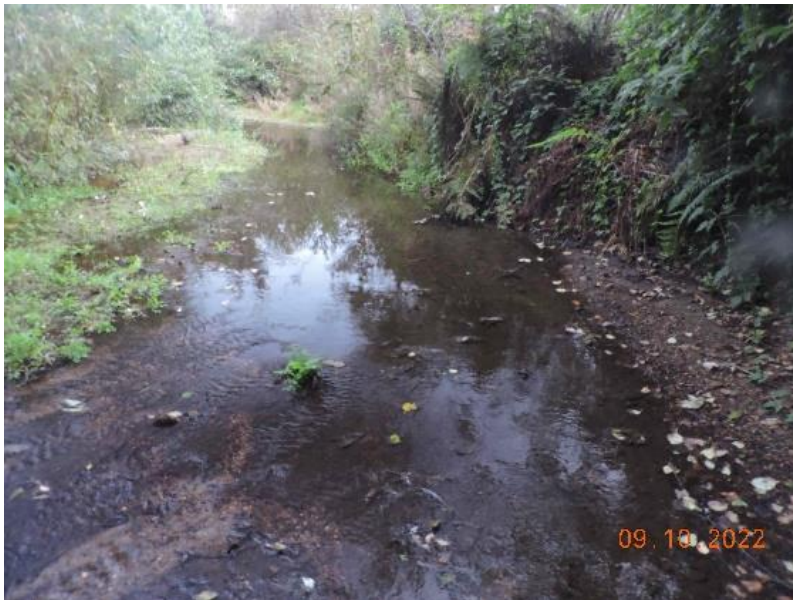
Photo 22. Looking upstream of the sample reach. The sandy glide and run habitat is similar to earlier years, except small and medium wood is now absent from the channel.

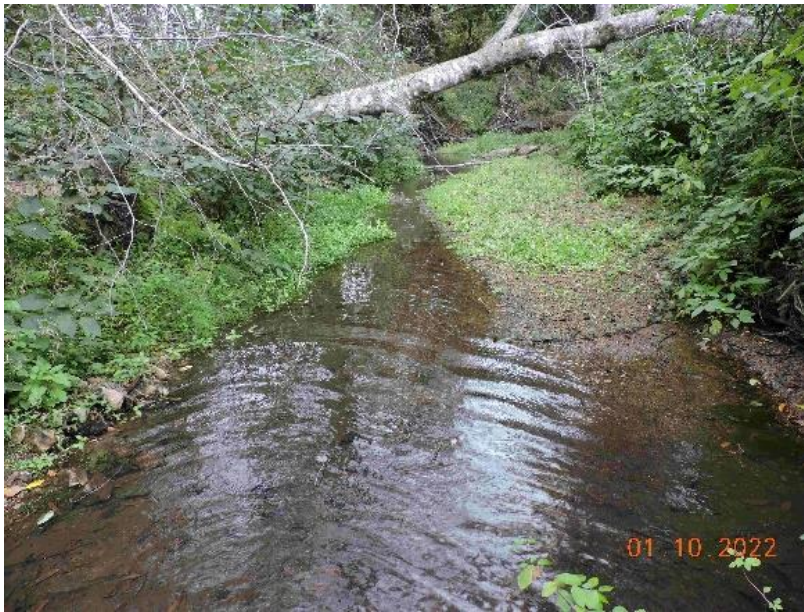
Photo 23. Looking downstream. A series of pools to 2-2.5 ft deep downstream to a sharp bend were rearranged and filled. This photo shows a formerly long 2.5 ft deep pool, with deeply undercut right bank. The pool was almost completely filled and is now a shallow run moved to the left bank. Canopy is still intact.

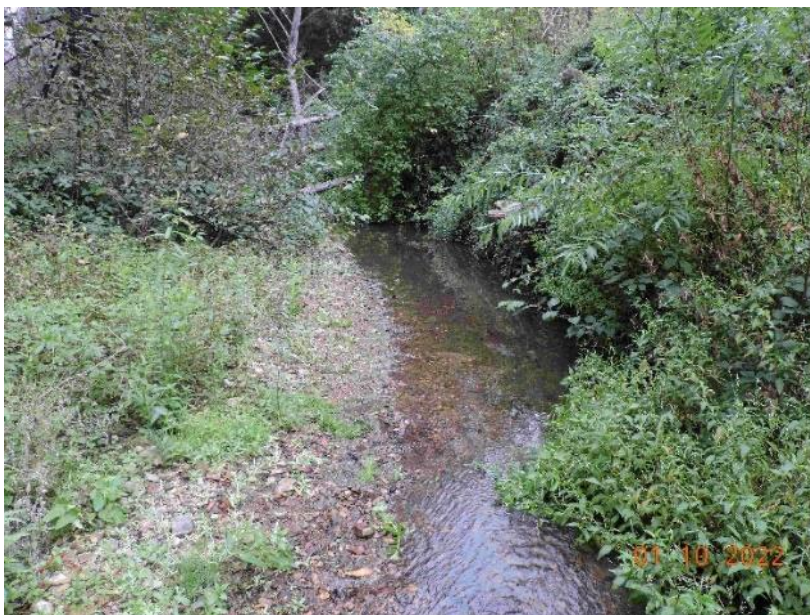
Photo 24. Looking downstream. A new, long glide and pool (to 1-1.5 ft deep) has formed along the right bank, where a glide/run had previously crossed from left to right to enter the pool in the previous photo.

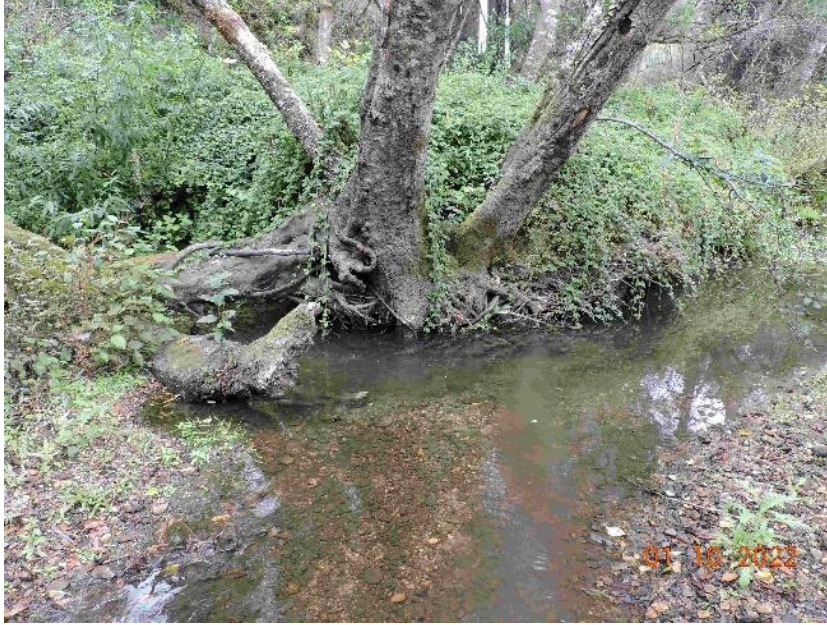
Photo 25. Looking downstream. A deep pool (to 3+ ft) with undercut bank and large wood in a backwater alcove to the left had been present since 1992. The straightened stream channel with a shallower pool now bypasses the 80% filled alcove/backwater.

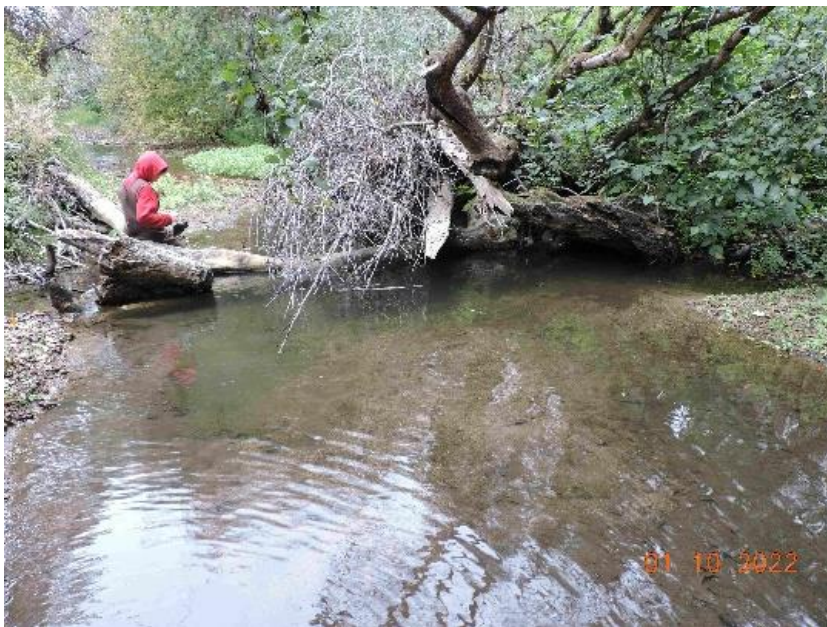
Photo 26. Looking upstream. The shallow run that used to enter the alcove pool has been scoured to a short, moderately deep (2+ ft) pool and glide immediately below a large log.

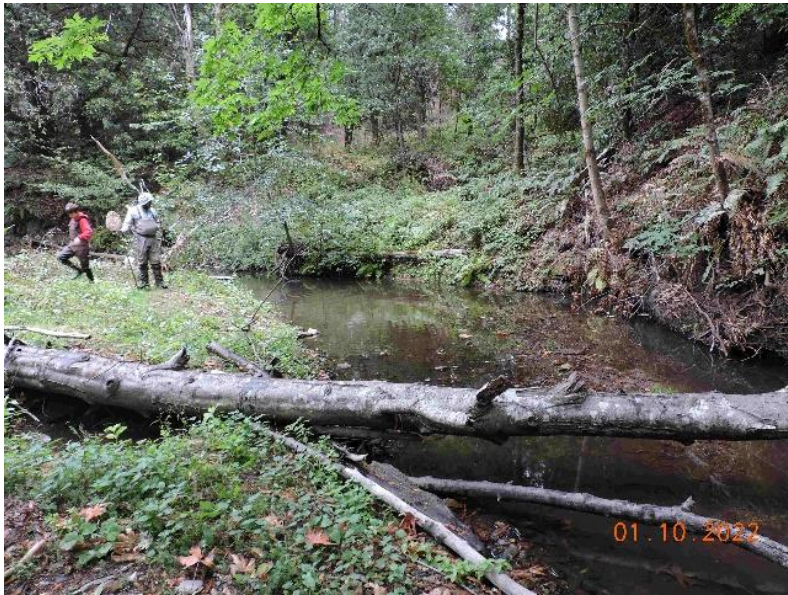
Photo 27. Looking upstream. The formerly deep pool at the bend at the downstream end of the sample site was often too deep to sample effectively. The pool configuration has changed and the pool has lost more than half of its depth.

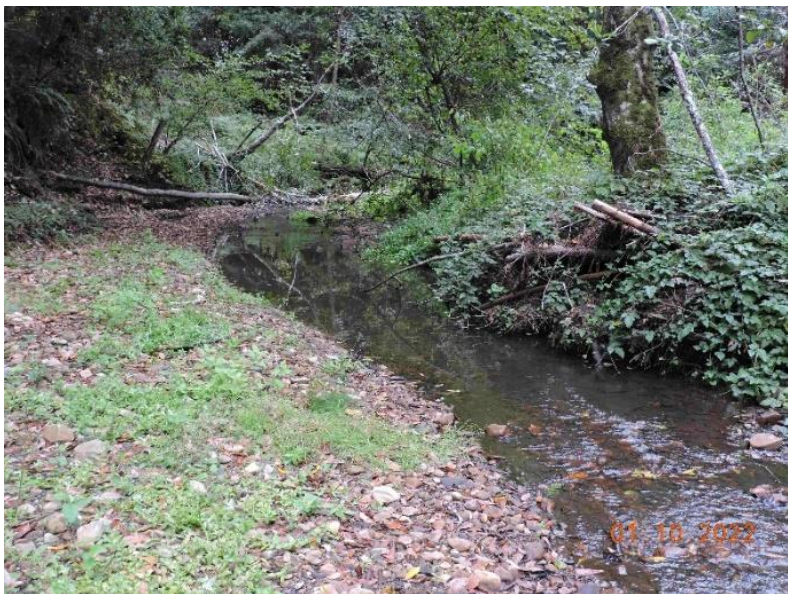
Photo 28. Looking downstream. In 2017- 2019 several deep (2.5+ ft) pools associated with large wood in the middle of the sample reach were rearranged and replaced by shallow pools and runs. The channel additionally rearranged and shifted within the flood plain in 2021 and 2022. The pool shown is less than 1 ft deep.

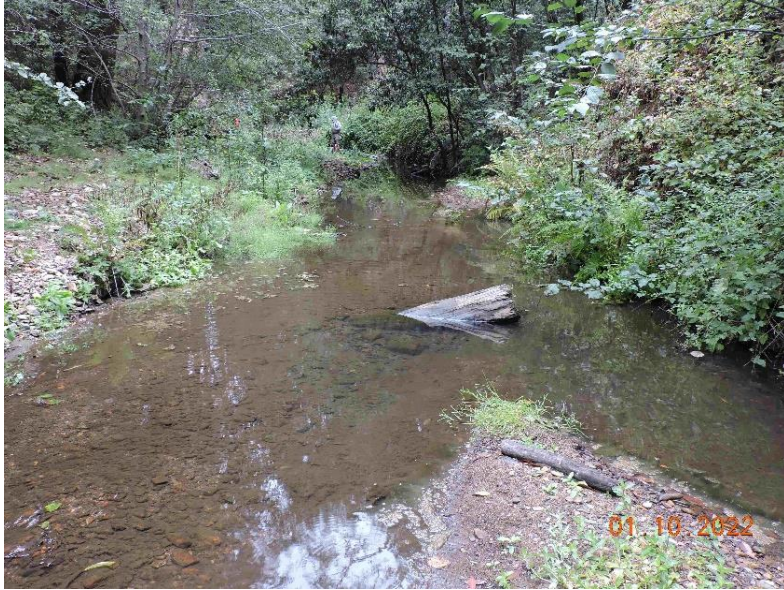
Photo 29. Looking upstream. Tail of a long, narrow glide and shallow pool (mostly <math><1.5\text{ ft}</math>) in a channel with most wood removed and a sand/silt substrate.

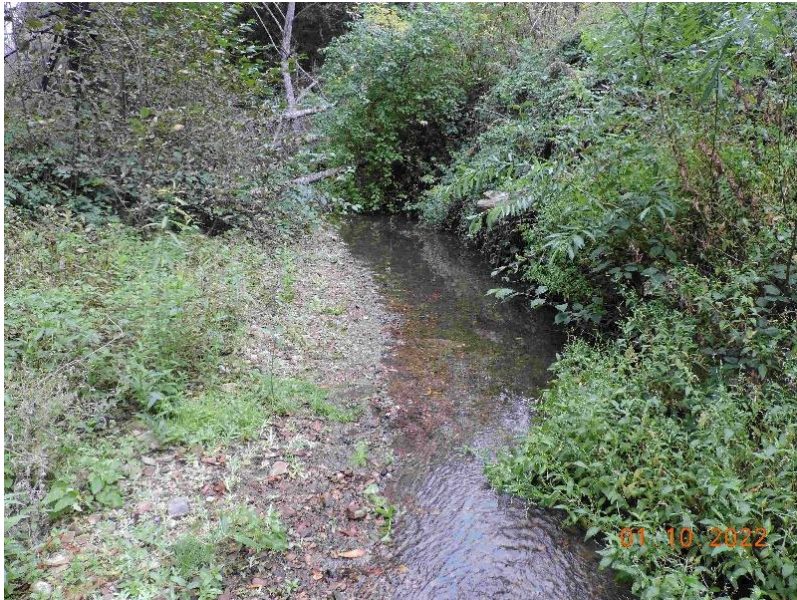
Photo 30. Looking downstream. Head of pool in photo 29, with narrow pool, glide, and run habitat.

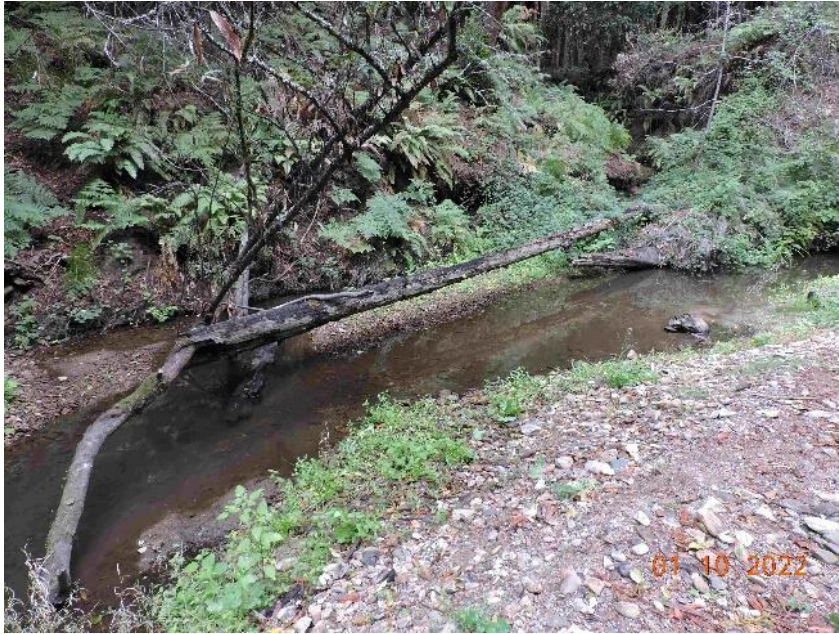
Photo 31. Looking upstream. Narrowed and partially (50%) filled downstream portion of pool at bend.

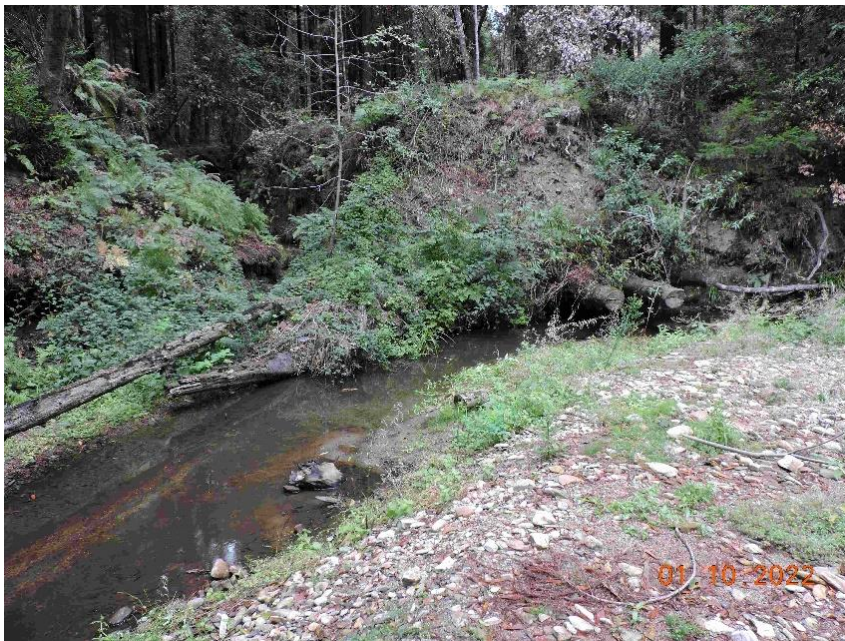
Photo 32. Looking upstream. Head of the pool in photo 31, located at the bend. The pool has been present since 1992, when the right bank multi-trunked California bay tree had partially fallen into the channel. In 2021 the pool at the bend was 4 times as wide, contained several fallen trees, and was up to 4 ft deep (and difficult to sample!). In 2022, the scoured pool (<2.5 ft deep) was narrowed to the undercut right bank.

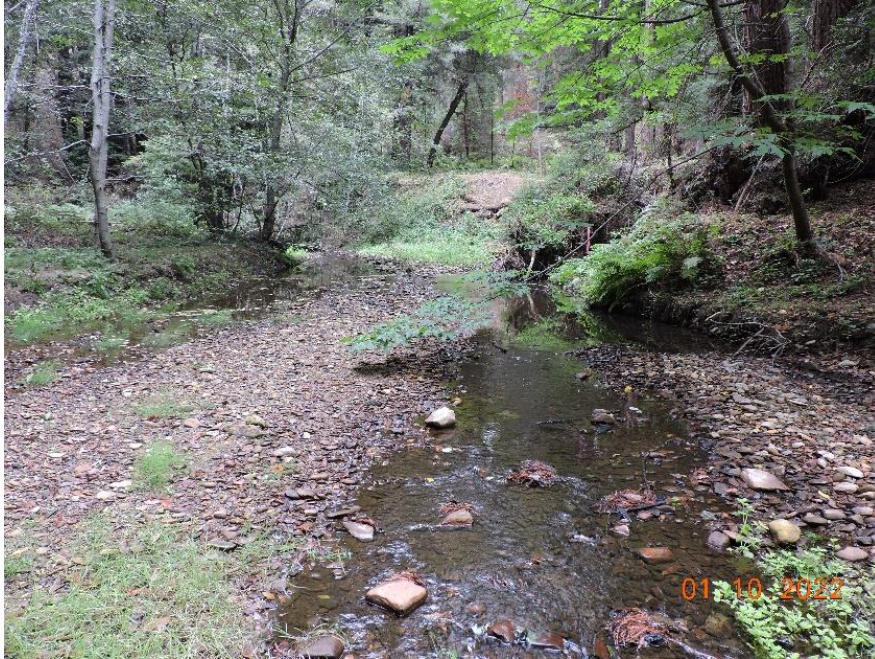
Photo 33. Looking upstream. From 1992-2021, deep pool and glide occupied all but the foreground of this photo, extending upstream to the sharp bend (and often even farther upstream around the bend). The configuration moderately changed over the years. In 2021 most of the pool was too deep to effectively electrofish. In 2022 the habitat was narrowed (the pool was previously bank to bank) and about three-fourths of the habitat filled. Only a narrow deep channel exists along the left bank.
