Gazos Creek Post-fire Stream Habitat Assessment in July and September 2022 (revised from August 2022; text changes are in *italics bold*)

Jerry J. Smith

29 October 2022

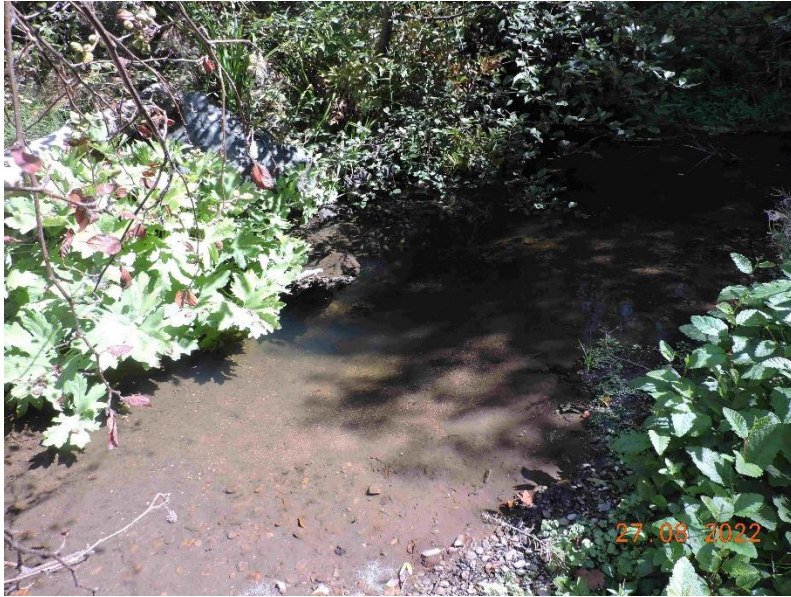
Photo 1. Mile 1.8 mile. Head of lowermost fish sampling pool at a sharp bend in stream, with pool 50% filled with fines. Tail of pool now has fallen alders. The site is downstream of Old Woman's Creek watershed, which provided abundant sediment after the CZU Fire in 2021 and 2022 (and frequently prior to the fire).

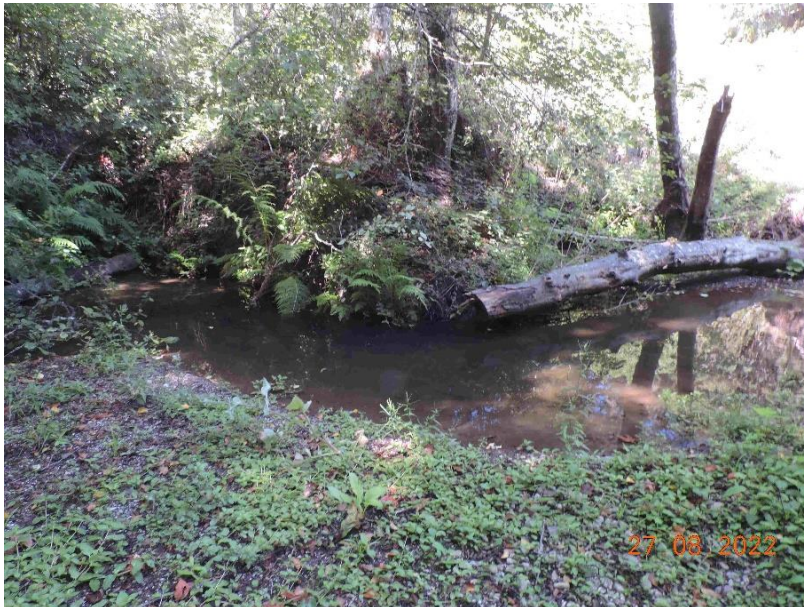
Photo 2. Mile 1.8, looking downstream. Formerly deep corner pool and backwater (to left), now about 60% filled with fines, including reduction in amount of undercut bank.

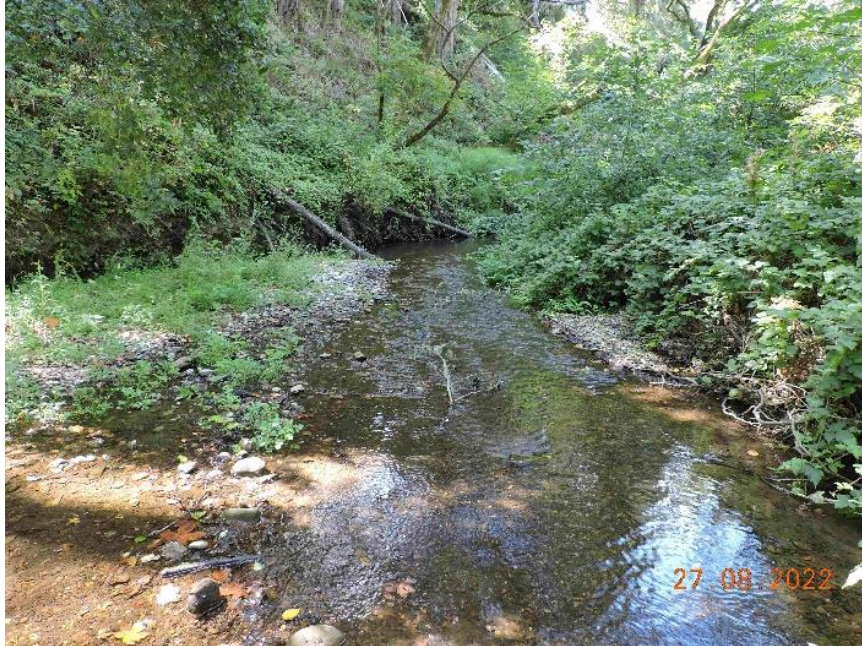
Photo 5. 1.8 mile, looking downstream. Pool 4 in the distance is now mostly glide and without undercut left bank. Pool 5, a corner pool and backwater out of the picture to the lower right, was lost (bypassed) in 2021 and 2022.

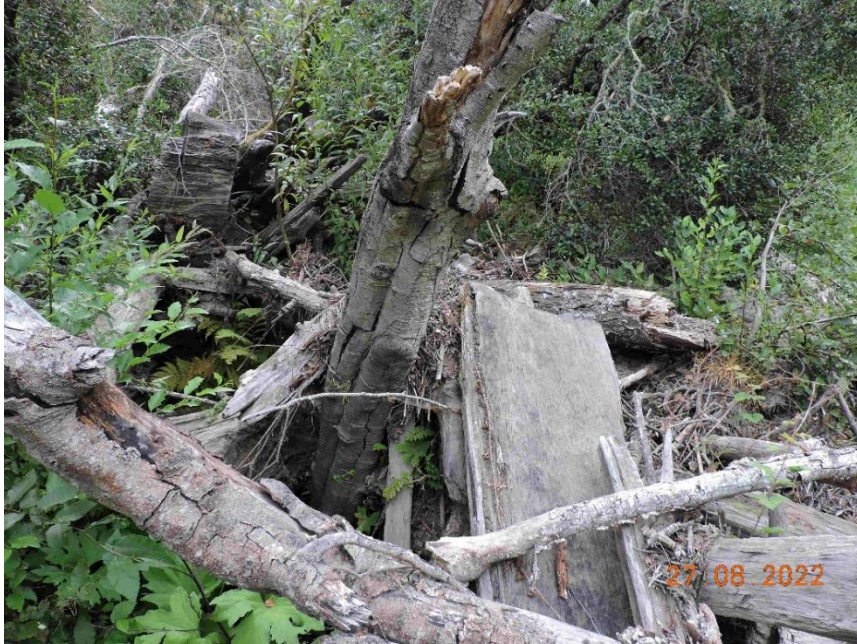
Photo 13. Mile 2.1, mid jam. The jam is 6+ ft high, 30 ft wide and well-anchored. It is a potential serious fish passage barrier except during high flows. Abundant young-of-year steelhead at the sample site in 2022 may have been the result of spawning below the barrier after passage flows disappeared in January-April.

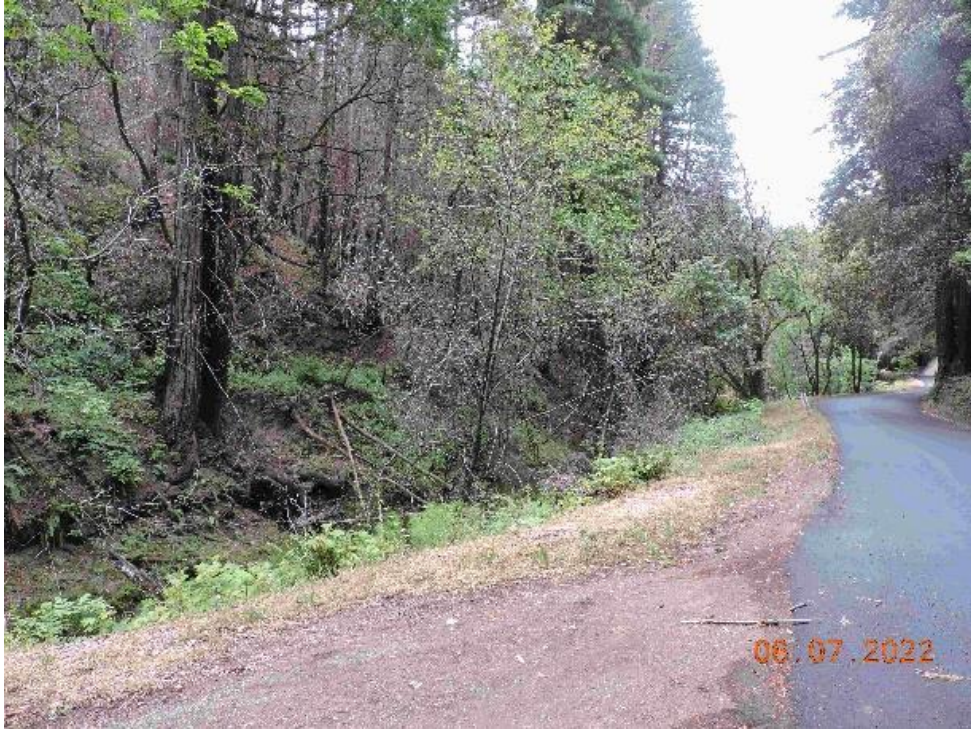
Photo 25. Mile 3.1, looking downstream from pullout. Road closely adjacent to shallow entrenched channel. Few right bank trees.

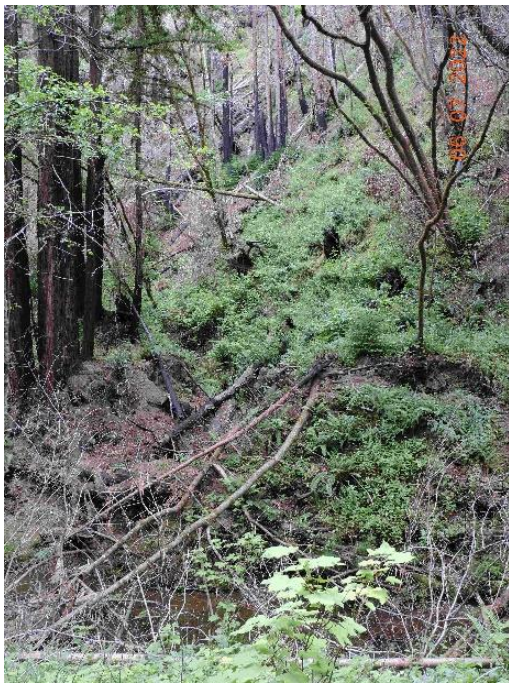
Photo 26. Mile 3.1. Steep south slope at the site, with ground cover now well-established, redwoods recovering, and upslope tanbark oaks and big-leaf maples mostly with dead trunks, but basal sprouts.

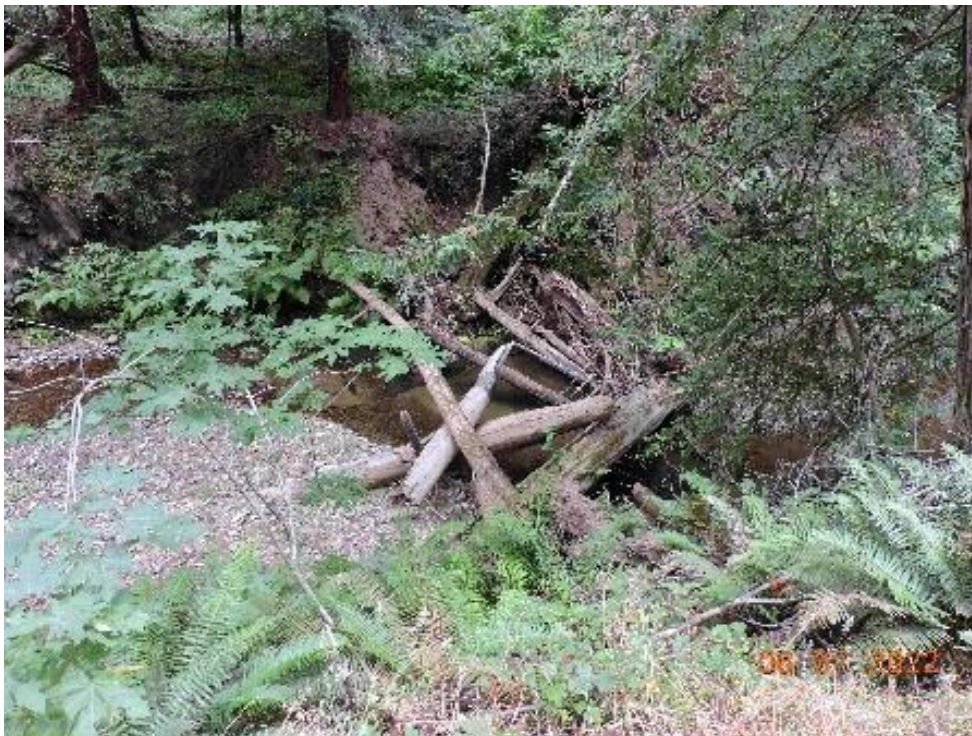
Photo 28. Mile 3.2. Old and persistent, but usually open, log jam relatively unchanged in 2022.

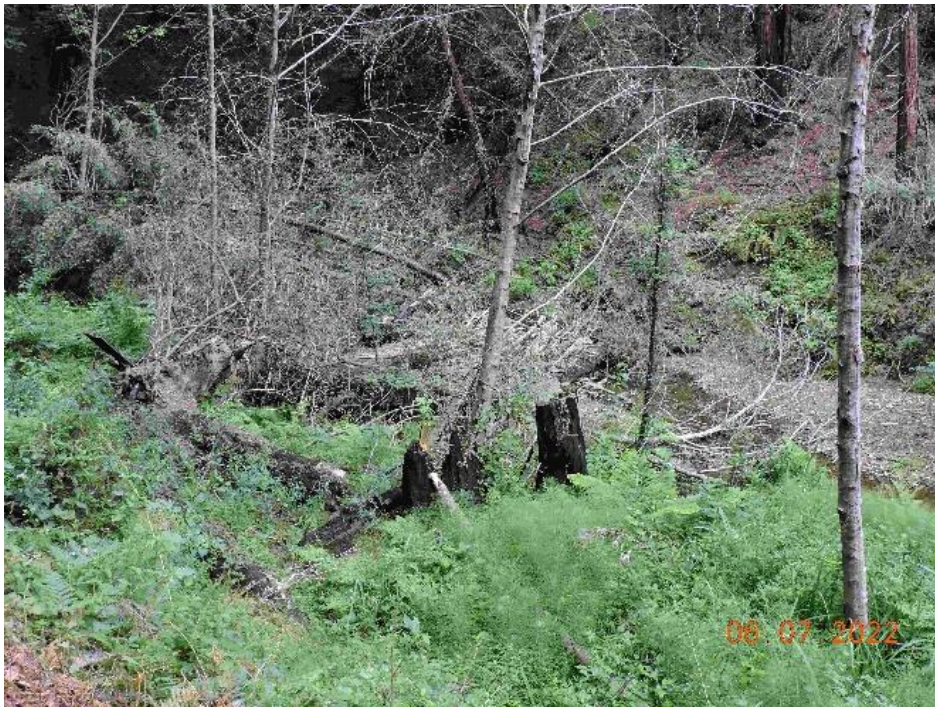
Photo 30. Mile 3.3. View upstream from the end of the one lane road section to the major new log jam in the entrenched channel. The alders at this site were killed by the fire.

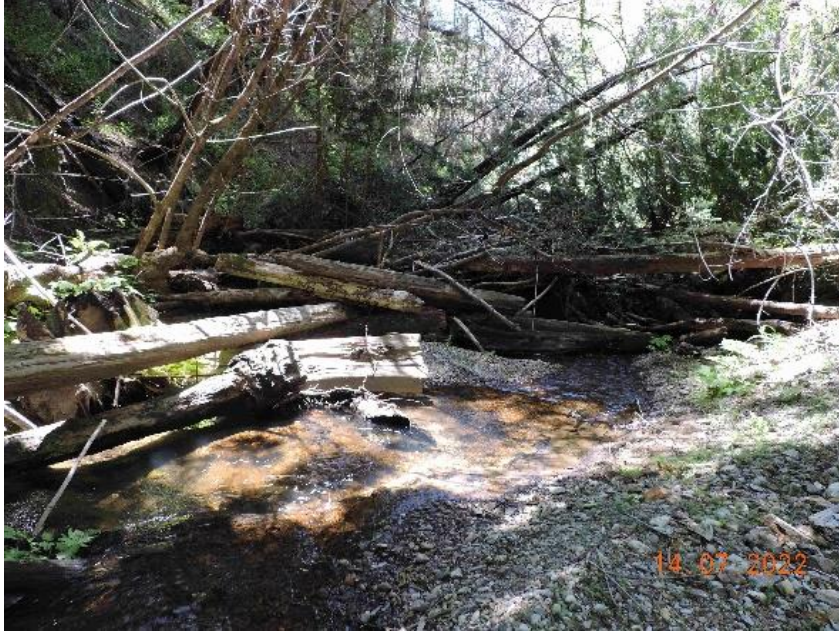
Photo 31. Mile 3.3. View from upstream of new logjam formed from transported wood against fallen streamside trees. The jam in the entrenched channel is well-anchored and 5 ft high and 30 ft wide. It presently may provide high flow fish passage underneath, but is a serious potential barrier, and should be monitored and likely modified.

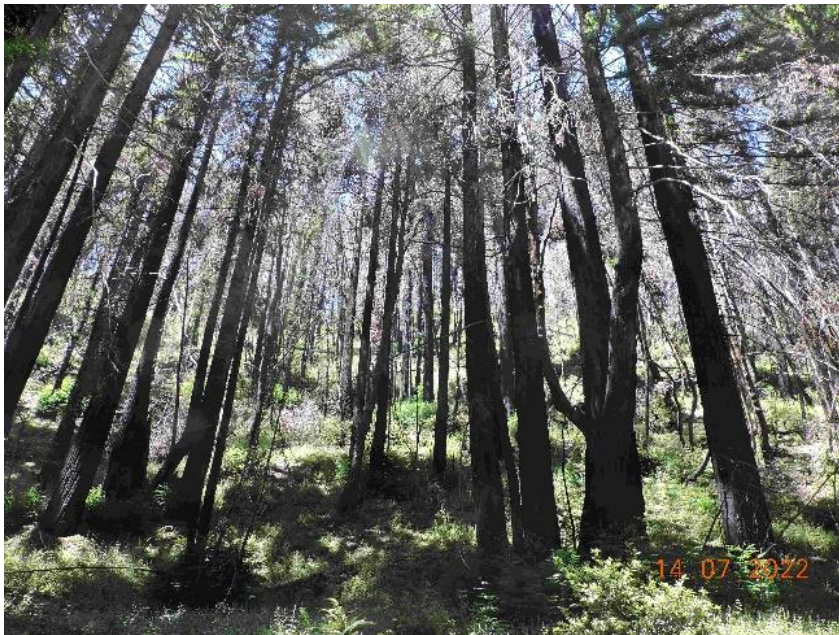
Photo 32. Mile 3.3. North slope above road with ground cover reestablished, recovering redwoods with trunk and branch epicormic sprouts, small Douglas firs dead, and tanbark oaks with dead trunk but with basal sprouts.

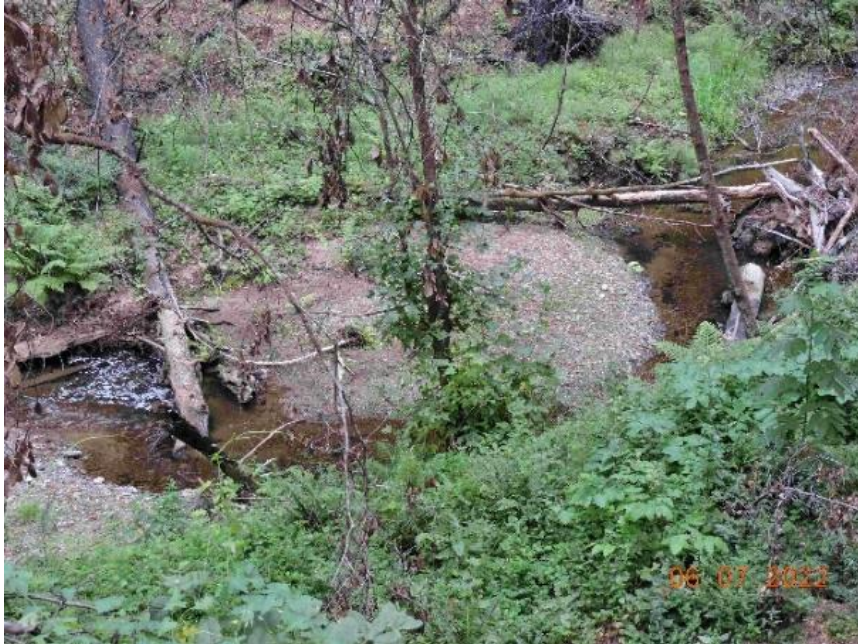
Photo 38. Mile 3.9. Formerly long deep pool at annual fish sampling site, now almost completely filled except local scour around new transported and fallen wood to right. The original deep pool was formed after the fallen Douglas fir (left in photo) was winched into the channel against a large stump and rootwad. The stump is now near the downstream end of the substantially filled pool.

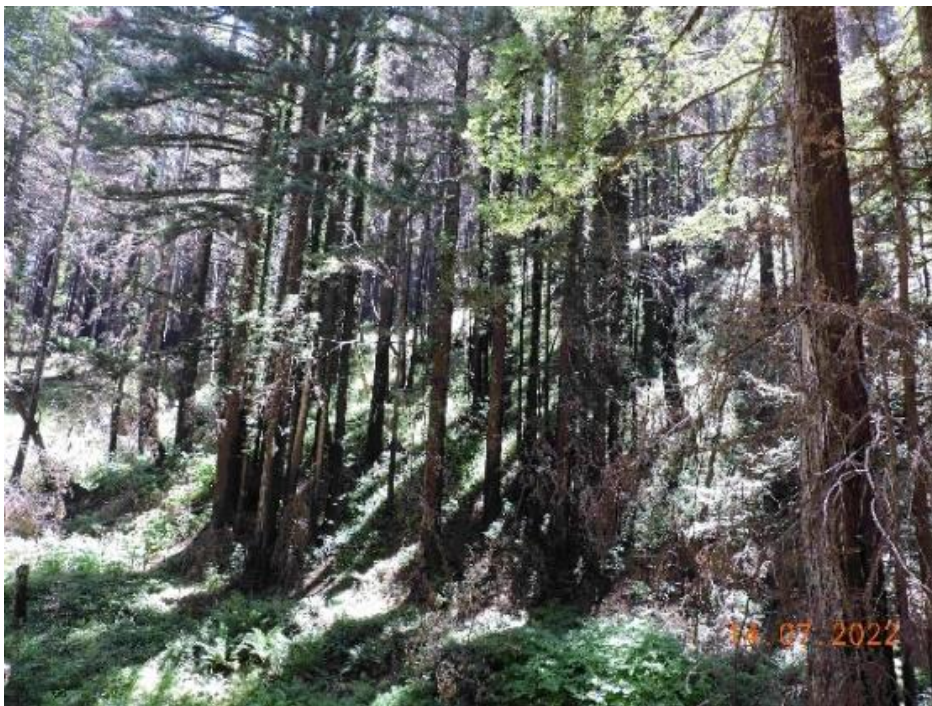
Photo 43. Mile 3.9. South slope with developed ground cover and most trees alive (although many tanbark oaks with only basal sprouts). Some small redwoods thought to be dead in 2021 have basal sprouts in 2022.

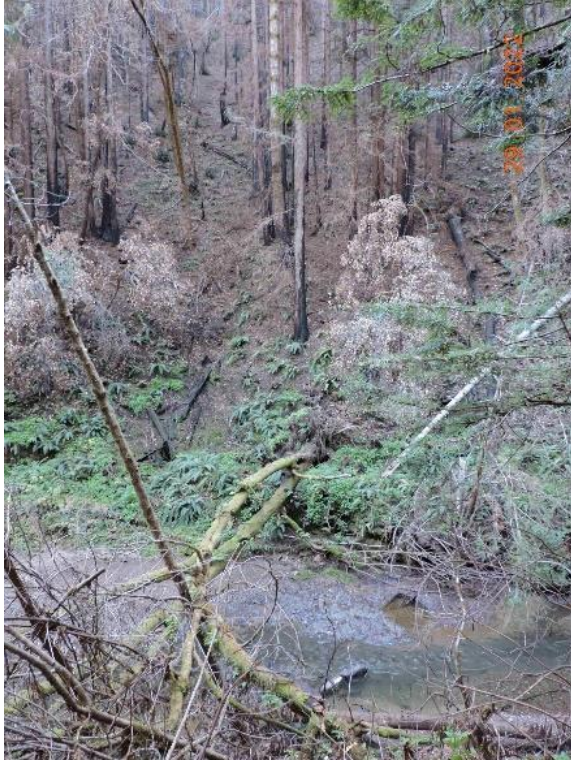
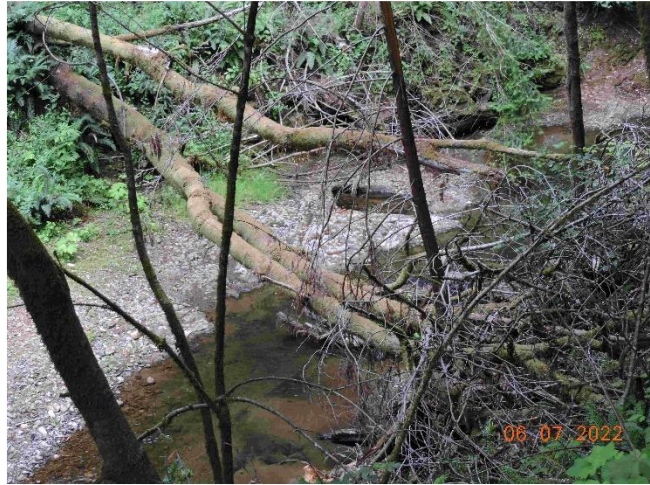
Photos 46 and 47. Mile 4.1-. (left) Upslope and channel habitat in January with fallen channel-spanning, big-leaf maple. (right) Aggraded, flat channel and the multi-trunk maple in July.

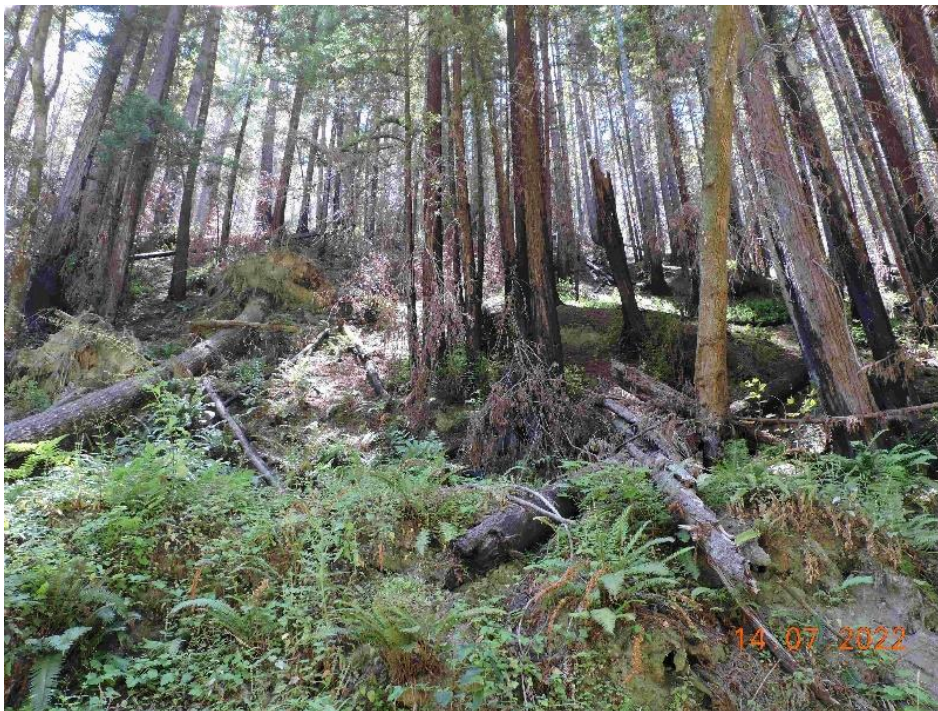
Photo 48. Mile 4.1+. South slope with burned but recovering redwoods and ground cover.

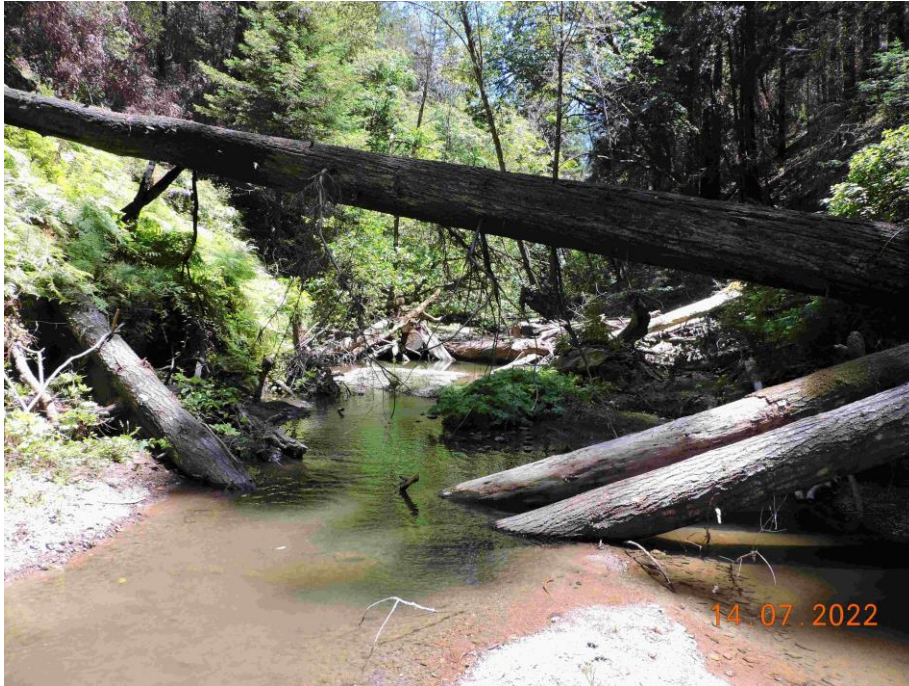
Photo 53. Mile 4.2-. Looking upstream, showing narrow, entrenched channel with new fallen logs in 2022 from fire. A major log jam from a debris flow with redwood trunks in 1999 is upstream in the background. It had been a significant fish passage barrier in about half of the years since. It was substantially dismantled in December 2021 (next two photos).

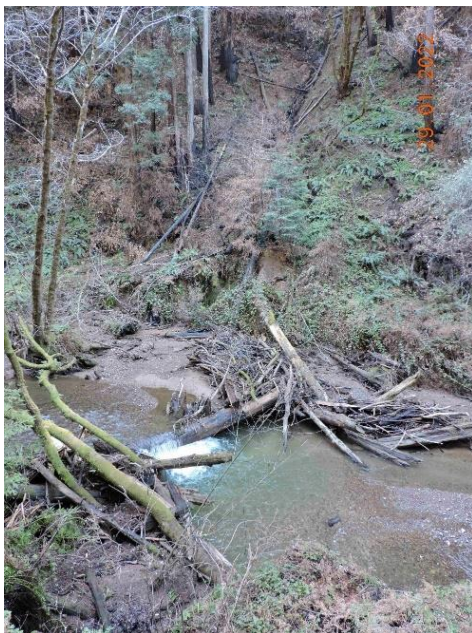
January Photo 54. Mile 4.2. Blown out major jam (of upslope trunks, captured debris, and right bank multi-trunked maple) present since 1999. This jam is now passable to adult steelhead and coho, with a deep jump pool and 2+ ft jump over the spanning log.

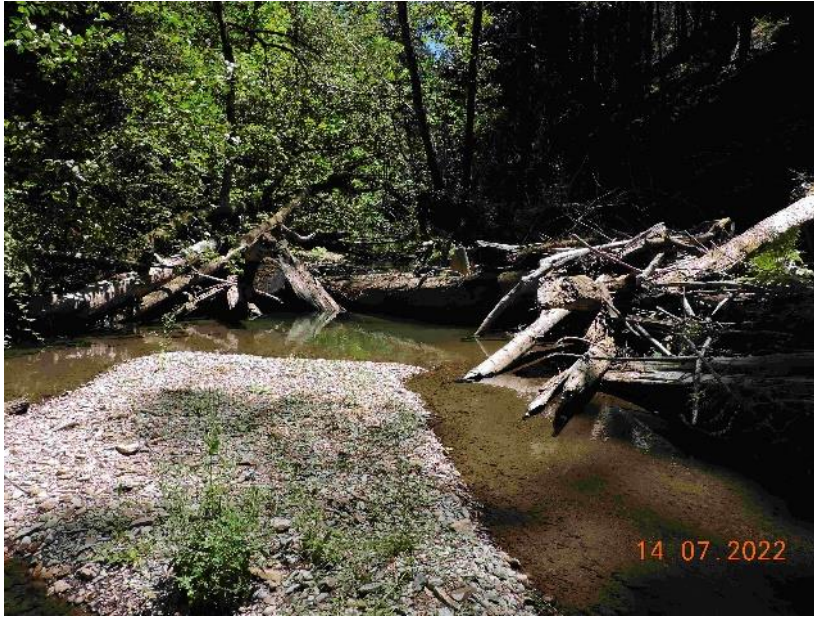
Photo 55. Mile 4.2, view from downstream of the jam formed in 1999. About three-fourths of the accumulated wood in the jam was lost downstream in winter 2021-2022. That wood is substantially responsible for the jam at mile 4.1. The aggraded channel upstream of the jam released substantial stored sediment downstream when the jam was partially dismantled.

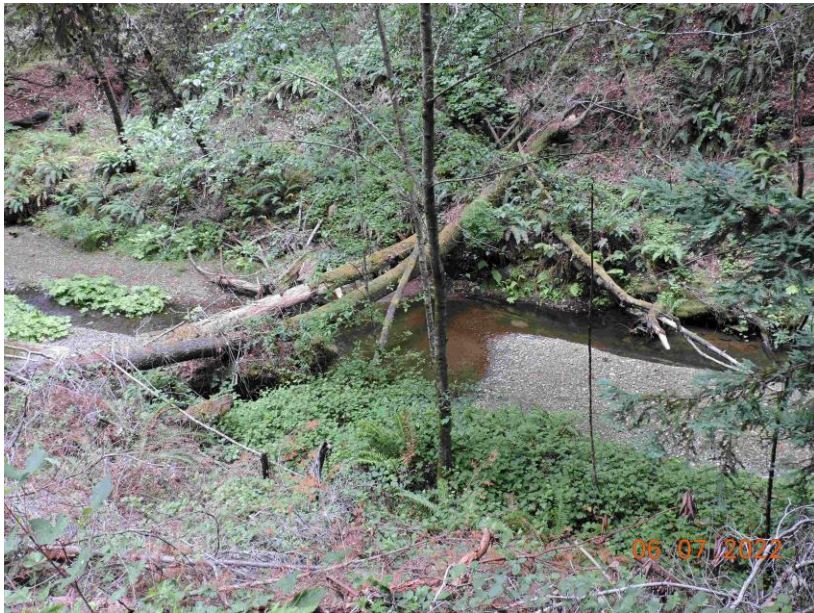
Photo 56. Mile 4.4. Long and deep fish sampling pool was formed after 1999 installation of 2 Douglas fir logs across channel. Pool is now filled with fines and gravel except immediately under the wood. Streambed immediately downstream leveled by October and December floods and bed-load movement. Several pools farther downstream were eliminated by channel down-cutting after the partial breakup of the logjam at mile 4.2.

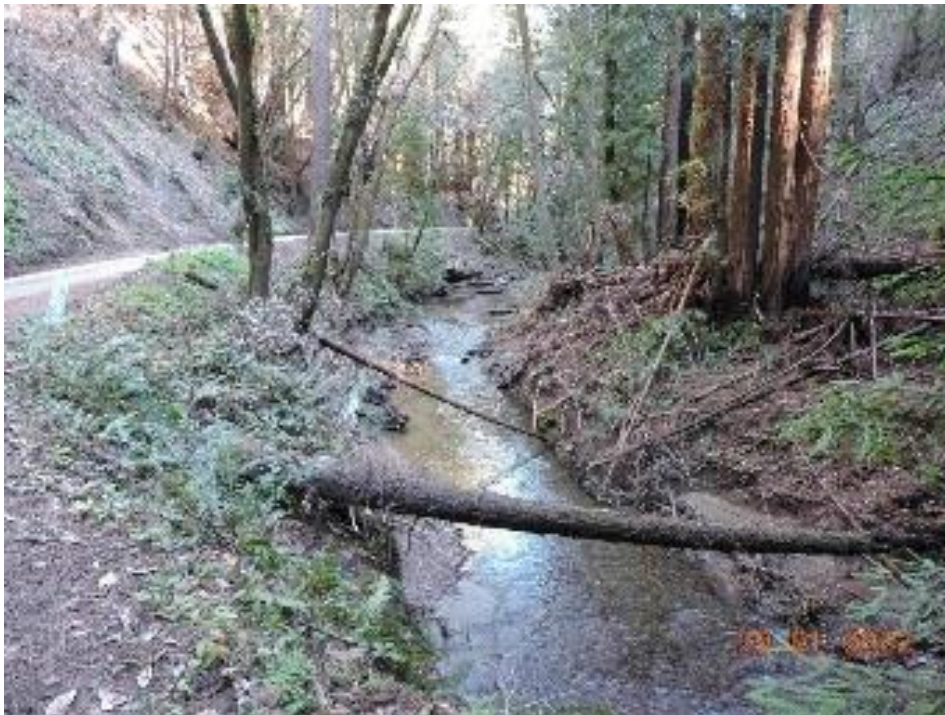
January Photo 66. Mile 4.9, looking upstream. Shallow entrenched channel close to road was leveled, and pool upstream of pullout (bottom of photo) was filled.

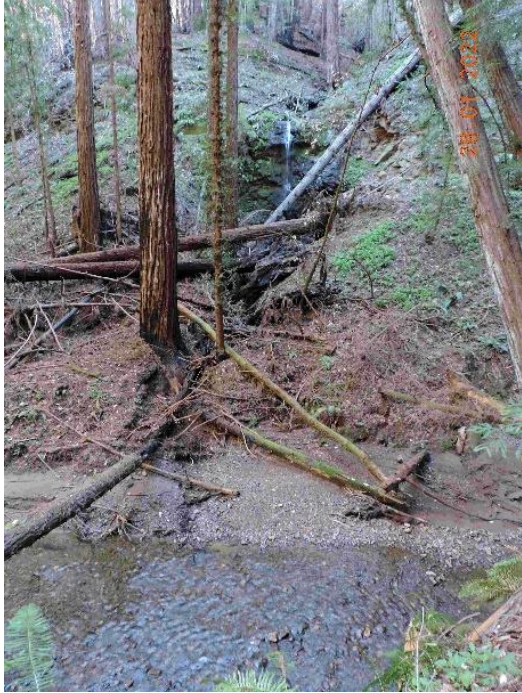
January Photo 67. Mile 4.9. South slope with scour line and widened and leveled stream bed (located at a steep flowing seasonal tributary). Dead trees have skidded down the steep slope.

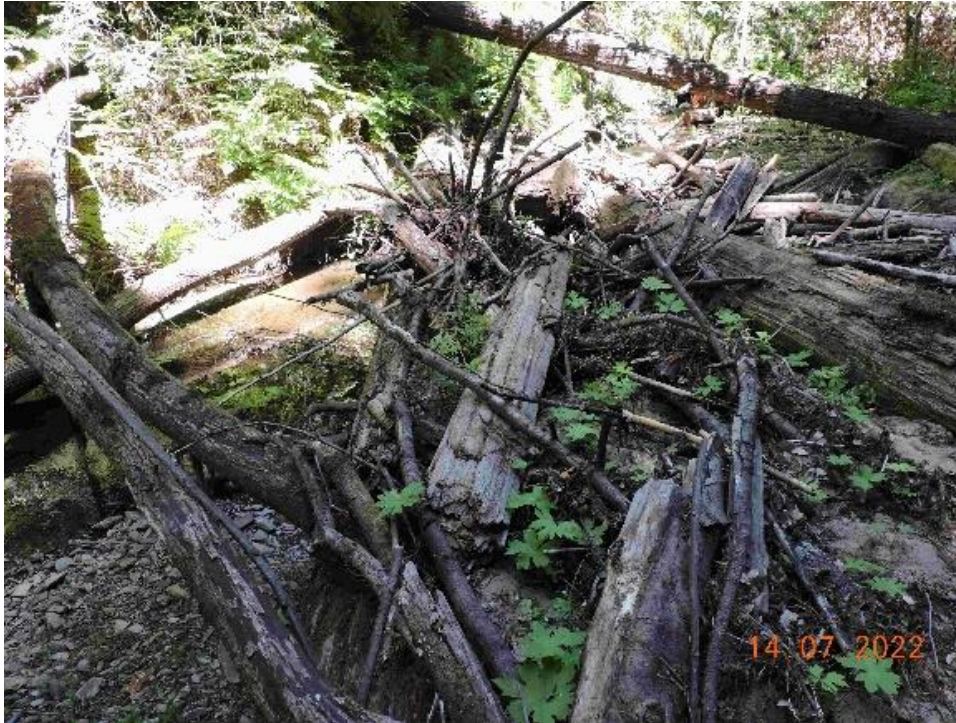
Photo 73. Mile 5.0+. The large upstream jam viewed from near the left bank.

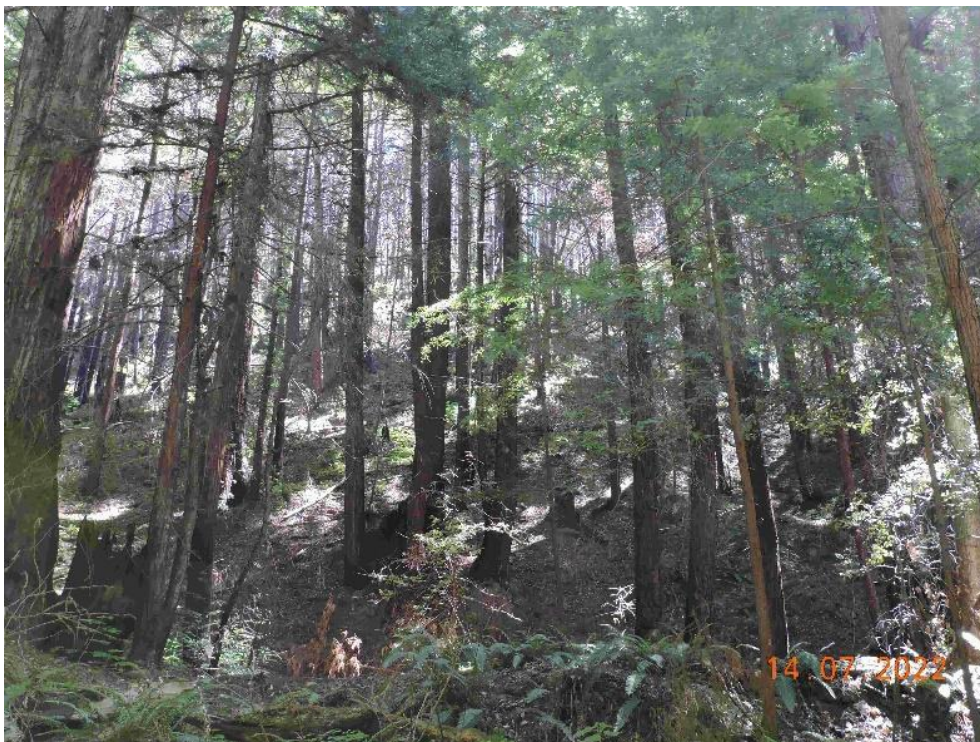
Photo 74. Mile 5.0+. The South slope with forest mostly recovering and ground cover partially reestablished.
