2022 Channel and Habitat Changes at Six Long-term Index Sites on Scott Creek from the CZU Fire.

Jerry J. Smith

31 October 2022

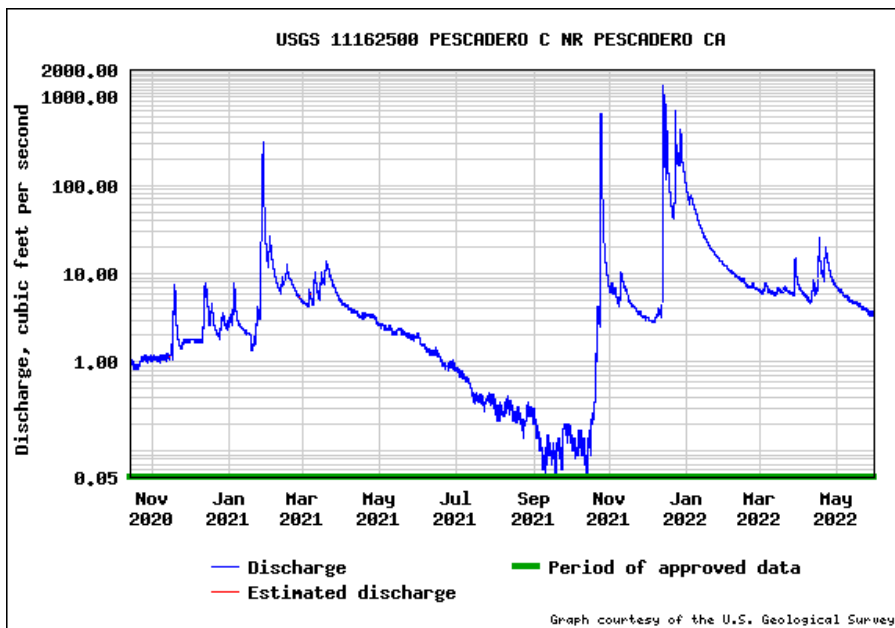
the Scotts Creek watershed (and in the Waddell and Gazos creek watersheds). In contrast, the winter of 2021-2022 had relatively large storms at the end of October and in December 2021 (Figure 2), before most recovery of the understory vegetation began. The storm flows were actually of higher magnitude in the watersheds of the CZU Fire in 2021-22 than the USGS gage for Pescadero Creek (Figure 2) indicates, since the Pescadero watershed was largely outside of the intense CZU Fire burn. Storm flow heights in Scott Creek were estimated to have been at least 1-2 times bankfull.

Figure 2. Low stream flow in Pescadero Creek in 2020-2021, with only a brief moderate late January storm, compared to relatively large storms in October and December 2021. The general pattern would be similar in Scott Creek, but with relatively larger flood peaks.
